## Profile/Photo Observation Report

Street:	<b>N LIVERPOOL RD</b>	Flow Control:	<b>Not Controlled</b>
City:	<b>Hobart, IN</b>	Year Renewed:	
Location:	<b>Light Highway</b>	Tape/Media #:	
Purpose:	<b>Routine Assessment</b>	Dia/Height:	<b>10"</b>
Use:	<b>Sanitary</b>	Material:	<b>VCP</b>
Drain Area:	<b>NA</b>	Lining:	
Category:	<b>NA</b>		
Comment:

Location Details:		Direction of Survey:	<b>Downstream</b>
US MH:	<b>M-303-052</b>	DS MH:	<b>M-303-051</b>
		Total Length Surveyed (ft):	<b>321.4</b>

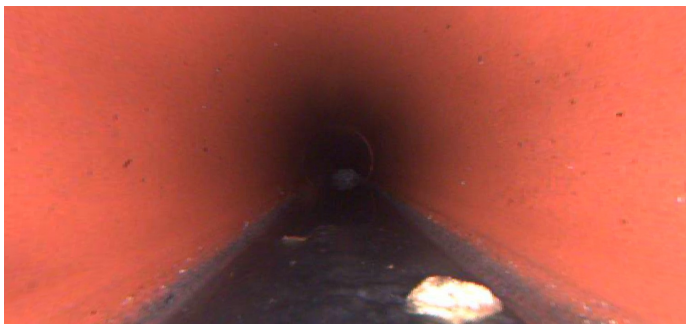
Code: **AMH**  
Description: **Manhole**

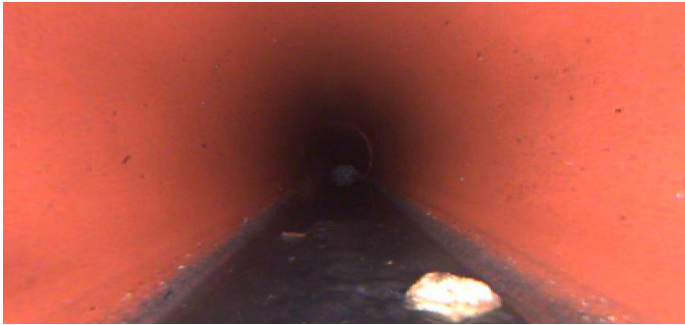
Code:	<b>MWL</b>
Description:	<b>Water Level</b>

Distance (ft):	<b>.0</b>
Structural Grade:	<b>0</b>
O&M Grade:	<b>0</b>
Clock Start/From:	
Clock To:	
1st Value:	
2nd Value:	
Value Percent:	<b>10.000</b>
Continuous Index:	
Within 8" of Joint:	<b>NO</b>
Remarks:

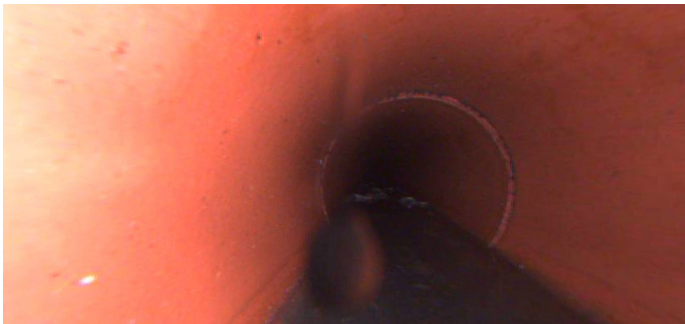
Code:	<b>MGO</b>
Description:	<b>General Observation</b>

Distance (ft):	<b>8.0</b>
Structural Grade:	<b>0</b>
O&M Grade:	<b>0</b>
Clock Start/From:	
Clock To:	
1st Value:	
2nd Value:	
Value Percent:	
Continuous Index:	
Within 8" of Joint:	<b>NO</b>
Remarks:	<b>WATER DROPLETS ON LENS FROM SPIDER WEBS</b>

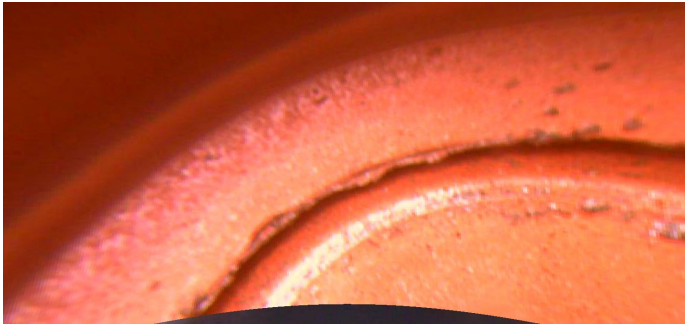
Code: **MGO**  
Description: **General Observation**

Distance (ft): **103.8**  
Structural Grade: **0**  
O&M Grade: **0**  
Clock Start/From:  
Clock To:  
1st Value:  
2nd Value:  
Value Percent:  
Continuous Index:  
Within 8" of Joint: **NO**  
Remarks: **ROBOT BRIEFLY IMMOBILE**

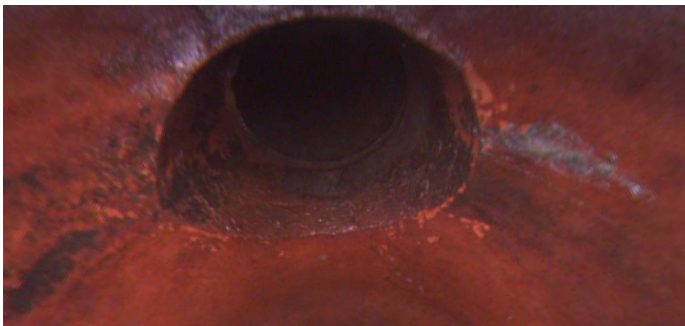
Code: **TF**  
Description: **Tap Factory**

Distance (ft): **153.7**  
Structural Grade: **0**  
O&M Grade: **0**  
Clock Start/From: **12**  
Clock To:  
1st Value: **4.000**  
2nd Value:  
Value Percent:  
Continuous Index:  
Within 8" of Joint:  
Remarks:

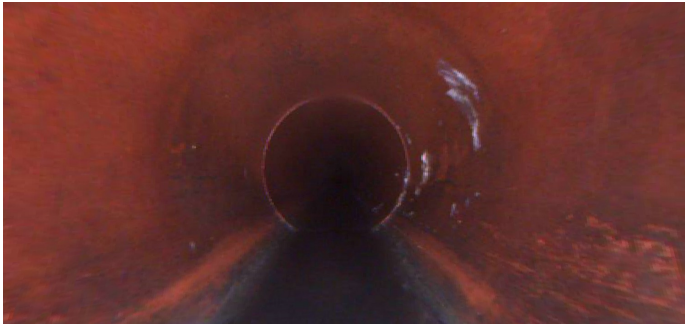
Code: **DAZ**  
Description: **Deposits Attached Other**

Distance (ft): **153.8**  
Structural Grade: **0**  
O&M Grade: **2**  
Clock Start/From: **3**  
Clock To: **5**  
1st Value:  
2nd Value:  
Value Percent: **5.000**  
Continuous Index:  
Within 8" of Joint: **NO**  
Remarks:

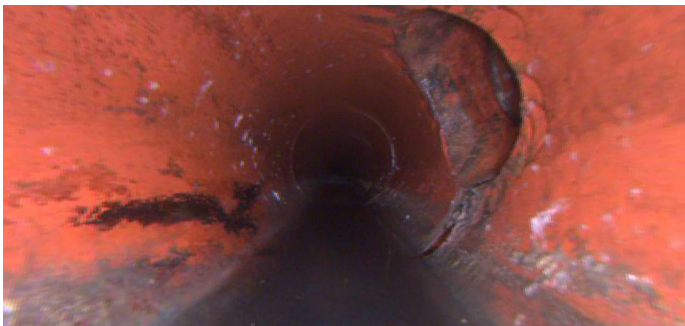
Code: **DAZ**  
Description: **Deposits Attached Other**

Distance (ft): **239.8**  
Structural Grade: **0**  
O&M Grade: **2**  
Clock Start/From: **7**  
Clock To: **5**  
1st Value:  
2nd Value:  
Value Percent: **5.000**  
Continuous Index:  
Within 8" of Joint: **NO**  
Remarks:

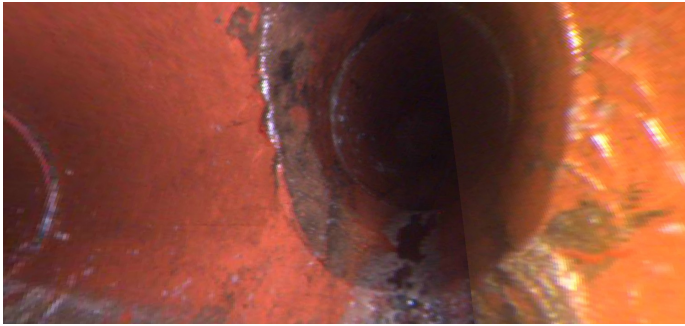
Code: **TF**  
Description: **Tap Factory**

Distance (ft): **240.6**  
Structural Grade: **0**  
O&M Grade: **0**  
Clock Start/From: **3**  
Clock To:  
1st Value: **4.000**  
2nd Value:  
Value Percent:  
Continuous Index:  
Within 8" of Joint:  
Remarks:

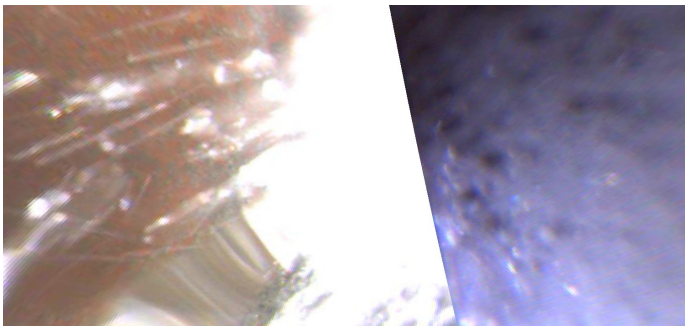
Code: **TFA**  
Description: **Tap Factory Active**

Distance (ft): **250.1**  
Structural Grade: **0**  
O&M Grade: **0**  
Clock Start/From: **9**  
Clock To:  
1st Value: **4.000**  
2nd Value:  
Value Percent:  
Continuous Index:  
Within 8" of Joint:  
Remarks: **SOAP SUDS COMING FROM TAP**

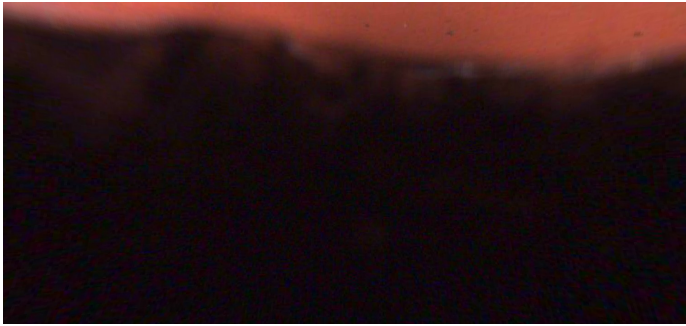
Code: **MCU**  
Description: **Camera Underwater**

Distance (ft): **309.6**  
Structural Grade: **0**  
O&M Grade: **4**  
Clock Start/From:  
Clock To:  
1st Value:  
2nd Value:  
Value Percent:  
Continuous Index:  
Within 8" of Joint: **NO**  
Remarks:

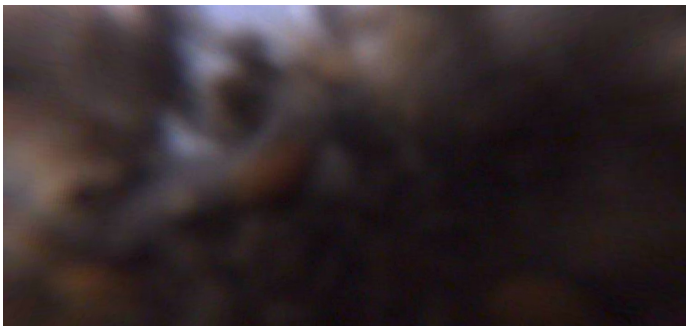
Code: **MCU**  
Description: **Camera Underwater**

Distance (ft): **320.0**  
Structural Grade: **0**  
O&M Grade: **4**  
Clock Start/From:  
Clock To:  
1st Value:  
2nd Value:  
Value Percent:  
Continuous Index:  
Within 8" of Joint: **NO**  
Remarks:
