## Profile/Photo Observation Report

Street:	<b>Maxwell St</b>	Flow Control:	<b>Not Controlled</b>
City:	<b>Hobart, IN</b>	Year Renewed:	
Location:	<b>Light Highway</b>	Tape/Media #:	
Purpose:	<b>Routine Assessment</b>	Dia/Height:	<b>10"</b>
Use:	<b>Sanitary</b>	Material:	<b>VCP</b>
Drain Area:	<b>NA</b>	Lining:	
Category:	<b>NA</b>		
Comment:

Location Details:		Direction of Survey:	<b>Downstream</b>
US MH:	<b>M-303-052</b>	DS MH:	<b>M-303-051</b>
		Total Length Surveyed (ft):	<b>321.4</b>

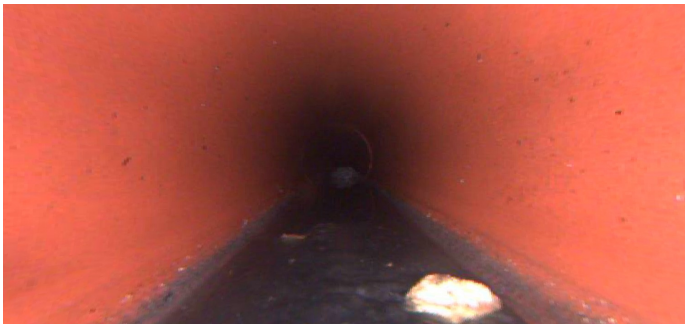
Code: **AMH**  
Description: **Manhole**

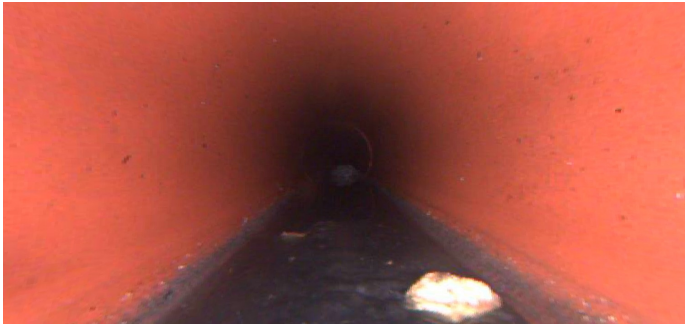
Code: **MWL**  
Description: **Water Level**

Distance (ft): **.0**  
Structural Grade: **0**  
O&M Grade: **0**  
Clock Start/From:  
Clock To:  
1st Value:  
2nd Value:  
Value Percent: **10.000**  
Continuous Index:  
Within 8" of Joint: **NO**  
Remarks:

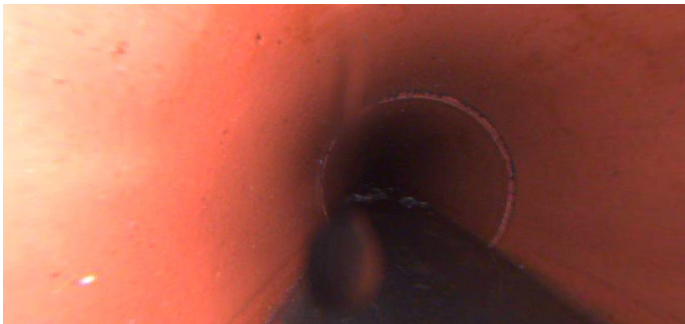
Code: **MGO**  
Description: **General Observation**

Distance (ft): **8.0**  
Structural Grade: **0**  
O&M Grade: **0**  
Clock Start/From:  
Clock To:  
1st Value:  
2nd Value:  
Value Percent:  
Continuous Index:  
Within 8" of Joint: **NO**  
Remarks: **WATER DROPLETS ON LENS FROM SPIDER WEBS**

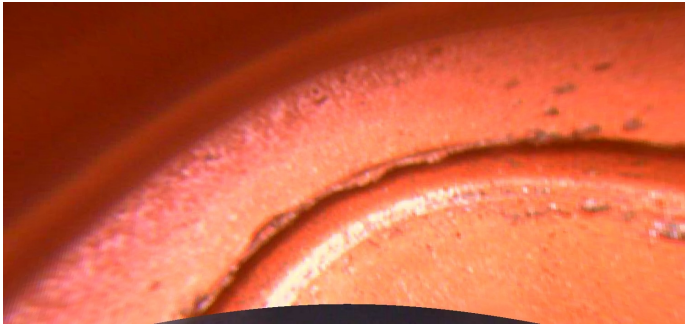
Code: **MGO**  
Description: **General Observation**

Distance (ft): **103.8**  
Structural Grade: **0**  
O&M Grade: **0**  
Clock Start/From:  
Clock To:  
1st Value:  
2nd Value:  
Value Percent:  
Continuous Index:  
Within 8" of Joint: **NO**  
Remarks: **ROBOT BRIEFLY IMMOBILE**

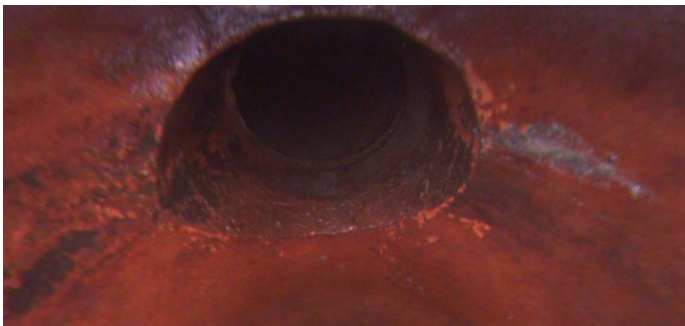
Code: **TF**  
Description: **Tap Factory**

Distance (ft): **153.7**  
Structural Grade: **0**  
O&M Grade: **0**  
Clock Start/From: **12**  
Clock To:  
1st Value: **4.000**  
2nd Value:  
Value Percent:  
Continuous Index:  
Within 8" of Joint:  
Remarks:

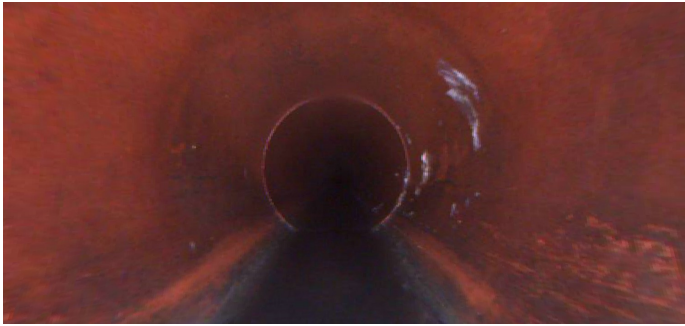
Code: **DAZ**  
Description: **Deposits Attached Other**

Distance (ft): **153.8**  
Structural Grade: **0**  
O&M Grade: **2**  
Clock Start/From: **3**  
Clock To: **5**  
1st Value:  
2nd Value:  
Value Percent: **5.000**  
Continuous Index:  
Within 8" of Joint: **NO**  
Remarks:

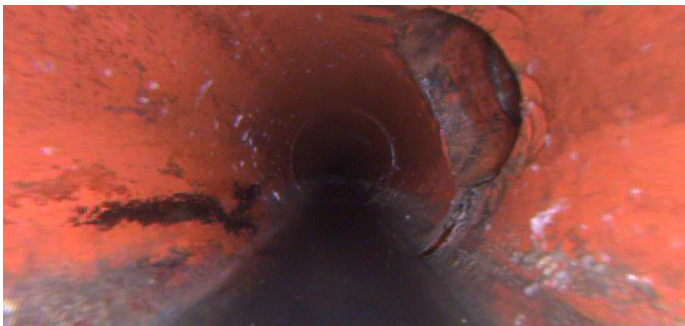
Code: **DAZ**  
Description: **Deposits Attached Other**

Distance (ft): **239.8**  
Structural Grade: **0**  
O&M Grade: **2**  
Clock Start/From: **7**  
Clock To: **5**  
1st Value:  
2nd Value:  
Value Percent: **5.000**  
Continuous Index:  
Within 8" of Joint: **NO**  
Remarks:

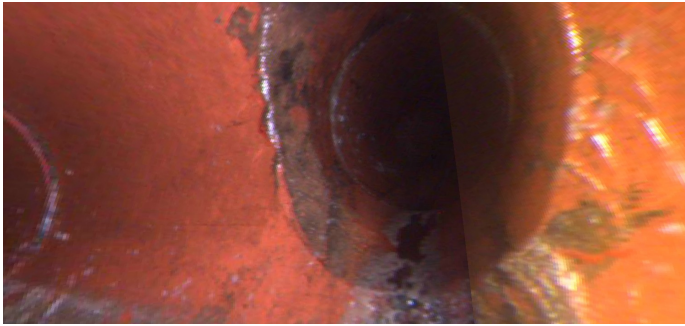
Code: **TF**  
Description: **Tap Factory**

Distance (ft): **240.6**  
Structural Grade: **0**  
O&M Grade: **0**  
Clock Start/From: **3**  
Clock To:  
1st Value: **4.000**  
2nd Value:  
Value Percent:  
Continuous Index:  
Within 8" of Joint:  
Remarks:

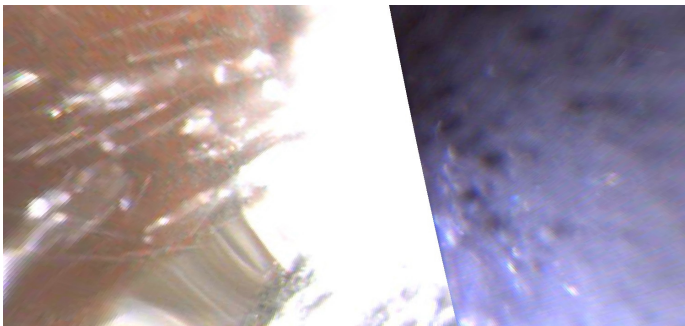
Code: **TFA**  
Description: **Tap Factory Active**

Distance (ft): **250.1**  
Structural Grade: **0**  
O&M Grade: **0**  
Clock Start/From: **9**  
Clock To:  
1st Value: **4.000**  
2nd Value:  
Value Percent:  
Continuous Index:  
Within 8" of Joint:  
Remarks: **SOAP SUDS COMING FROM TAP**

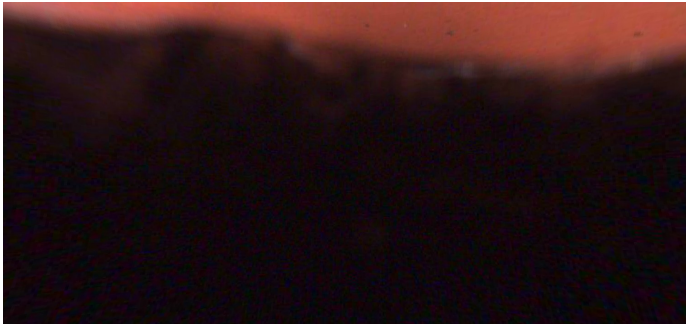
Code: **MCU**  
Description: **Camera Underwater**

Distance (ft): **309.6**  
Structural Grade: **0**  
O&M Grade: **4**  
Clock Start/From:  
Clock To:  
1st Value:  
2nd Value:  
Value Percent:  
Continuous Index:  
Within 8" of Joint: **NO**  
Remarks:

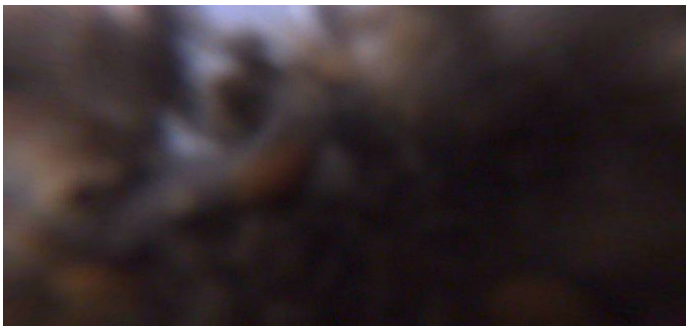
Code: **MCU**  
Description: **Camera Underwater**

Distance (ft): **320.0**  
Structural Grade: **0**  
O&M Grade: **4**  
Clock Start/From:  
Clock To:  
1st Value:  
2nd Value:  
Value Percent:  
Continuous Index:  
Within 8" of Joint: **NO**  
Remarks:
