## Profile/Photo Observation Report

Street:	<b>W HANSEN BLVD &amp; S HANSEN BLVD</b>	Flow Control:	<b>Not Controlled</b>
City:	<b>Hobart, IN</b>	Year Renewed:	
Location:	<b>Other</b>	Tape/Media #:	
Purpose:	<b>Not Known</b>	Dia/Height:	<b>10"</b>
Use:	<b>Sanitary</b>	Material:	<b>PVC</b>
Drain Area:	<b>NA</b>	Lining:	
Category:	<b>NA</b>		
Comment:

Location Details:		Direction of Survey:	<b>Downstream</b>
US MH:	<b>M-303-059</b>	DS MH:	<b>M-303-058</b>
		Total Length Surveyed (ft):	<b>200.6</b>

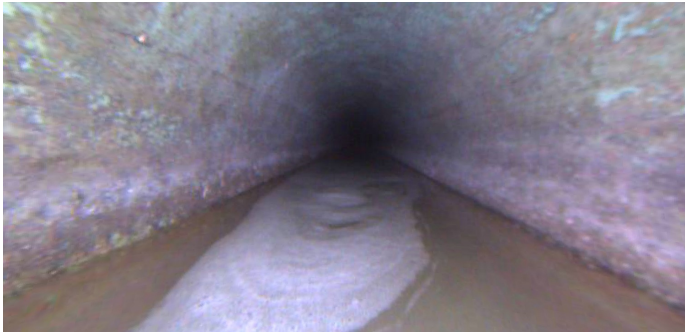
Code:	<b>MWL</b>
Description:	<b>Water Level</b>

Distance (ft):	<b>.0</b>
Structural Grade:	<b>0</b>
O&M Grade:	<b>0</b>
Clock Start/From:	
Clock To:	
1st Value:	
2nd Value:	
Value Percent:	<b>30.000</b>
Continuous Index:	
Within 8" of Joint:	<b>NO</b>
Remarks:

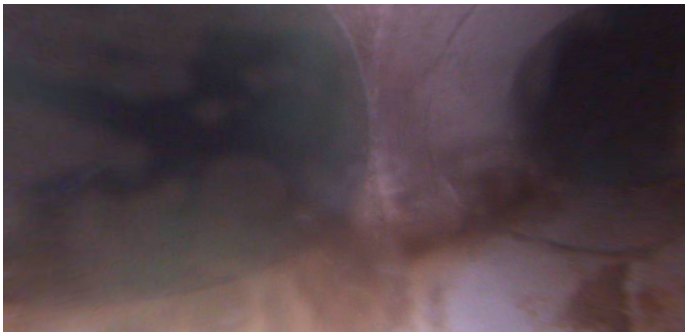
Code:	<b>TFA</b>
Description:	<b>Tap Factory Active</b>

Distance (ft):	<b>75.9</b>
Structural Grade:	<b>0</b>
O&M Grade:	<b>0</b>
Clock Start/From:	<b>3</b>
Clock To:	
1st Value:	<b>4.000</b>
2nd Value:	
Value Percent:	
Continuous Index:	
Within 8" of Joint:	
Remarks:

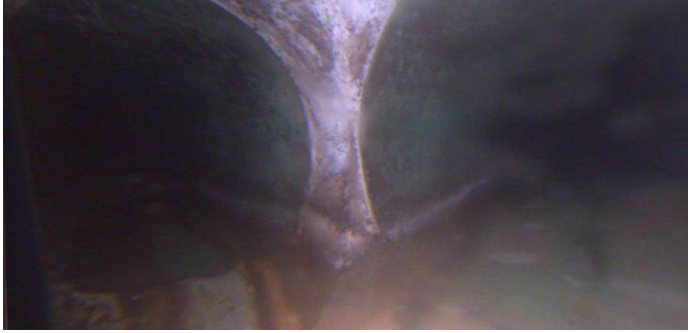
Code: **TFA**  
Description: **Tap Factory Active**

Distance (ft): **89.2**  
Structural Grade: **0**  
O&M Grade: **0**  
Clock Start/From: **9**  
Clock To:  
1st Value: **4.000**  
2nd Value:  
Value Percent:  
Continuous Index:  
Within 8" of Joint:  
Remarks:

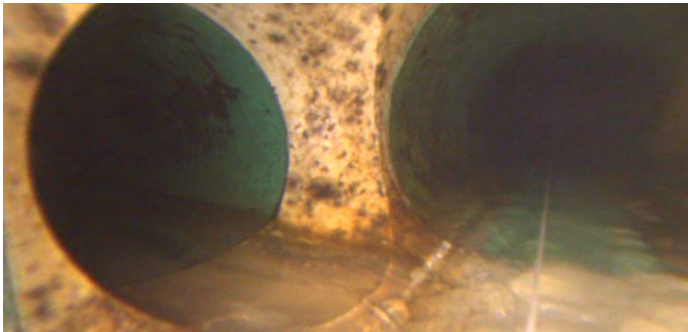
Code: **TFA**  
Description: **Tap Factory Active**

Distance (ft): **152.7**  
Structural Grade: **0**  
O&M Grade: **0**  
Clock Start/From: **3**  
Clock To:  
1st Value: **4.000**  
2nd Value:  
Value Percent:  
Continuous Index:  
Within 8" of Joint:  
Remarks:

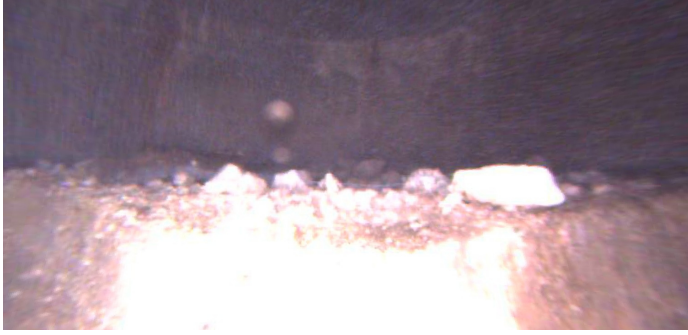
Code:	AMH
Description:	Manhole
Distance (ft):	200.6
Structural Grade:	0
O&M Grade:	0
Clock Start/From:	
Clock To:	
1st Value:	
2nd Value:	
Value Percent:	
Continuous Index:	
Within 8" of Joint:	NO
Remarks:	M-303-058
