Profile/Photo Observation Report

Date:	04/04/2018	Weather:		Coding:	PACP 6.0
Pipe Length (ft):	178.0	Owner:	NA	Pre Clean:	Not Known
P.O.#:		Surveyor:	Jen Costello	PSR:	P-303-060-059
Customer:		Clean Date:	01/01/1900	Shape:	C

Street:	W HANSEN BLVD & S HANSEN BLVD	Flow Control:	Not Controlled
City:	Hobart, IN	Year Renewed:	
Location:	Other	Tape/Media #:	
Purpose:	Not Known	Dia/Height:	10"
Use:	Sanitary	Material:	PVC
Drain Area:	NA	Lining:	
Category:	NA		
Comment:

Location Details:		Direction of Survey:	Downstream
US MH:	M-303-059	DS MH:	M-303-060
		Total Length Surveyed (ft):	170.8

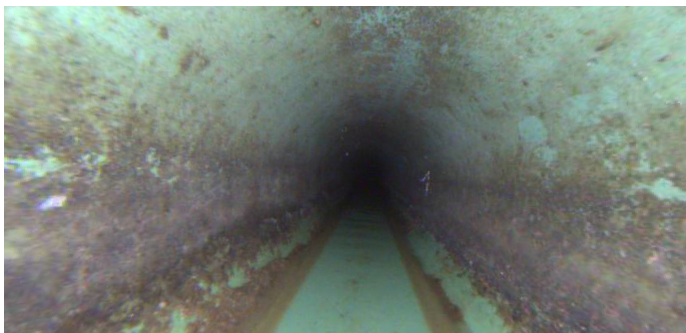
Code: **AMH**
Description: **Manhole**

Distance (ft): **.0**
Structural Grade: **0**
O&M Grade: **0**
Clock Start/From:
Clock To:
1st Value:
2nd Value:
Value Percent:
Continuous Index:
Within 8" of Joint: **NO**
Remarks: **M-303-059**

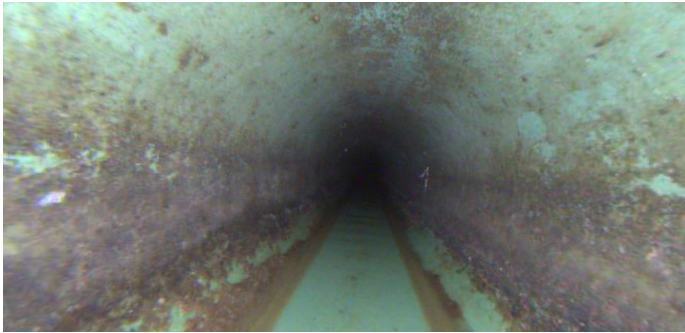
Code:	MWL
Description:	Water Level

Distance (ft):	.0
Structural Grade:	0
O&M Grade:	0
Clock Start/From:	
Clock To:	
1st Value:	
2nd Value:	
Value Percent:	5.000
Continuous Index:	
Within 8" of Joint:	NO
Remarks:

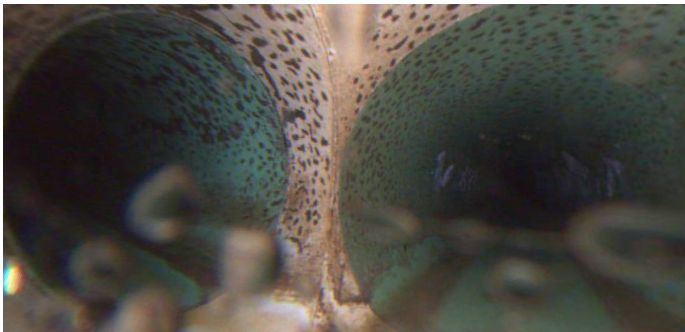
Code:	TFA
Description:	Tap Factory Active

Distance (ft):	50.3
Structural Grade:	0
O&M Grade:	0
Clock Start/From:	9
Clock To:	
1st Value:	4.000
2nd Value:	
Value Percent:	
Continuous Index:	
Within 8" of Joint:	
Remarks:

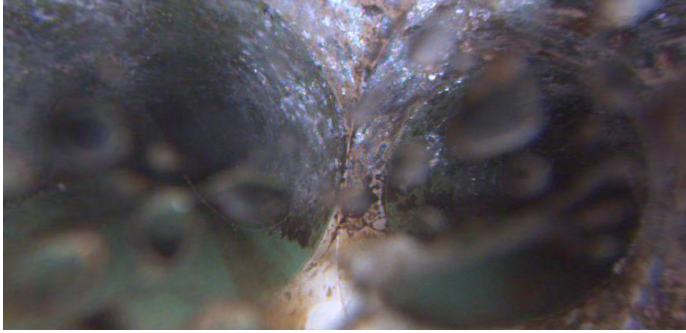
Code: **TF**
Description: **Tap Factory**

Distance (ft): **76.0**
Structural Grade: **0**
O&M Grade: **0**
Clock Start/From: **3**
Clock To:
1st Value: **4.000**
2nd Value:
Value Percent:
Continuous Index:
Within 8" of Joint:
Remarks:

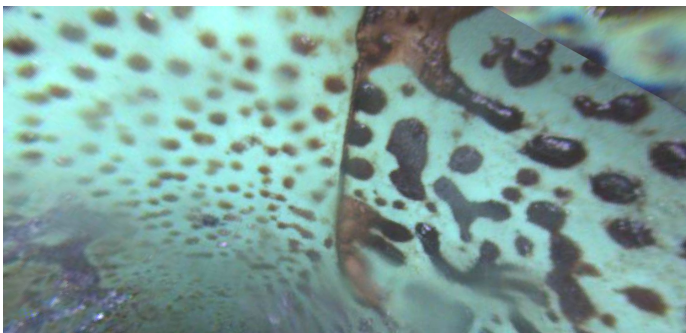
Code: **FL**
Description: **Fracture Longitudinal**

Distance (ft): **108.4**
Structural Grade: **3**
O&M Grade: **0**
Clock Start/From: **11**
Clock To:
1st Value:
2nd Value:
Value Percent:
Continuous Index:
Within 8" of Joint:
Remarks:

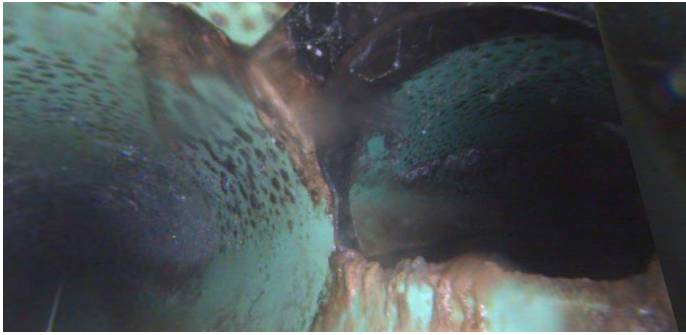
Code: **TBD**
Description: **Tap Break-in Defective**

Distance (ft): **108.9**
Structural Grade: **0**
O&M Grade: **3**
Clock Start/From: **9**
Clock To:
1st Value: **4.000**
2nd Value:
Value Percent:
Continuous Index:
Within 8" of Joint:
Remarks: **shifted connection**

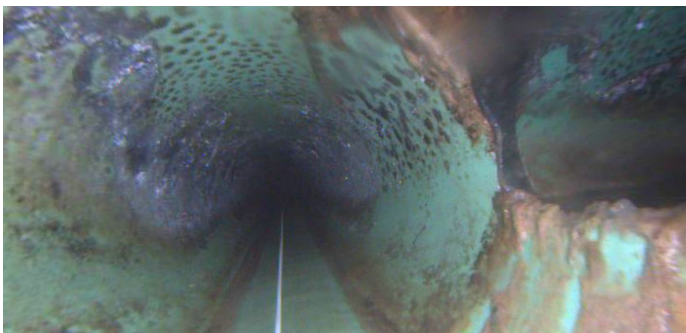
Code: **MGO**
Description: **General Observation**

Distance (ft): **108.9**
Structural Grade: **0**
O&M Grade: **0**
Clock Start/From:
Clock To:
1st Value:
2nd Value:
Value Percent:
Continuous Index:
Within 8" of Joint: **NO**
Remarks: **rear camera**

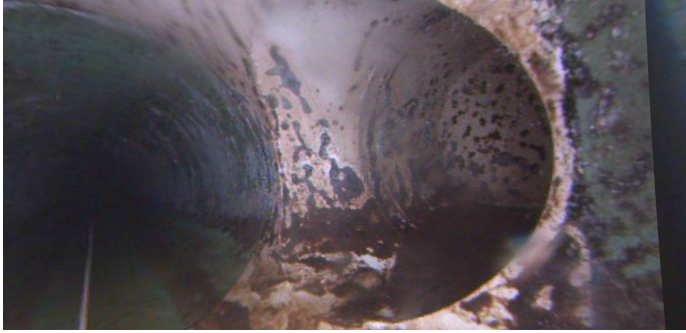
Code: **TFC**
Description: **Tap Factory Capped**

Distance (ft): **140.3**
Structural Grade: **0**
O&M Grade: **0**
Clock Start/From: **9**
Clock To:
1st Value: **4.000**
2nd Value:
Value Percent:
Continuous Index:
Within 8" of Joint:
Remarks:

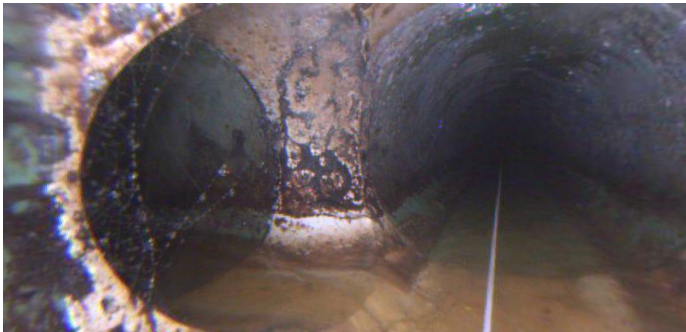
Code: **TFA**
Description: **Tap Factory Active**

Distance (ft): **153.5**
Structural Grade: **0**
O&M Grade: **0**
Clock Start/From: **3**
Clock To:
1st Value: **4.000**
2nd Value:
Value Percent:
Continuous Index:
Within 8" of Joint:
Remarks:

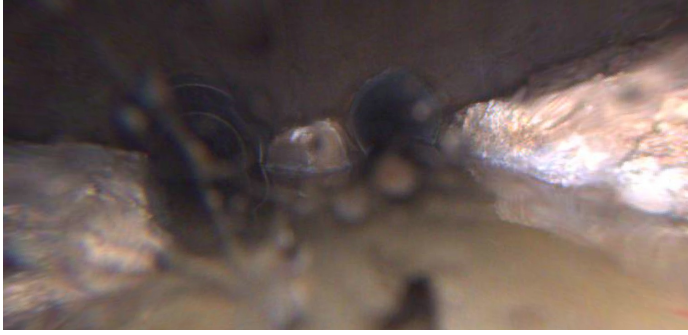
Code:	AMH
Description:	Manhole
Distance (ft):	170.8
Structural Grade:	0
O&M Grade:	0
Clock Start/From:	
Clock To:	
1st Value:	
2nd Value:	
Value Percent:	
Continuous Index:	
Within 8" of Joint:	NO
Remarks:	M-303-060
