## Profile/Photo Observation Report

Date:	<b>04/04/2018</b>	Weather:		Coding:	<b>PACP 6.0</b>
Pipe Length (ft):	<b>178.0</b>	Owner:	<b>NA</b>	Pre Clean:	<b>Not Known</b>
P.O.#:		Surveyor:	<b>Jen Costello</b>	PSR:	<b>P-303-060-059</b>
Customer:		Clean Date:	<b>01/01/1900</b>	Shape:	<b>C</b>

Street:	<b>w hansen blvd</b>	Flow Control:	<b>Not Controlled</b>
City:	<b>Hobart, IN</b>	Year Renewed:	
Location:	<b>Other</b>	Tape/Media #:	
Purpose:	<b>Not Known</b>	Dia/Height:	<b>10"</b>
Use:	<b>Sanitary</b>	Material:	<b>PVC</b>
Drain Area:	<b>NA</b>	Lining:	
Category:	<b>NA</b>		
Comment:

Location Details:		Direction of Survey:	<b>Downstream</b>
US MH:	<b>M-303-059</b>	DS MH:	<b>M-303-060</b>
		Total Length Surveyed (ft):	<b>170.8</b>

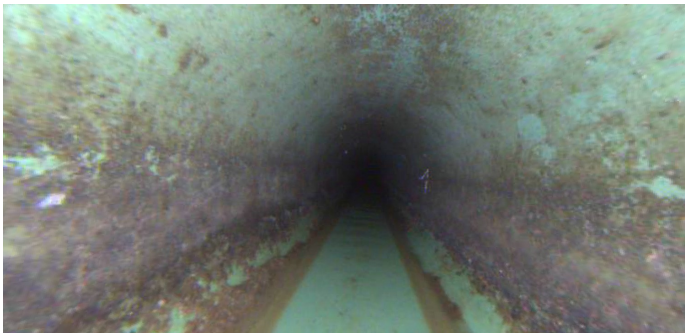
Code: **AMH**  
Description: **Manhole**

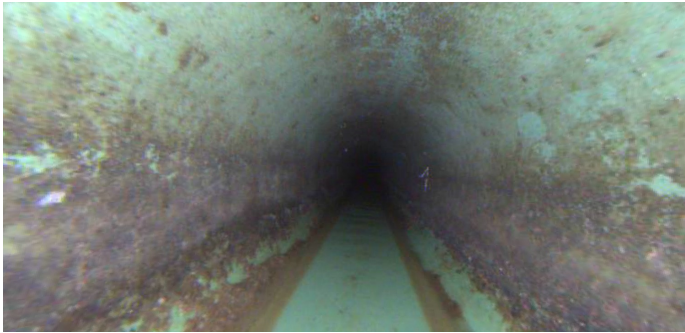
Code:	<b>MWL</b>
Description:	<b>Water Level</b>

Distance (ft):	<b>.0</b>
Structural Grade:	<b>0</b>
O&M Grade:	<b>0</b>
Clock Start/From:	
Clock To:	
1st Value:	
2nd Value:	
Value Percent:	<b>5.000</b>
Continuous Index:	
Within 8" of Joint:	<b>NO</b>
Remarks:

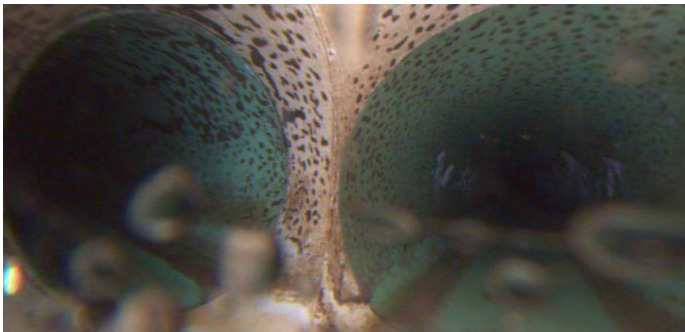
Code:	<b>TFA</b>
Description:	<b>Tap Factory Active</b>

Distance (ft):	<b>50.3</b>
Structural Grade:	<b>0</b>
O&M Grade:	<b>0</b>
Clock Start/From:	<b>9</b>
Clock To:	
1st Value:	<b>4.000</b>
2nd Value:	
Value Percent:	
Continuous Index:	
Within 8" of Joint:	
Remarks:

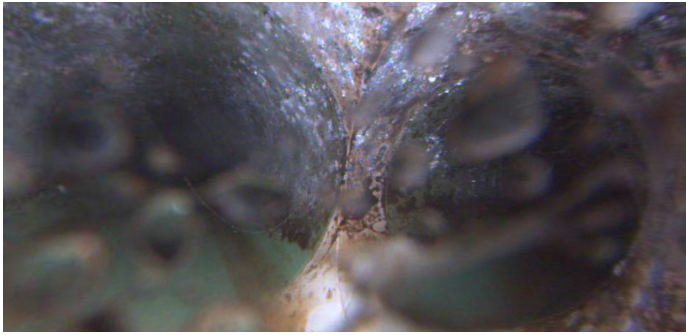
Code: **TF**  
Description: **Tap Factory**

Distance (ft): **76.0**  
Structural Grade: **0**  
O&M Grade: **0**  
Clock Start/From: **3**  
Clock To:  
1st Value: **4.000**  
2nd Value:  
Value Percent:  
Continuous Index:  
Within 8" of Joint:  
Remarks:

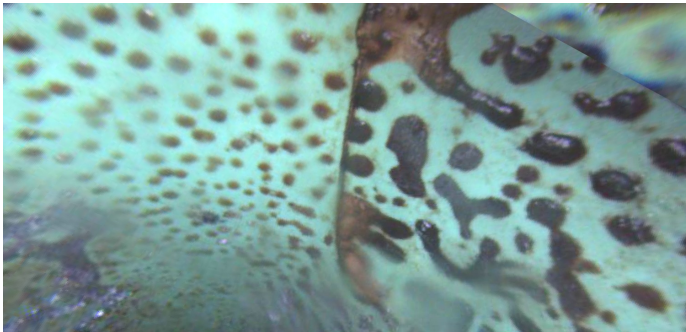
Code: **FL**  
Description: **Fracture Longitudinal**

Distance (ft): **108.4**  
Structural Grade: **3**  
O&M Grade: **0**  
Clock Start/From: **11**  
Clock To:  
1st Value:  
2nd Value:  
Value Percent:  
Continuous Index:  
Within 8" of Joint:  
Remarks:

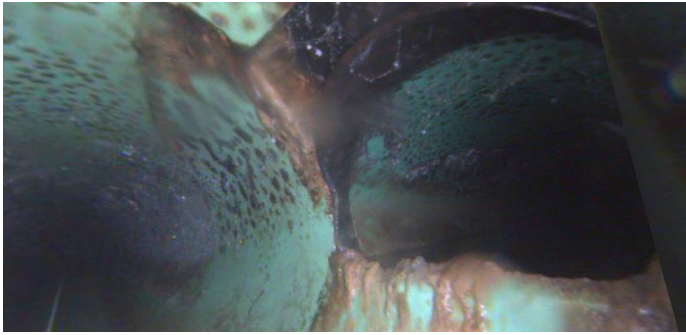
Code: **TBD**  
Description: **Tap Break-in Defective**

Distance (ft): **108.9**  
Structural Grade: **0**  
O&M Grade: **3**  
Clock Start/From: **9**  
Clock To:  
1st Value: **4.000**  
2nd Value:  
Value Percent:  
Continuous Index:  
Within 8" of Joint:  
Remarks: **shifted connection**

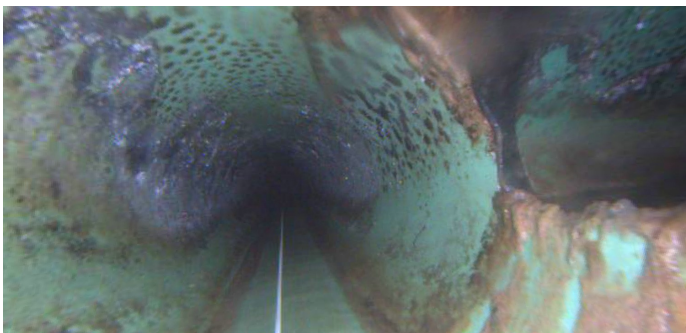
Code: **MGO**  
Description: **General Observation**

Distance (ft): **108.9**  
Structural Grade: **0**  
O&M Grade: **0**  
Clock Start/From:  
Clock To:  
1st Value:  
2nd Value:  
Value Percent:  
Continuous Index:  
Within 8" of Joint: **NO**  
Remarks: **rear camera**

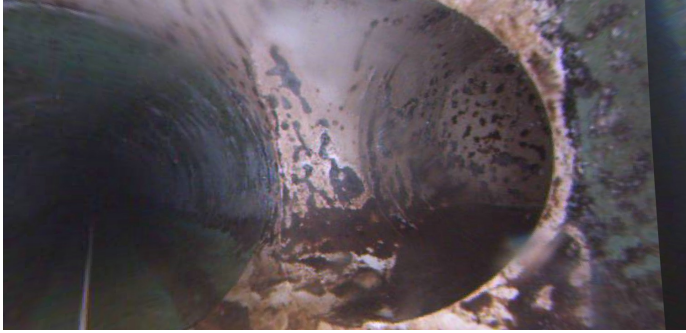
Code: **TFC**  
Description: **Tap Factory Capped**

Distance (ft): **140.3**  
Structural Grade: **0**  
O&M Grade: **0**  
Clock Start/From: **9**  
Clock To:  
1st Value: **4.000**  
2nd Value:  
Value Percent:  
Continuous Index:  
Within 8" of Joint:  
Remarks:

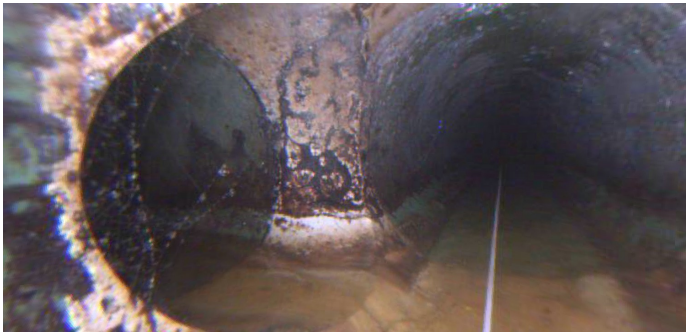
Code: **TFA**  
Description: **Tap Factory Active**

Distance (ft): **153.5**  
Structural Grade: **0**  
O&M Grade: **0**  
Clock Start/From: **3**  
Clock To:  
1st Value: **4.000**  
2nd Value:  
Value Percent:  
Continuous Index:  
Within 8" of Joint:  
Remarks:

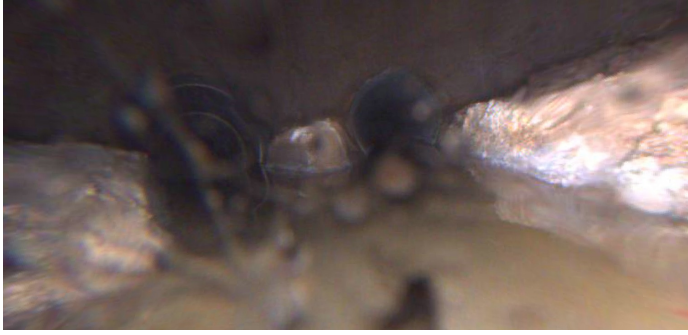
Code:	<b>AMH</b>
Description:	<b>Manhole</b>
Distance (ft):	<b>170.8</b>
Structural Grade:	<b>0</b>
O&M Grade:	<b>0</b>
Clock Start/From:	
Clock To:	
1st Value:	
2nd Value:	
Value Percent:	
Continuous Index:	
Within 8" of Joint:	<b>NO</b>
Remarks:	<b>M-303-060</b>
