Profile/Photo Observation Report

Date:	04/04/2018	Weather:		Coding:	PACP 6.0
Pipe Length (ft):	283.0	Owner:	NA	Pre Clean:	Not Known
P.O.#:		Surveyor:	Jen Costello	PSR:	P-303-061-060
Customer:		Clean Date:	01/01/1900	Shape:	C

Street:	w hansen blvd	Flow Control:	Not Controlled
City:	Hobart, IN	Year Renewed:	
Location:	Other	Tape/Media #:	
Purpose:	Not Known	Dia/Height:	10"
Use:	Sanitary	Material:	PVC
Drain Area:	NA	Lining:	
Category:	NA		
Comment:

Location Details:		Direction of Survey:	Upstream
US MH:	M-303-060	DS MH:	M-303-061
		Total Length Surveyed (ft):	277.8

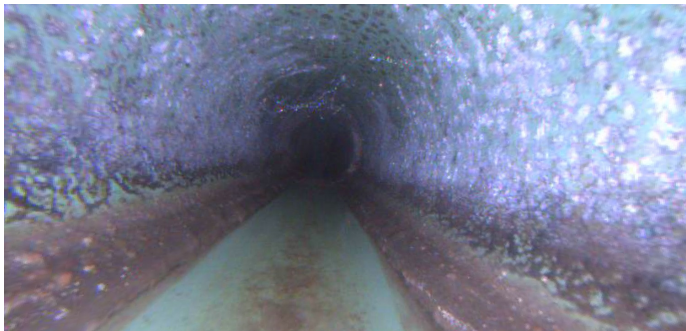
Code: **AMH**
Description: **Manhole**

Distance (ft): **.0**
Structural Grade: **0**
O&M Grade: **0**
Clock Start/From:
Clock To:
1st Value:
2nd Value:
Value Percent:
Continuous Index:
Within 8" of Joint: **NO**
Remarks: **M-303-061**

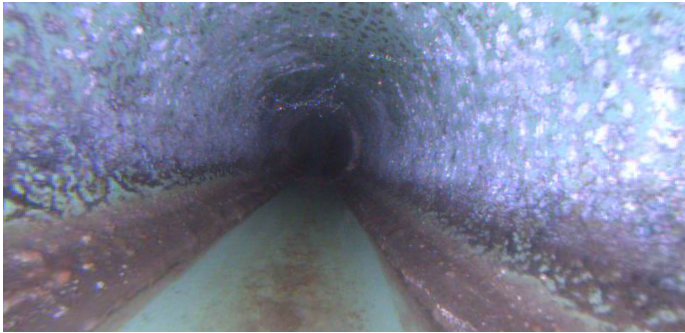
Code:	MWL
Description:	Water Level

Distance (ft):	.0
Structural Grade:	0
O&M Grade:	0
Clock Start/From:	
Clock To:	
1st Value:	
2nd Value:	
Value Percent:	5.000
Continuous Index:	
Within 8" of Joint:	NO
Remarks:

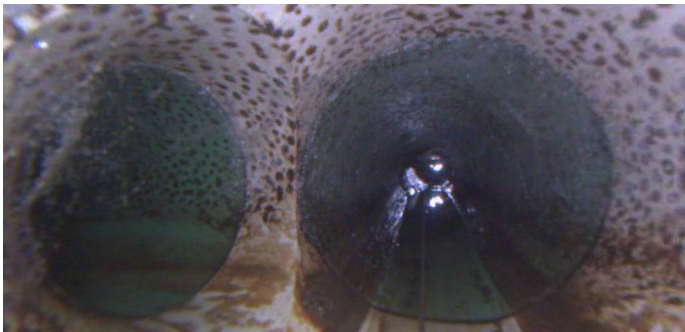
Code:	TF
Description:	Tap Factory

Distance (ft):	3.7
Structural Grade:	0
O&M Grade:	0
Clock Start/From:	3
Clock To:	
1st Value:	4.000
2nd Value:	
Value Percent:	
Continuous Index:	
Within 8" of Joint:	
Remarks:

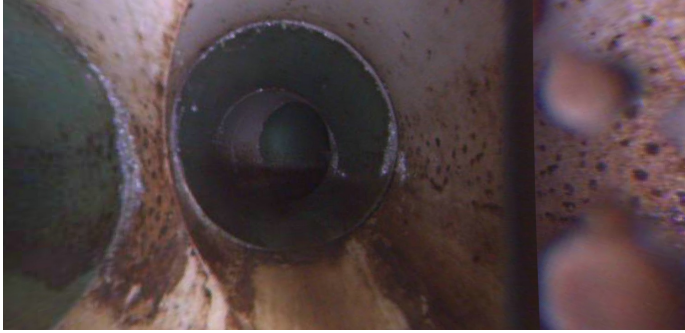
Code: **TF**
Description: **Tap Factory**

Distance (ft): **34.6**
Structural Grade: **0**
O&M Grade: **0**
Clock Start/From: **9**
Clock To:
1st Value: **4.000**
2nd Value:
Value Percent:
Continuous Index:
Within 8" of Joint:
Remarks:

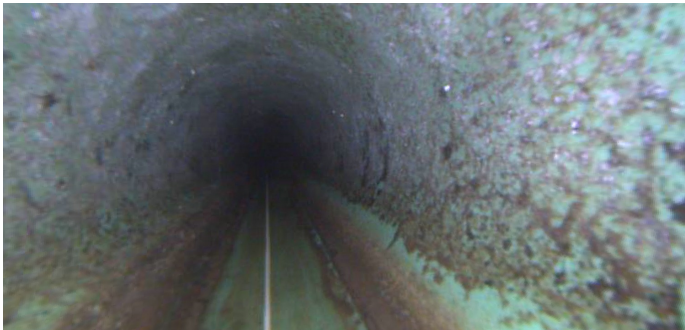
Code: **MGO**
Description: **General Observation**

Distance (ft): **92.8**
Structural Grade: **0**
O&M Grade: **0**
Clock Start/From:
Clock To:
1st Value:
2nd Value:
Value Percent:
Continuous Index:
Within 8" of Joint: **NO**
Remarks: **REAR CAMERA**

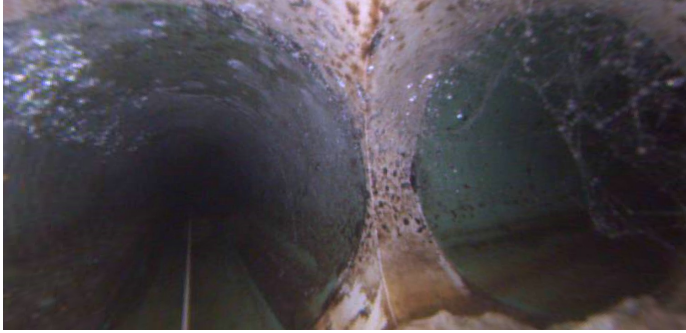
Code: **TFA**
Description: **Tap Factory Active**

Distance (ft): **95.0**
Structural Grade: **0**
O&M Grade: **0**
Clock Start/From: **9**
Clock To:
1st Value: **4.000**
2nd Value:
Value Percent:
Continuous Index:
Within 8" of Joint:
Remarks:

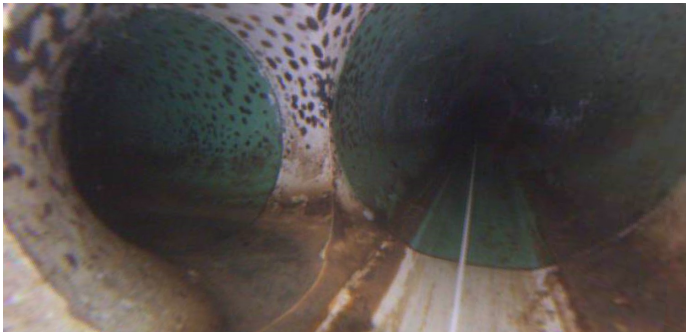
Code: **TFA**
Description: **Tap Factory Active**

Distance (ft): **98.6**
Structural Grade: **0**
O&M Grade: **0**
Clock Start/From: **3**
Clock To:
1st Value: **4.000**
2nd Value:
Value Percent:
Continuous Index:
Within 8" of Joint:
Remarks:

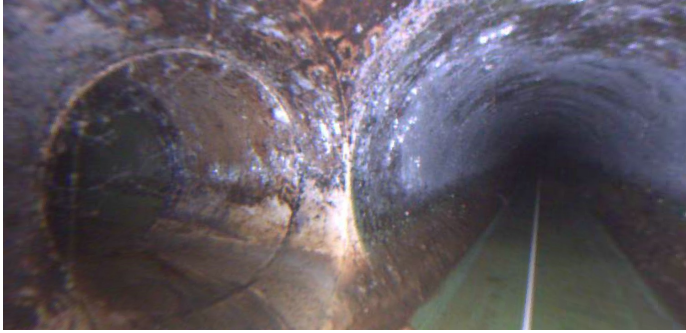
Code: **TFA**
Description: **Tap Factory Active**

Distance (ft): **162.2**
Structural Grade: **0**
O&M Grade: **0**
Clock Start/From: **3**
Clock To:
1st Value: **4.000**
2nd Value:
Value Percent:
Continuous Index:
Within 8" of Joint:
Remarks:

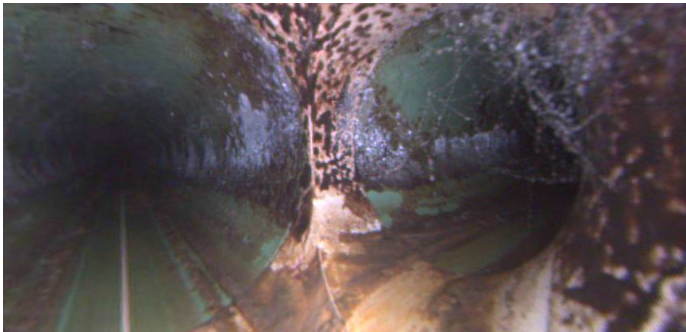
Code: **TFA**
Description: **Tap Factory Active**

Distance (ft): **175.3**
Structural Grade: **0**
O&M Grade: **0**
Clock Start/From: **9**
Clock To:
1st Value: **4.000**
2nd Value:
Value Percent:
Continuous Index:
Within 8" of Joint:
Remarks:

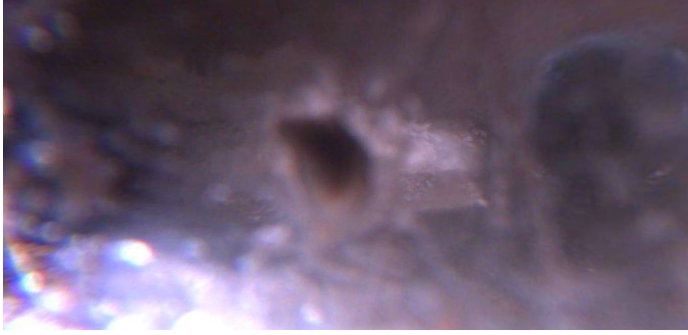
Code:	AMH
Description:	Manhole
Distance (ft):	277.8
Structural Grade:	0
O&M Grade:	0
Clock Start/From:	
Clock To:	
1st Value:	
2nd Value:	
Value Percent:	
Continuous Index:	
Within 8" of Joint:	NO
Remarks:	M-303-060
