Profile/Photo Observation Report

| Street: | w hansen blvd | Flow Control: | Not Controlled |
| City: | Hobart, IN | Year Renewed: | |

| US MH: | M-303-061 | DS MH: | M-303-062 |

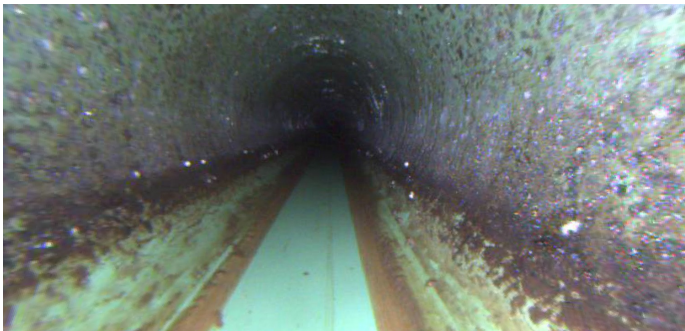
Code: **AMH**
Description: **Manhole**

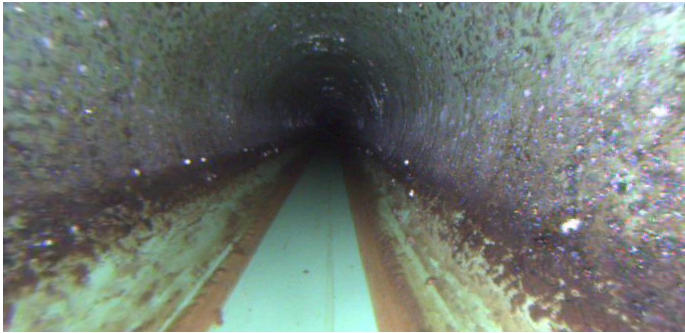
| Code: | MWL |
| Description: | Water Level |

| Value Percent: | 5.000 |

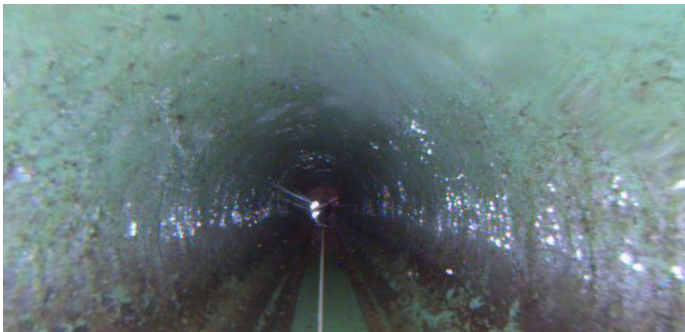
| Code: | MGO |
| Description: | General Observation |

| Remarks: | rear camera |

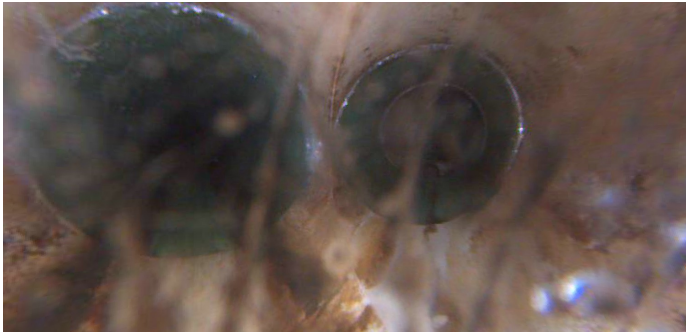
Code: **TF**
Description: **Tap Factory**

Distance (ft): **100.7**
Structural Grade: **0**
O&M Grade: **0**
Clock Start/From: **3**
Clock To:
1st Value: **4.000**
2nd Value:
Value Percent:
Continuous Index:
Within 8" of Joint:
Remarks:

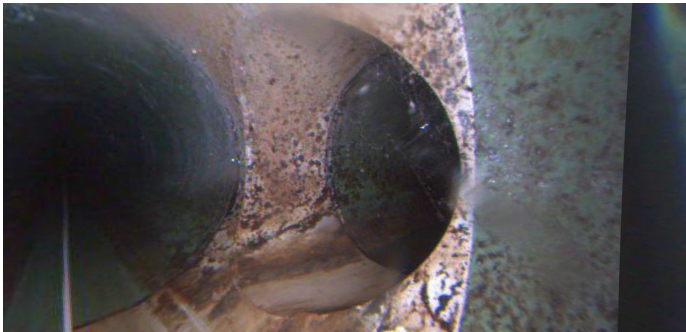
Code: **TF**
Description: **Tap Factory**

Distance (ft): **114.7**
Structural Grade: **0**
O&M Grade: **0**
Clock Start/From: **9**
Clock To:
1st Value: **4.000**
2nd Value:
Value Percent:
Continuous Index:
Within 8" of Joint:
Remarks:

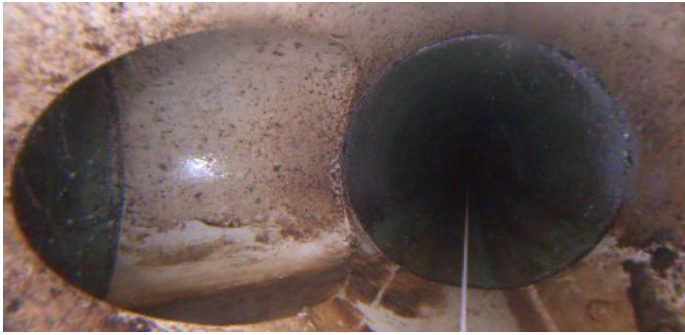
Code: **TFA**
Description: **Tap Factory Active**

Distance (ft): **165.5**
Structural Grade: **0**
O&M Grade: **0**
Clock Start/From: **3**
Clock To:
1st Value: **4.000**
2nd Value:
Value Percent:
Continuous Index:
Within 8" of Joint:
Remarks:

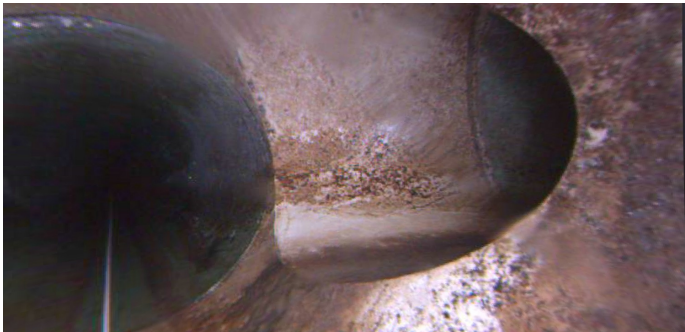
Code: **TFA**
Description: **Tap Factory Active**

Distance (ft): **178.7**
Structural Grade: **0**
O&M Grade: **0**
Clock Start/From: **9**
Clock To:
1st Value: **4.000**
2nd Value:
Value Percent:
Continuous Index:
Within 8" of Joint:
Remarks:

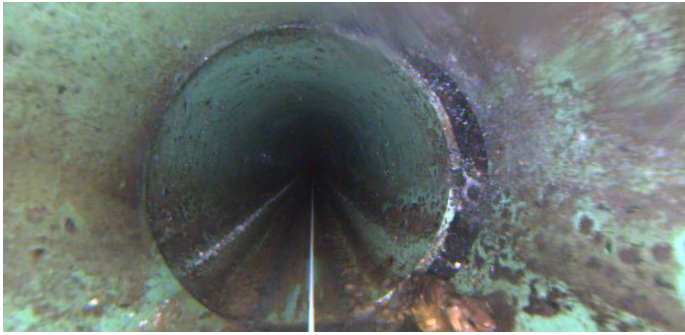
| Position | Code | Observation | Video (sec) | Grade |
|---|---|---|---|---|
| 228.3 | JOM | Joint Offset Medium | 555 | S 1 |

Code: **JOM**
Description: **Joint Offset Medium**

Distance (ft): **228.3**
Structural Grade: **1**
O&M Grade: **0**
Clock Start/From:
Clock To:
1st Value:
2nd Value:
Value Percent:
Continuous Index:
Within 8" of Joint: **NO**
Remarks:

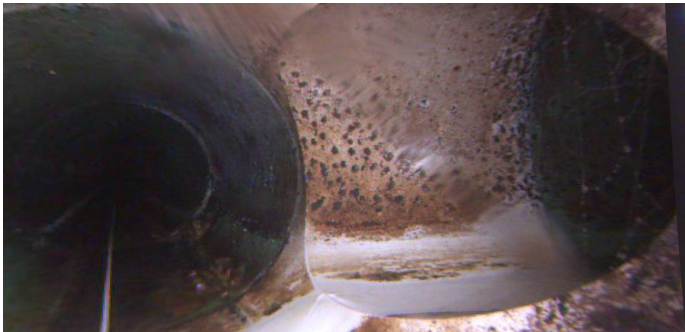
Code: **TFA**
Description: **Tap Factory Active**

Distance (ft): **229.3**
Structural Grade: **0**
O&M Grade: **0**
Clock Start/From: **9**
Clock To:
1st Value: **4.000**
2nd Value:
Value Percent:
Continuous Index:
Within 8" of Joint:
Remarks:

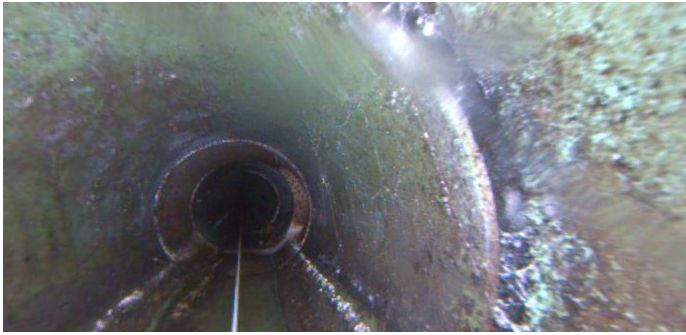
| Position | Code | Observation | Video (sec) | Grade |
|---|---|---|---|---|
| 230.9 | JOM | Joint Offset Medium | 584 | S 1 |

Code: **JOM**
Description: **Joint Offset Medium**

Distance (ft): **230.9**
Structural Grade: **1**
O&M Grade: **0**
Clock Start/From:
Clock To:
1st Value:
2nd Value:
Value Percent:
Continuous Index:
Within 8" of Joint: **NO**
Remarks:

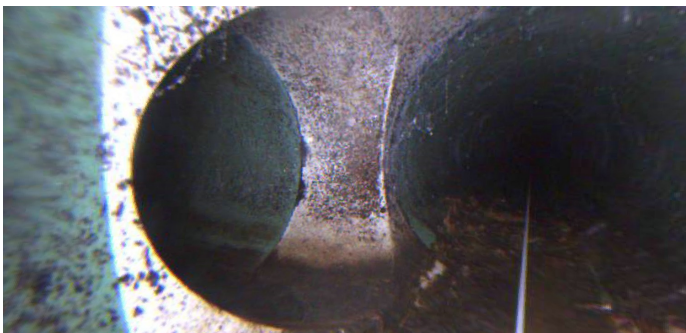
Code: **TFA**
Description: **Tap Factory Active**

Distance (ft): **242.0**
Structural Grade: **0**
O&M Grade: **0**
Clock Start/From: **3**
Clock To:
1st Value: **4.000**
2nd Value:
Value Percent:
Continuous Index:
Within 8" of Joint:
Remarks:

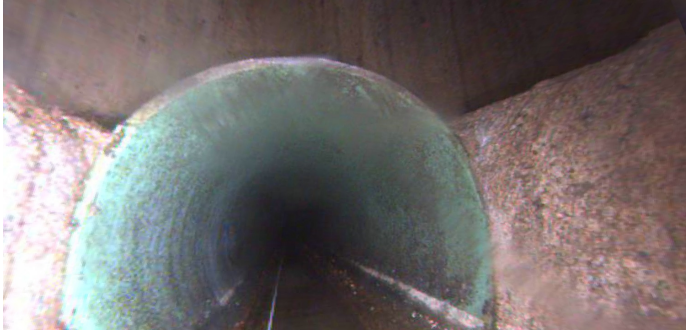
| Code: | AMH |
| Description: | Manhole |
| Distance (ft): | 277.8 |
| Remarks: | M-303-062 |
