Profile/Photo Observation Report

| Street: | w hansen blvd | Flow Control: | Not Controlled |
| City: | Hobart, IN | Year Renewed: | |

| US MH: | M-303-063 | DS MH: | M-303-059 |

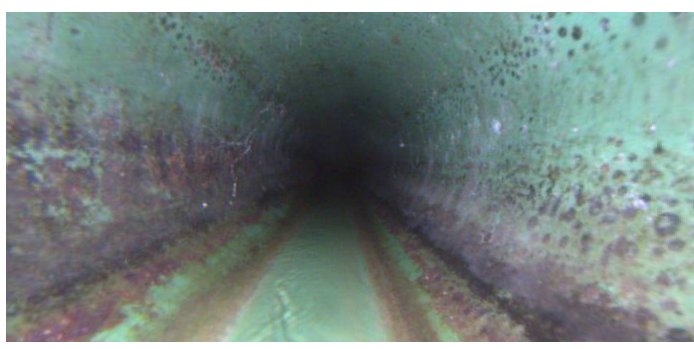
Code: **AMH**
Description: **Manhole**

Distance (ft): **.0**
Structural Grade: **0**
O&M Grade: **0**
Clock Start/From:
Clock To:
1st Value:
2nd Value:
Value Percent:
Continuous Index:
Within 8" of Joint: **NO**
Remarks: **M-303-059**

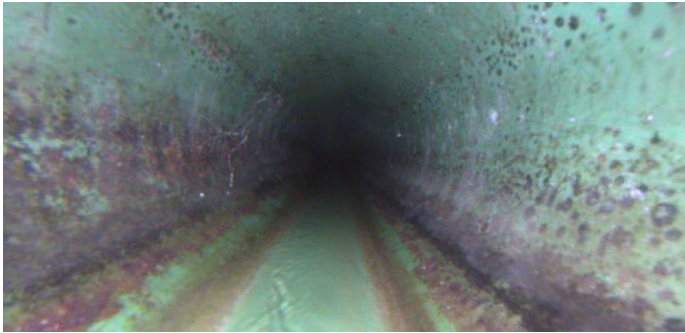
| Code: | MWL |
| Description: | Water Level |

| Distance (ft): | .0 |
| Value Percent: | 5.000 |

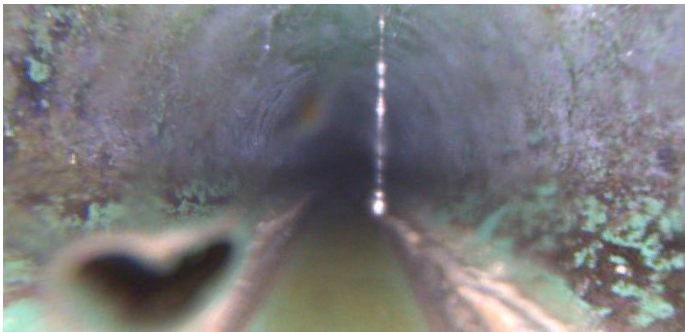
| Code: | MSA |
| Description: | Abandoned Survey |

| Distance (ft): | 66.9 |
| Remarks: | unknown |
