Profile/Photo Observation Report

Street:	W HANSEN BLVD & S HANSEN BLVD	Flow Control:	Not Controlled
City:	Hobart, IN	Year Renewed:	
Location:	Other	Tape/Media #:	
Purpose:	Not Known	Dia/Height:	10"
Use:	Sanitary	Material:	PVC
Drain Area:	NA	Lining:	
Category:	NA		
Comment:

Location Details:		Direction of Survey:	Downstream
US MH:	M-303-063	DS MH:	M-303-059
		Total Length Surveyed (ft):	97.0

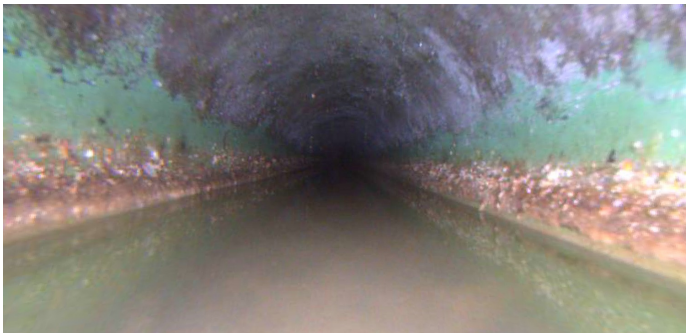
Code:	MWL
Description:	Water Level

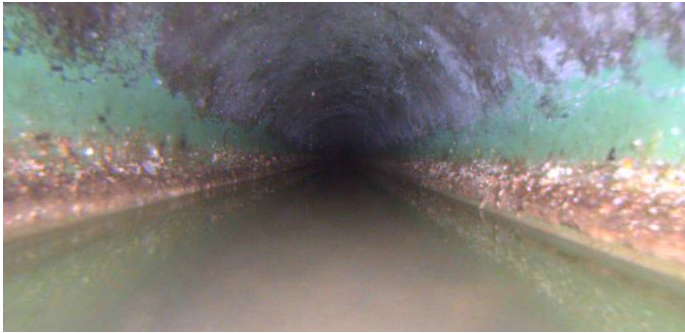
Distance (ft):	.0
Structural Grade:	0
O&M Grade:	0
Clock Start/From:	
Clock To:	
1st Value:	
2nd Value:	
Value Percent:	30.000
Continuous Index:	
Within 8" of Joint:	NO
Remarks:

Code:	DAGS
Description:	Deposits Attached Grease

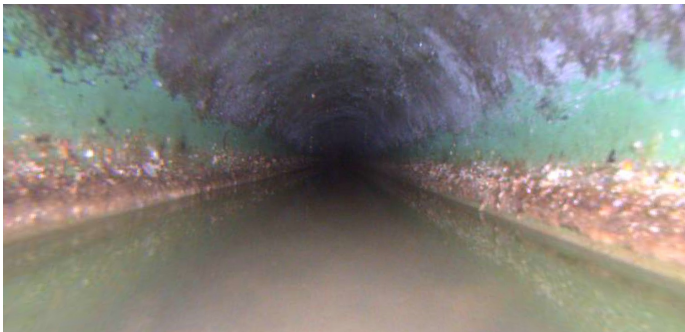
Distance (ft):	.0
Structural Grade:	0
O&M Grade:	2
Clock Start/From:	8
Clock To:	4
1st Value:	
2nd Value:	
Value Percent:	5.000
Continuous Index:	S01
Within 8" of Joint:	NO
Remarks:

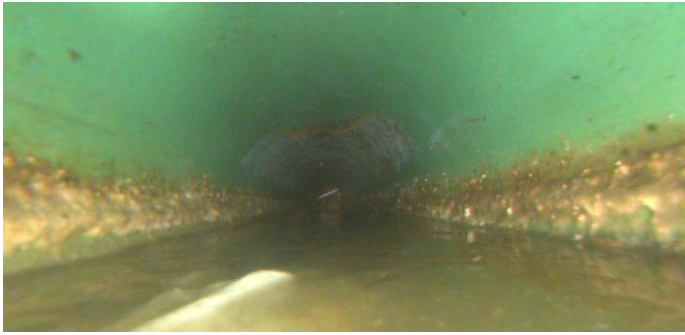
Code: **MGO**
Description: **General Observation**

Distance (ft): **7.5**
Structural Grade: **0**
O&M Grade: **0**
Clock Start/From:
Clock To:
1st Value:
2nd Value:
Value Percent:
Continuous Index:
Within 8" of Joint: **NO**
Remarks: **REAR CAMERA**

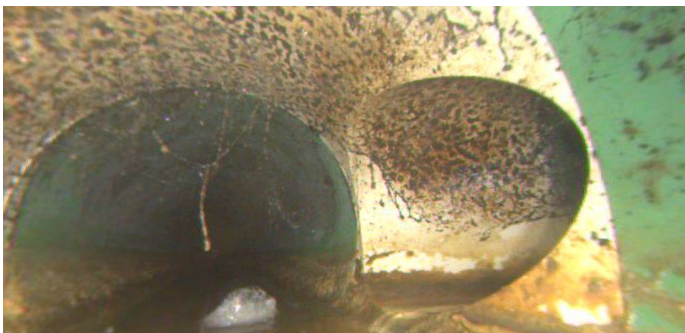
Code: **TFA**
Description: **Tap Factory Active**

Distance (ft): **50.5**
Structural Grade: **0**
O&M Grade: **0**
Clock Start/From: **9**
Clock To:
1st Value: **4.000**
2nd Value:
Value Percent:
Continuous Index:
Within 8" of Joint:
Remarks:

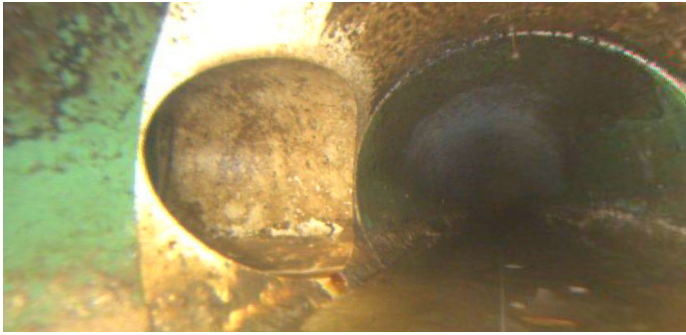
Code: **TF**
Description: **Tap Factory**

Distance (ft): **77.4**
Structural Grade: **0**
O&M Grade: **0**
Clock Start/From: **3**
Clock To:
1st Value: **4.000**
2nd Value:
Value Percent:
Continuous Index:
Within 8" of Joint:
Remarks:

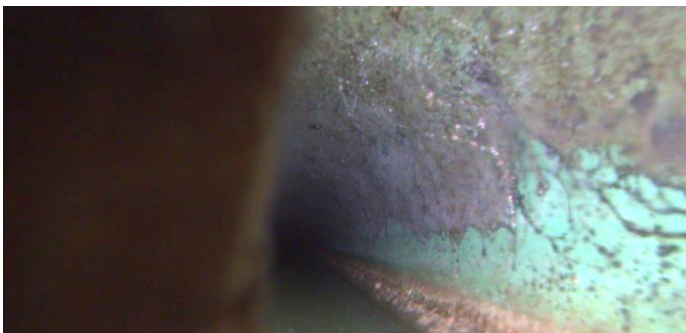
Code: **MSA**
Description: **Abandoned Survey**

Distance (ft): **97.0**
Structural Grade: **0**
O&M Grade: **0**
Clock Start/From:
Clock To:
1st Value:
2nd Value:
Value Percent:
Continuous Index:
Within 8" of Joint: **NO**
Remarks: **UNKNOWN**

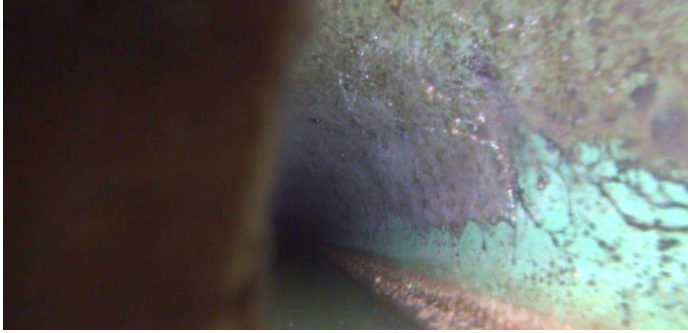
Code:	DAGS
Description:	Deposits Attached Grease
Distance (ft):	97.0
Structural Grade:	0
O&M Grade:	2
Clock Start/From:	8
Clock To:	4
1st Value:	
2nd Value:	
Value Percent:	5.000
Continuous Index:	F01
Within 8" of Joint:	NO
Remarks:
