Profile/Photo Observation Report

Date:	04/04/2018	Weather:		Coding:	PACP 6.0
Pipe Length (ft):	227.7	Owner:	NA	Pre Clean:	Not Known
P.O.#:		Surveyor:	Jen Costello	PSR:	P-303-059-063
Customer:		Clean Date:	01/01/1900	Shape:	C

Street:	w hansen blvd	Flow Control:	Not Controlled
City:	Hobart, IN	Year Renewed:	
Location:	Other	Tape/Media #:	
Purpose:	Not Known	Dia/Height:	10"
Use:	Sanitary	Material:	PVC
Drain Area:	NA	Lining:	
Category:	NA		
Comment:

Location Details:		Direction of Survey:	Downstream
US MH:	M-303-063	DS MH:	M-303-059
		Total Length Surveyed (ft):	97.0

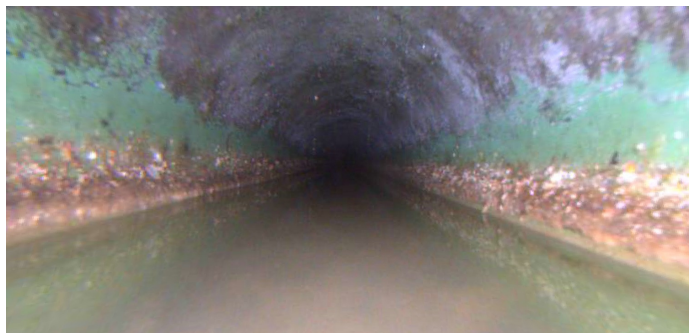
Code: **AMH**
 Description: **Manhole**

Distance (ft): **.0**
 Structural Grade: **0**
 O&M Grade: **0**
 Clock Start/From:
 Clock To:
 1st Value:
 2nd Value:
 Value Percent:
 Continuous Index:
 Within 8" of Joint: **NO**
 Remarks: **M-303-063**

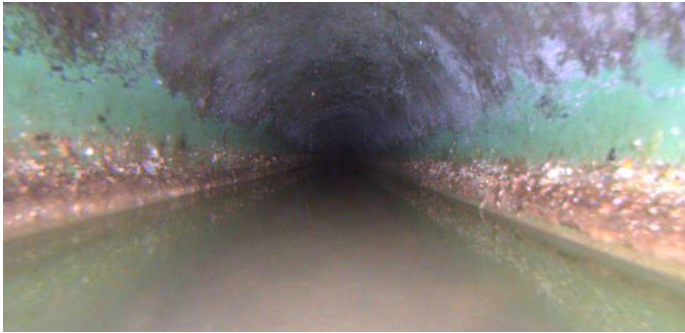
Code:	MWL
Description:	Water Level

Distance (ft):	.0
Structural Grade:	0
O&M Grade:	0
Clock Start/From:	
Clock To:	
1st Value:	
2nd Value:	
Value Percent:	30.000
Continuous Index:	
Within 8" of Joint:	NO
Remarks:

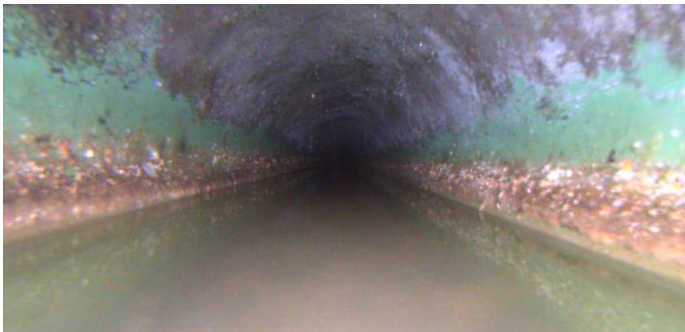
Code:	DAGS
Description:	Deposits Attached Grease

Distance (ft):	.0
Structural Grade:	0
O&M Grade:	2
Clock Start/From:	8
Clock To:	4
1st Value:	
2nd Value:	
Value Percent:	5.000
Continuous Index:	S01
Within 8" of Joint:	NO
Remarks:

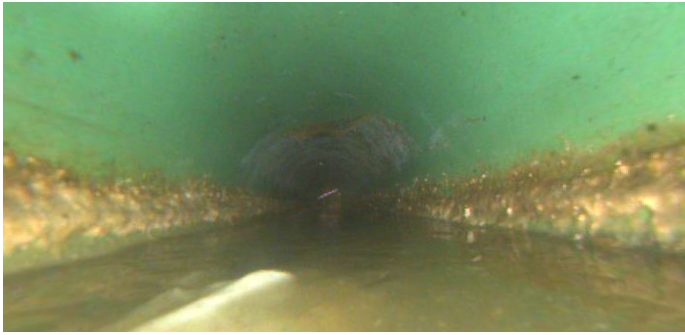
Code: **MGO**
Description: **General Observation**

Distance (ft): **7.5**
Structural Grade: **0**
O&M Grade: **0**
Clock Start/From:
Clock To:
1st Value:
2nd Value:
Value Percent:
Continuous Index:
Within 8" of Joint: **NO**
Remarks: **REAR CAMERA**

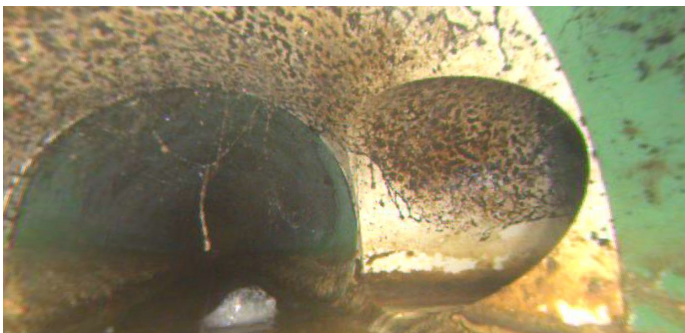
Code: **TFA**
Description: **Tap Factory Active**

Distance (ft): **50.5**
Structural Grade: **0**
O&M Grade: **0**
Clock Start/From: **9**
Clock To:
1st Value: **4.000**
2nd Value:
Value Percent:
Continuous Index:
Within 8" of Joint:
Remarks:

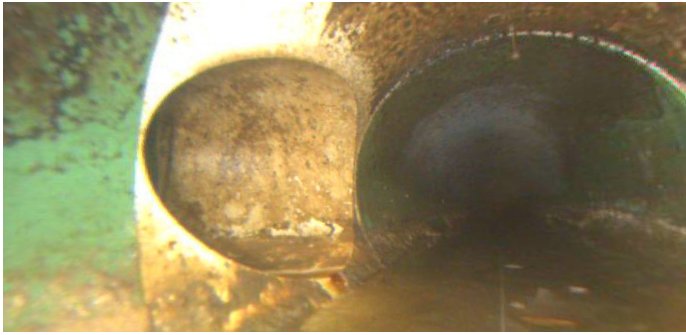
Code: **TF**
Description: **Tap Factory**

Distance (ft): **77.4**
Structural Grade: **0**
O&M Grade: **0**
Clock Start/From: **3**
Clock To:
1st Value: **4.000**
2nd Value:
Value Percent:
Continuous Index:
Within 8" of Joint:
Remarks:

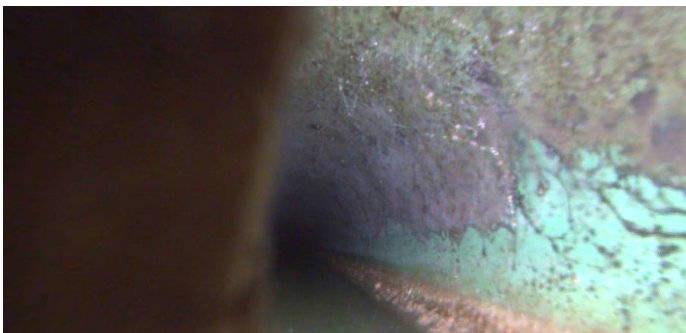
Code: **MSA**
Description: **Abandoned Survey**

Distance (ft): **97.0**
Structural Grade: **0**
O&M Grade: **0**
Clock Start/From:
Clock To:
1st Value:
2nd Value:
Value Percent:
Continuous Index:
Within 8" of Joint: **NO**
Remarks: **UNKNOWN**

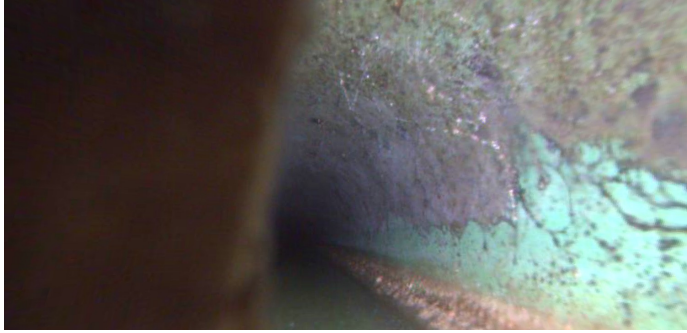
Code:	DAGS
Description:	Deposits Attached Grease
Distance (ft):	97.0
Structural Grade:	0
O&M Grade:	2
Clock Start/From:	8
Clock To:	4
1st Value:	
2nd Value:	
Value Percent:	5.000
Continuous Index:	F01
Within 8" of Joint:	NO
Remarks:
