## Profile/Photo Observation Report

Date:	<b>04/04/2018</b>	Weather:		Coding:	<b>PACP 6.0</b>
Pipe Length (ft):	<b>189.5</b>	Owner:	<b>NA</b>	Pre Clean:	<b>Not Known</b>
P.O.#:		Surveyor:	<b>Jen Costello</b>	PSR:	<b>P-303-063-064</b>
Customer:		Clean Date:	<b>01/01/1900</b>	Shape:	<b>C</b>

Street:	<b>S HANSEN BLVD</b>	Flow Control:	<b>Not Controlled</b>
City:	<b>Hobart, IN</b>	Year Renewed:	
Location:	<b>Other</b>	Tape/Media #:	
Purpose:	<b>Not Known</b>	Dia/Height:	<b>10"</b>
Use:	<b>Sanitary</b>	Material:	<b>PVC</b>
Drain Area:	<b>NA</b>	Lining:	
Category:	<b>NA</b>		
Comment:

Location Details:		Direction of Survey:	<b>Upstream</b>
US MH:	<b>M-303-064</b>	DS MH:	<b>M-303-063</b>
		Total Length Surveyed (ft):	<b>187.6</b>

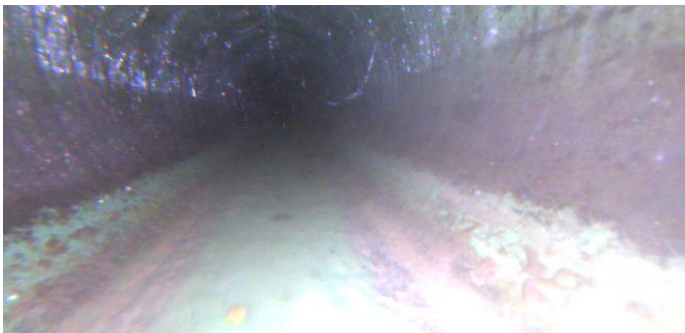
Code: **AMH**  
Description: **Manhole**

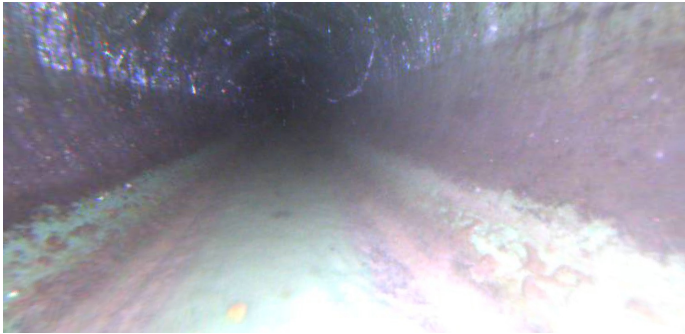
Code:	<b>MWL</b>
Description:	<b>Water Level</b>

Distance (ft):	<b>.0</b>
Structural Grade:	<b>0</b>
O&M Grade:	<b>0</b>
Clock Start/From:	
Clock To:	
1st Value:	
2nd Value:	
Value Percent:	<b>5.000</b>
Continuous Index:	
Within 8" of Joint:	<b>NO</b>
Remarks:

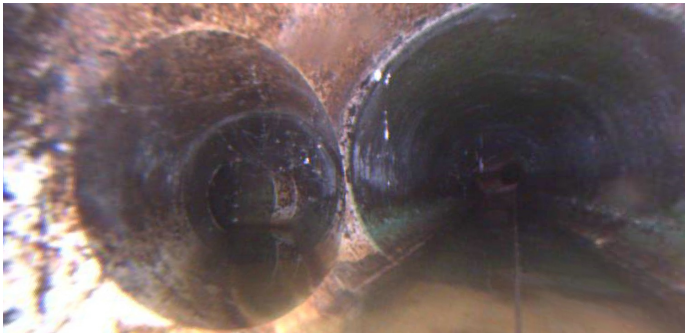
Code:	<b>TFA</b>
Description:	<b>Tap Factory Active</b>

Distance (ft):	<b>6.7</b>
Structural Grade:	<b>0</b>
O&M Grade:	<b>0</b>
Clock Start/From:	<b>3</b>
Clock To:	
1st Value:	<b>4.000</b>
2nd Value:	
Value Percent:	
Continuous Index:	
Within 8" of Joint:	
Remarks:

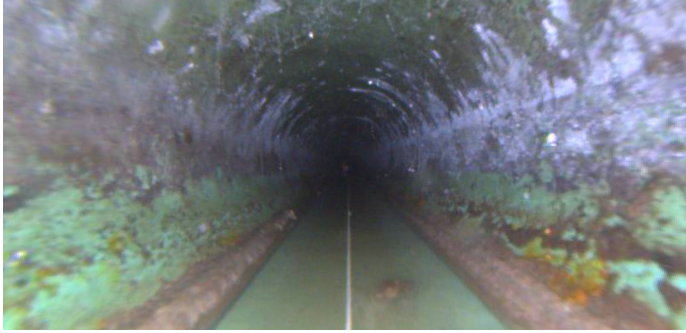
Code: **MGO**  
Description: **General Observation**

Distance (ft): **30.9**  
Structural Grade: **0**  
O&M Grade: **0**  
Clock Start/From:  
Clock To:  
1st Value:  
2nd Value:  
Value Percent:  
Continuous Index:  
Within 8" of Joint: **NO**  
Remarks: **REAR CAMERA**

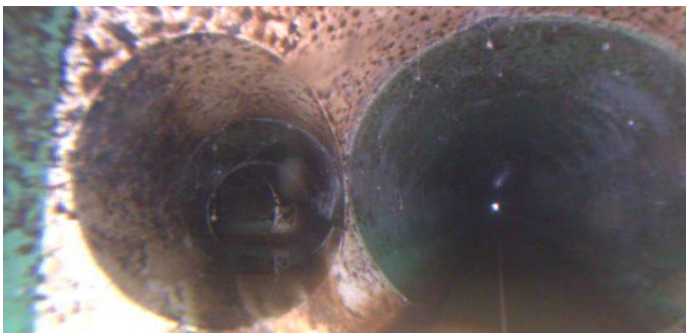
Code: **TFA**  
Description: **Tap Factory Active**

Distance (ft): **65.5**  
Structural Grade: **0**  
O&M Grade: **0**  
Clock Start/From: **3**  
Clock To:  
1st Value: **4.000**  
2nd Value:  
Value Percent:  
Continuous Index:  
Within 8" of Joint:  
Remarks:

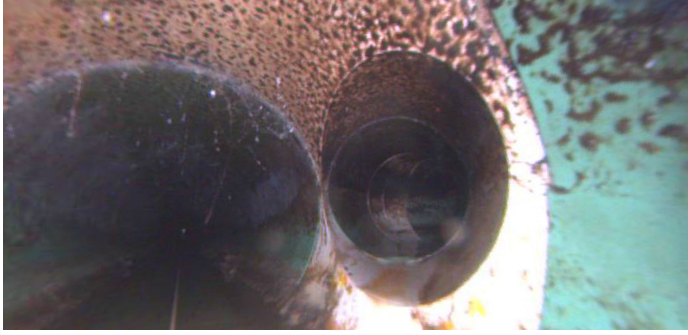
Code: **TF**  
Description: **Tap Factory**

Distance (ft): **89.4**  
Structural Grade: **0**  
O&M Grade: **0**  
Clock Start/From: **9**  
Clock To:  
1st Value: **4.000**  
2nd Value:  
Value Percent:  
Continuous Index:  
Within 8" of Joint:  
Remarks:

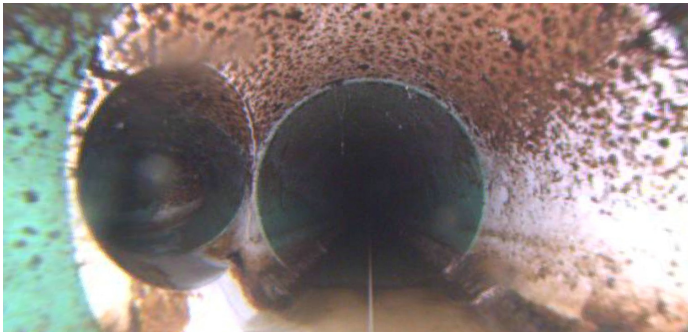
Code: **TF**  
Description: **Tap Factory**

Distance (ft): **135.0**  
Structural Grade: **0**  
O&M Grade: **0**  
Clock Start/From: **3**  
Clock To:  
1st Value: **4.000**  
2nd Value:  
Value Percent:  
Continuous Index:  
Within 8" of Joint:  
Remarks:

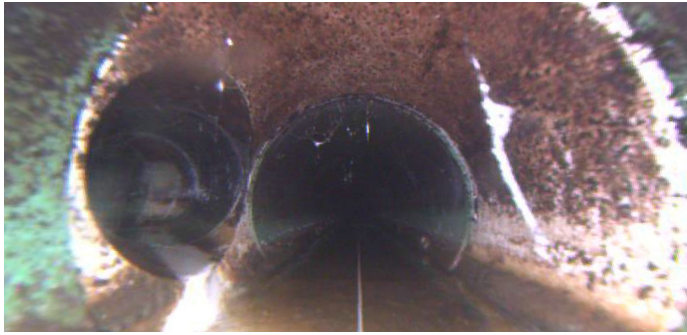
Code: **TFA**  
Description: **Tap Factory Active**

Distance (ft): **180.2**  
Structural Grade: **0**  
O&M Grade: **0**  
Clock Start/From: **3**  
Clock To:  
1st Value: **4.000**  
2nd Value:  
Value Percent:  
Continuous Index:  
Within 8" of Joint:  
Remarks:

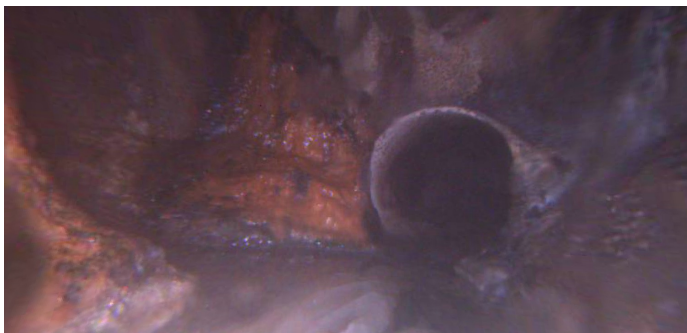
Code: **AMH**  
Description: **Manhole**

Distance (ft): **187.6**  
Structural Grade: **0**  
O&M Grade: **0**  
Clock Start/From:  
Clock To:  
1st Value:  
2nd Value:  
Value Percent:  
Continuous Index:  
Within 8" of Joint: **NO**  
Remarks: **M-303-064**
