Profile/Photo Observation Report

Date:	04/04/2018	Weather:		Coding:	PACP 6.0
Pipe Length (ft):	189.5	Owner:	NA	Pre Clean:	Not Known
P.O.#:		Surveyor:	Jen Costello	PSR:	P-303-063-064
Customer:		Clean Date:	01/01/1900	Shape:	C

Street:	w hansen blvd	Flow Control:	Not Controlled
City:	Hobart, IN	Year Renewed:	
Location:	Other	Tape/Media #:	
Purpose:	Not Known	Dia/Height:	10"
Use:	Sanitary	Material:	PVC
Drain Area:	NA	Lining:	
Category:	NA		
Comment:

Location Details:		Direction of Survey:	Upstream
US MH:	M-303-064	DS MH:	M-303-063
		Total Length Surveyed (ft):	187.6

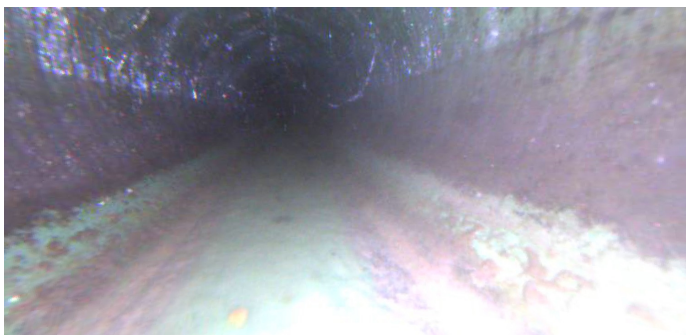
Code: **AMH**
Description: **Manhole**

Distance (ft): **.0**
Structural Grade: **0**
O&M Grade: **0**
Clock Start/From:
Clock To:
1st Value:
2nd Value:
Value Percent:
Continuous Index:
Within 8" of Joint: **NO**
Remarks: **M-303-063**

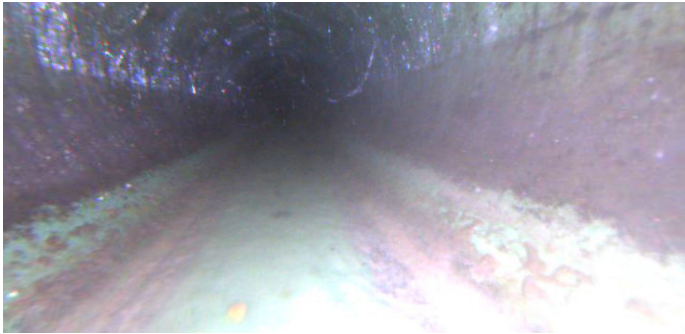
Code:	MWL
Description:	Water Level

Distance (ft):	.0
Structural Grade:	0
O&M Grade:	0
Clock Start/From:	
Clock To:	
1st Value:	
2nd Value:	
Value Percent:	5.000
Continuous Index:	
Within 8" of Joint:	NO
Remarks:

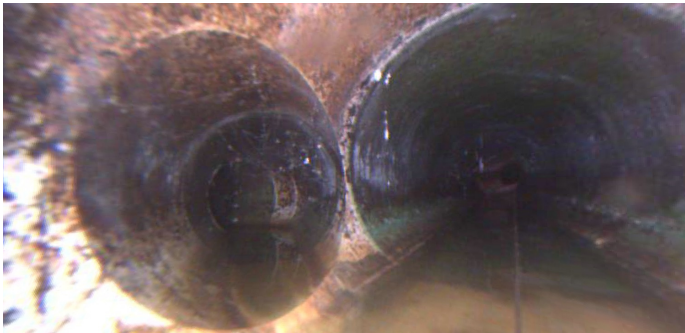
Code:	TFA
Description:	Tap Factory Active

Distance (ft):	6.7
Structural Grade:	0
O&M Grade:	0
Clock Start/From:	3
Clock To:	
1st Value:	4.000
2nd Value:	
Value Percent:	
Continuous Index:	
Within 8" of Joint:	
Remarks:

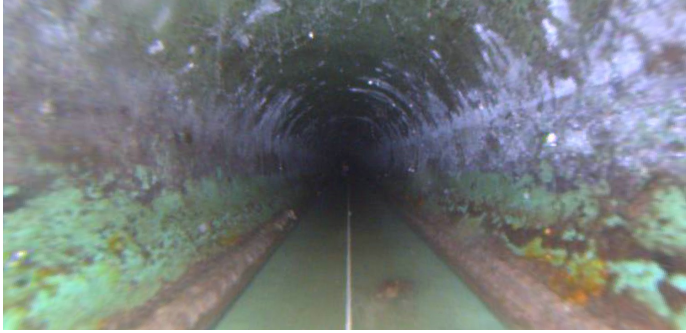
Code: **MGO**
Description: **General Observation**

Distance (ft): **30.9**
Structural Grade: **0**
O&M Grade: **0**
Clock Start/From:
Clock To:
1st Value:
2nd Value:
Value Percent:
Continuous Index:
Within 8" of Joint: **NO**
Remarks: **REAR CAMERA**

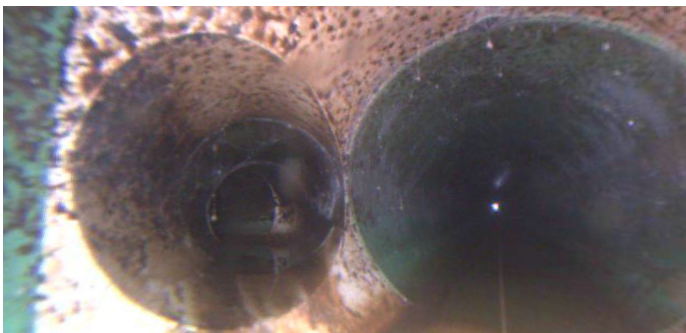
Code: **TFA**
Description: **Tap Factory Active**

Distance (ft): **65.5**
Structural Grade: **0**
O&M Grade: **0**
Clock Start/From: **3**
Clock To:
1st Value: **4.000**
2nd Value:
Value Percent:
Continuous Index:
Within 8" of Joint:
Remarks:

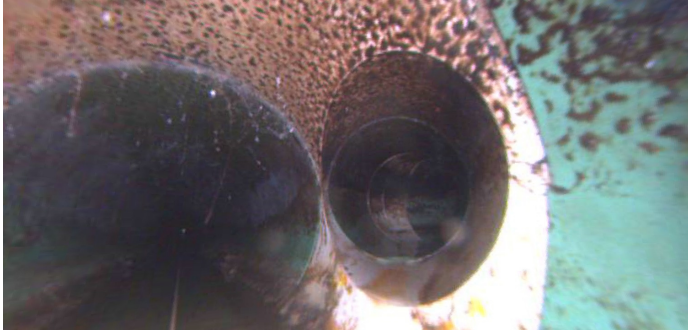
Code: **TF**
Description: **Tap Factory**

Distance (ft): **89.4**
Structural Grade: **0**
O&M Grade: **0**
Clock Start/From: **9**
Clock To:
1st Value: **4.000**
2nd Value:
Value Percent:
Continuous Index:
Within 8" of Joint:
Remarks:

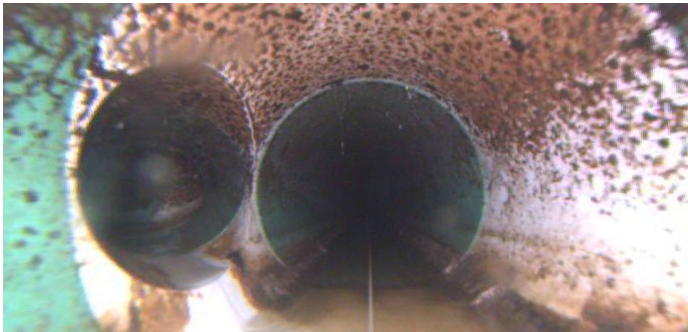
Code: **TF**
Description: **Tap Factory**

Distance (ft): **135.0**
Structural Grade: **0**
O&M Grade: **0**
Clock Start/From: **3**
Clock To:
1st Value: **4.000**
2nd Value:
Value Percent:
Continuous Index:
Within 8" of Joint:
Remarks:

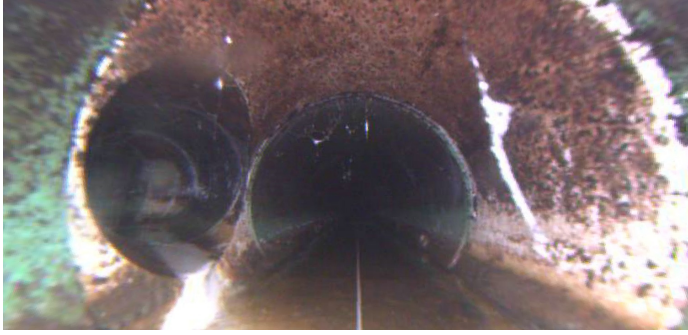
Code: **TFA**
Description: **Tap Factory Active**

Distance (ft): **180.2**
Structural Grade: **0**
O&M Grade: **0**
Clock Start/From: **3**
Clock To:
1st Value: **4.000**
2nd Value:
Value Percent:
Continuous Index:
Within 8" of Joint:
Remarks:

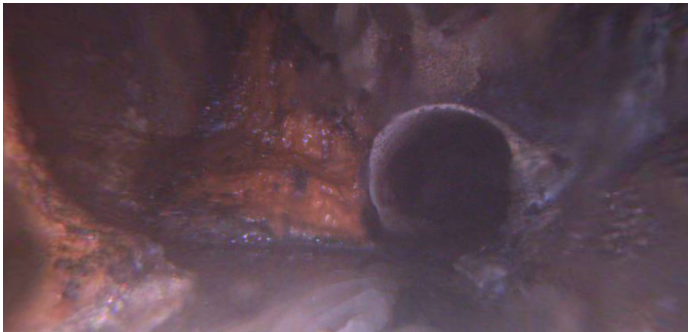
Code: **AMH**
Description: **Manhole**

Distance (ft): **187.6**
Structural Grade: **0**
O&M Grade: **0**
Clock Start/From:
Clock To:
1st Value:
2nd Value:
Value Percent:
Continuous Index:
Within 8" of Joint: **NO**
Remarks: **M-303-064**
