Profile/Photo Observation Report

Date:	04/04/2018	Weather:		Coding:	PACP 6.0
Pipe Length (ft):	282.5	Owner:	NA	Pre Clean:	Not Known
P.O.#:		Surveyor:	Jen Costello	PSR:	P-303-066-065
Customer:		Clean Date:	01/01/1900	Shape:	C

Street:	e hansen blvd	Flow Control:	Not Controlled
City:	Hobart, IN	Year Renewed:	
Location:	Other	Tape/Media #:	
Purpose:	Not Known	Dia/Height:	10"
Use:	Sanitary	Material:	PVC
Drain Area:	NA	Lining:	
Category:	NA		
Comment:

Location Details:		Direction of Survey:	Upstream
US MH:	M-303-065	DS MH:	M-303-066
		Total Length Surveyed (ft):	278.3

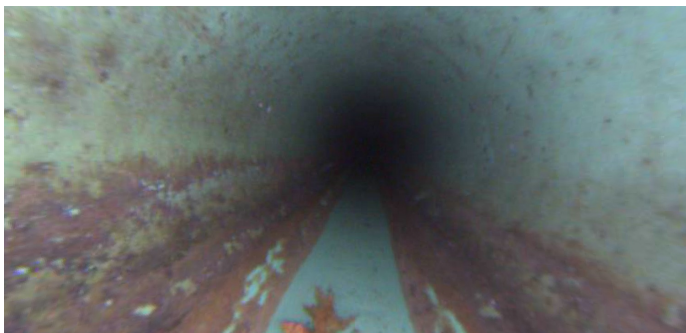
Code: **AMH**
Description: **Manhole**

Distance (ft): **.0**
Structural Grade: **0**
O&M Grade: **0**
Clock Start/From:
Clock To:
1st Value:
2nd Value:
Value Percent:
Continuous Index:
Within 8" of Joint: **NO**
Remarks: **M-303-066**

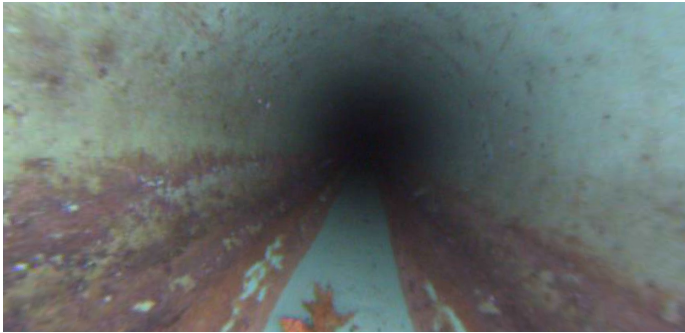
Code:	MWL
Description:	Water Level

Distance (ft):	.0
Structural Grade:	0
O&M Grade:	0
Clock Start/From:	
Clock To:	
1st Value:	
2nd Value:	
Value Percent:	5.000
Continuous Index:	
Within 8" of Joint:	NO
Remarks:

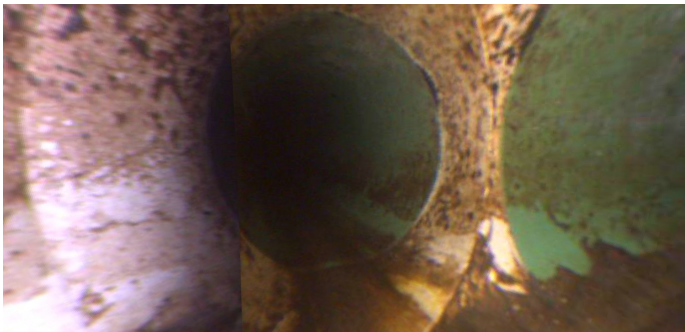
Code:	TFA
Description:	Tap Factory Active

Distance (ft):	32.0
Structural Grade:	0
O&M Grade:	0
Clock Start/From:	3
Clock To:	
1st Value:	4.000
2nd Value:	
Value Percent:	
Continuous Index:	
Within 8" of Joint:	
Remarks:

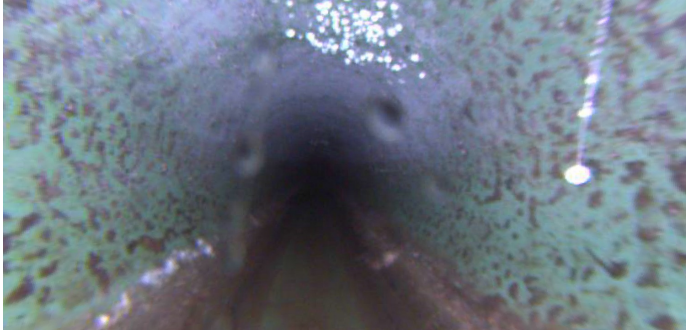
Code: **DAGS**
Description: **Deposits Attached Grease**

Distance (ft): **88.6**
Structural Grade: **0**
O&M Grade: **2**
Clock Start/From: **4**
Clock To: **8**
1st Value:
2nd Value:
Value Percent: **5.000**
Continuous Index: **S01**
Within 8" of Joint: **NO**
Remarks:

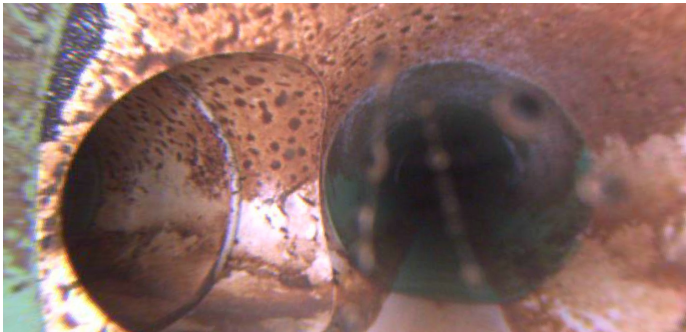
Code: **TF**
Description: **Tap Factory**

Distance (ft): **95.4**
Structural Grade: **0**
O&M Grade: **0**
Clock Start/From: **9**
Clock To:
1st Value: **4.000**
2nd Value:
Value Percent:
Continuous Index:
Within 8" of Joint:
Remarks:

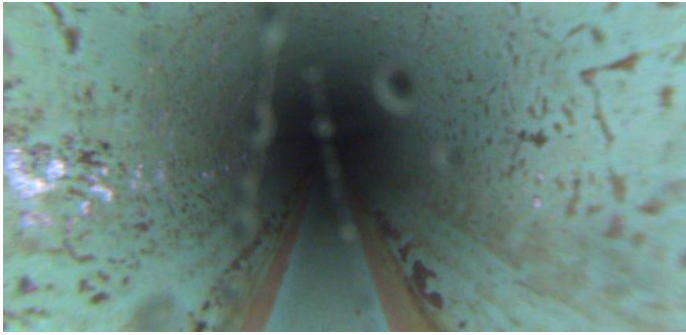
Code: **DAGS**
Description: **Deposits Attached Grease**

Distance (ft): **101.5**
Structural Grade: **0**
O&M Grade: **2**
Clock Start/From: **4**
Clock To: **8**
1st Value:
2nd Value:
Value Percent: **5.000**
Continuous Index: **F01**
Within 8" of Joint: **NO**
Remarks:

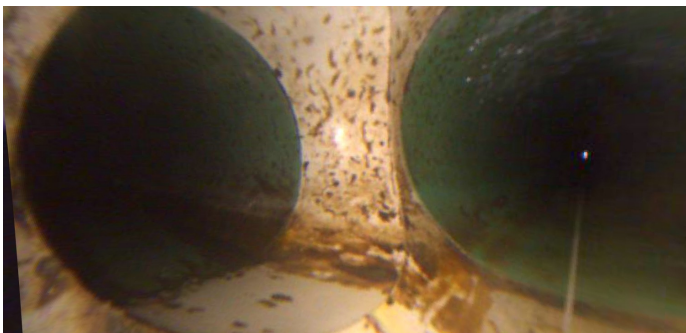
Code: **TF**
Description: **Tap Factory**

Distance (ft): **109.3**
Structural Grade: **0**
O&M Grade: **0**
Clock Start/From: **3**
Clock To:
1st Value: **4.000**
2nd Value:
Value Percent:
Continuous Index:
Within 8" of Joint:
Remarks:

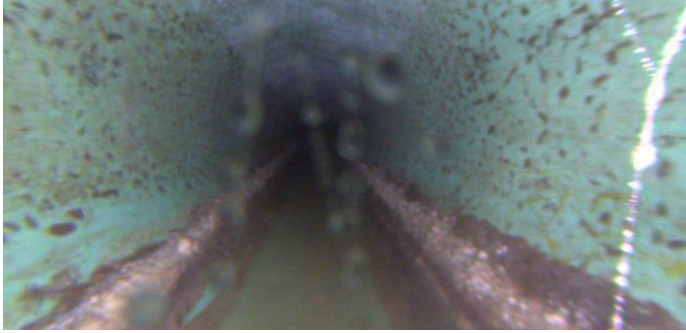
Code: **DAGS**
Description: **Deposits Attached Grease**

Distance (ft): **113.1**
Structural Grade: **0**
O&M Grade: **2**
Clock Start/From: **7**
Clock To: **5**
1st Value:
2nd Value:
Value Percent: **5.000**
Continuous Index: **S02**
Within 8" of Joint: **NO**
Remarks:

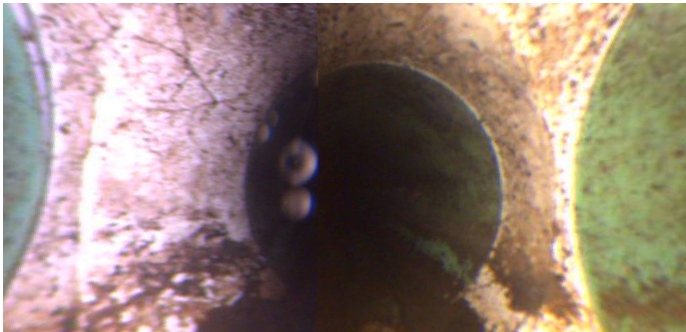
Code: **TF**
Description: **Tap Factory**

Distance (ft): **160.5**
Structural Grade: **0**
O&M Grade: **0**
Clock Start/From: **3**
Clock To:
1st Value: **4.000**
2nd Value:
Value Percent:
Continuous Index:
Within 8" of Joint: **NO**
Remarks:

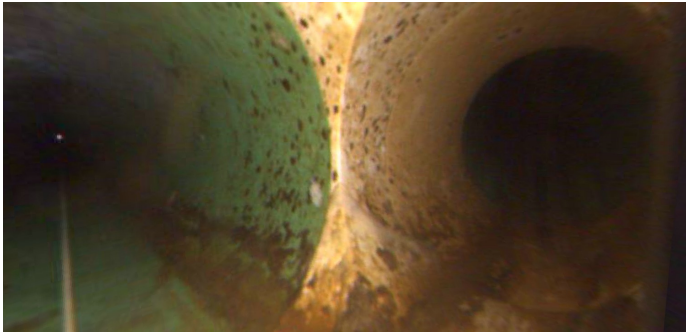
Code: **TF**
Description: **Tap Factory**

Distance (ft): **173.7**
Structural Grade: **0**
O&M Grade: **0**
Clock Start/From: **9**
Clock To:
1st Value: **4.000**
2nd Value:
Value Percent:
Continuous Index:
Within 8" of Joint:
Remarks:

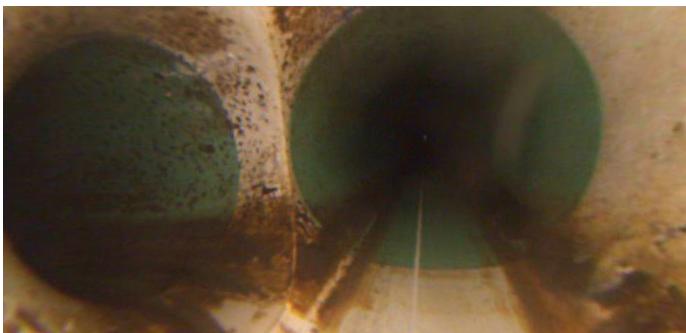
Code: **TF**
Description: **Tap Factory**

Distance (ft): **225.5**
Structural Grade: **0**
O&M Grade: **0**
Clock Start/From: **3**
Clock To:
1st Value: **4.000**
2nd Value:
Value Percent:
Continuous Index:
Within 8" of Joint:
Remarks:

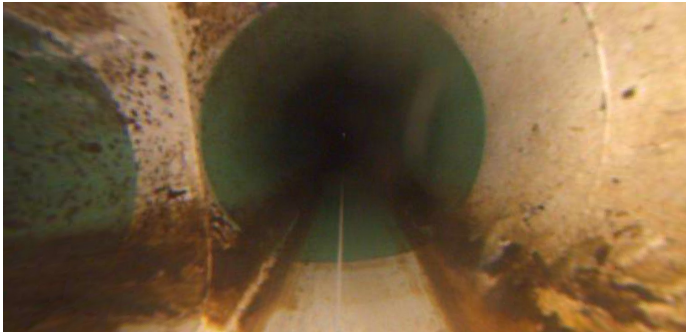
Code: **MGO**
Description: **General Observation**

Distance (ft): **225.5**
Structural Grade: **0**
O&M Grade: **0**
Clock Start/From:
Clock To:
1st Value:
2nd Value:
Value Percent:
Continuous Index:
Within 8" of Joint: **NO**
Remarks: **rear camera**

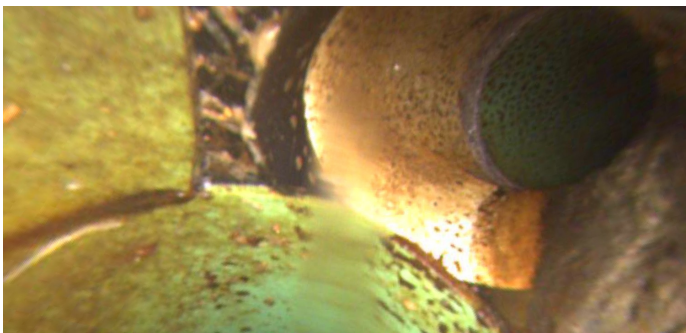
Code: **TB**
Description: **Tap Break-in**

Distance (ft): **226.6**
Structural Grade: **0**
O&M Grade: **0**
Clock Start/From: **11**
Clock To:
1st Value: **4.000**
2nd Value:
Value Percent:
Continuous Index:
Within 8" of Joint:
Remarks:

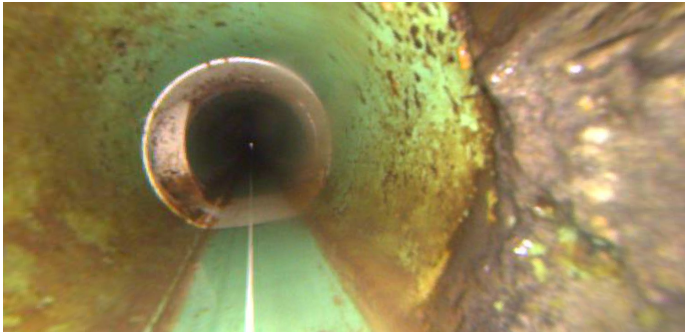
Code: **DAGS**
Description: **Deposits Attached Grease**

Distance (ft): **226.6**
Structural Grade: **0**
O&M Grade: **2**
Clock Start/From: **7**
Clock To: **11**
1st Value:
2nd Value:
Value Percent: **5.000**
Continuous Index:
Within 8" of Joint: **NO**
Remarks:

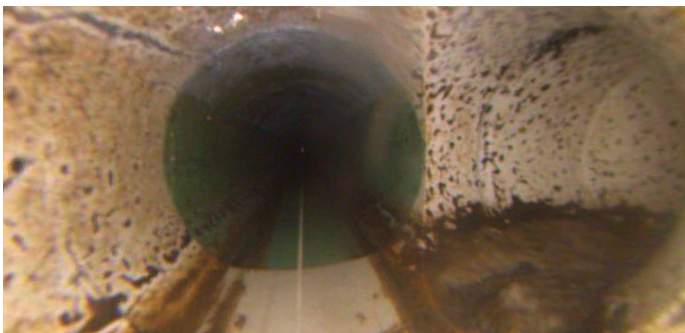
Code: **TFC**
Description: **Tap Factory Capped**

Distance (ft): **238.8**
Structural Grade: **0**
O&M Grade: **0**
Clock Start/From: **9**
Clock To:
1st Value: **4.000**
2nd Value:
Value Percent:
Continuous Index:
Within 8" of Joint:
Remarks:

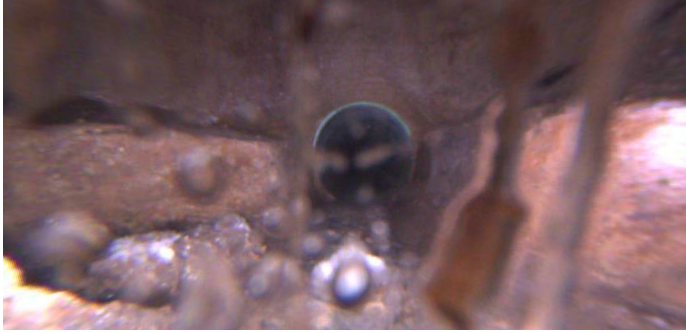
Code: **DAGS**
Description: **Deposits Attached Grease**

Distance (ft): **278.3**
Structural Grade: **0**
O&M Grade: **2**
Clock Start/From: **7**
Clock To: **5**
1st Value:
2nd Value:
Value Percent: **5.000**
Continuous Index: **F02**
Within 8" of Joint: **NO**
Remarks:

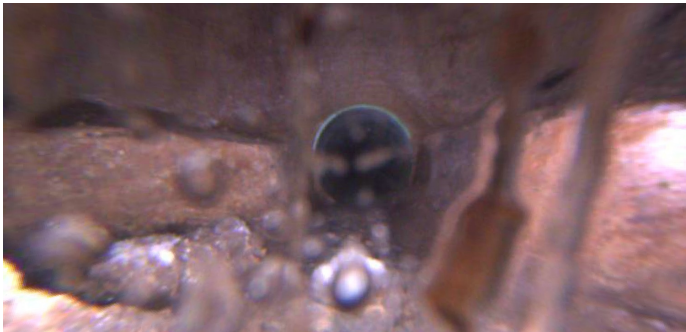
Code: **AMH**
Description: **Manhole**

Distance (ft): **278.3**
Structural Grade: **0**
O&M Grade: **0**
Clock Start/From:
Clock To:
1st Value:
2nd Value:
Value Percent:
Continuous Index:
Within 8" of Joint: **NO**
Remarks: **M-303-065**
