Profile/Photo Observation Report

| Street: | e hansen blvd | Flow Control: | Not Controlled |
| City: | Hobart, IN | Year Renewed: | |

| US MH: | M-303-066 | DS MH: | M-303-067 |

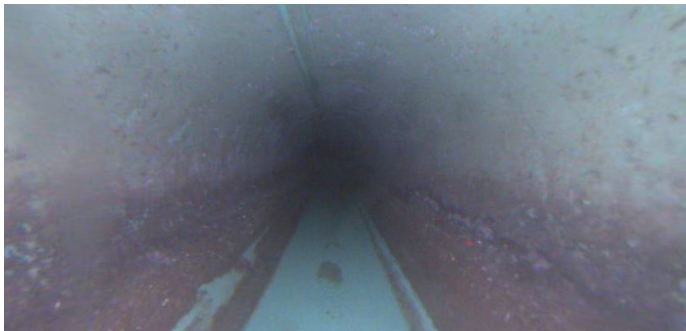
Code: **AMH**
Description: **Manhole**

Distance (ft): **.0**
Structural Grade: **0**
O&M Grade: **0**
Clock Start/From:
Clock To:
1st Value:
2nd Value:
Value Percent:
Continuous Index:
Within 8" of Joint: **NO**
Remarks: **M-303-066**

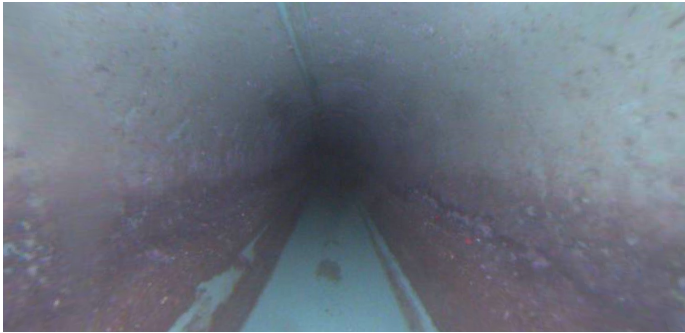
| Code: | MWL |
| Description: | Water Level |

| Value Percent: | 5.000 |

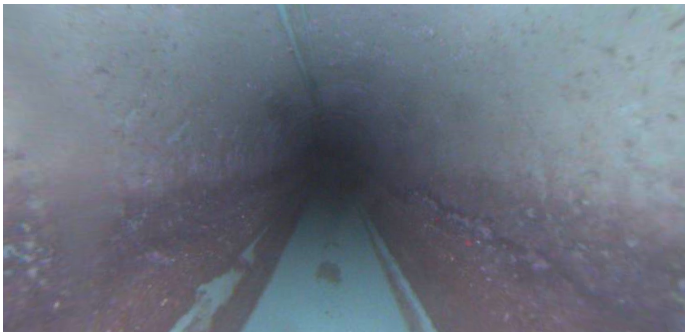
| Code: | DAGS |
| Description: | Deposits Attached Grease |

| O&M Grade: | 2 |
| Clock Start/From: | 8 |
| Clock To: | 4 |
| Continuous Index: | S01 |

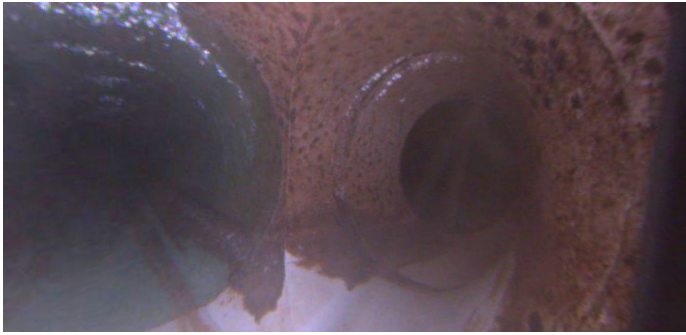
Code: **TFA**
Description: **Tap Factory Active**

Distance (ft): **37.2**
Structural Grade: **0**
O&M Grade: **0**
Clock Start/From: **3**
Clock To:
1st Value: **4.000**
2nd Value:
Value Percent:
Continuous Index:
Within 8" of Joint:
Remarks:

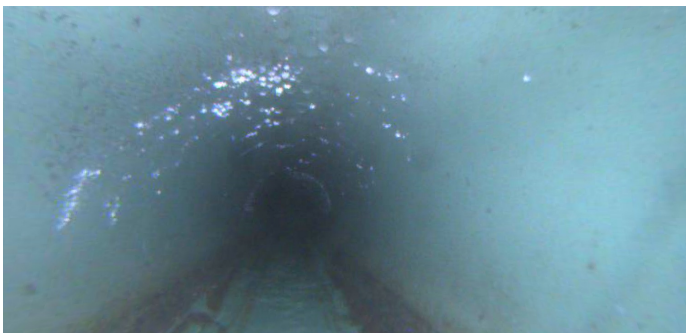
Code: **DAGS**
Description: **Deposits Attached Grease**

Distance (ft): **40.0**
Structural Grade: **0**
O&M Grade: **2**
Clock Start/From: **8**
Clock To: **4**
1st Value:
2nd Value:
Value Percent: **5.000**
Continuous Index: **F01**
Within 8" of Joint: **NO**
Remarks:

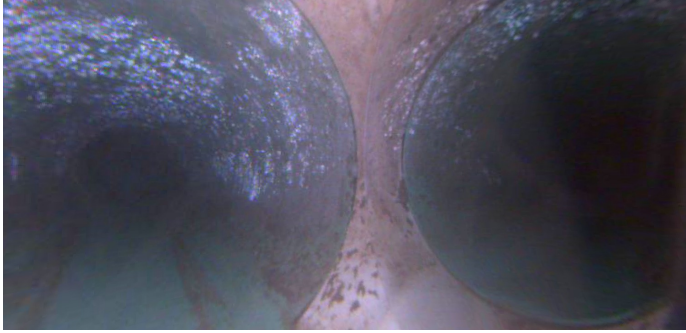
Code: **TF**
Description: **Tap Factory**

Distance (ft): **94.8**
Structural Grade: **0**
O&M Grade: **0**
Clock Start/From: **3**
Clock To:
1st Value: **4.000**
2nd Value:
Value Percent:
Continuous Index:
Within 8" of Joint:
Remarks:

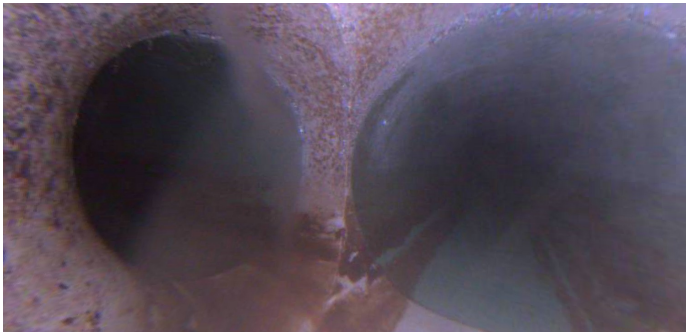
Code: **TF**
Description: **Tap Factory**

Distance (ft): **100.6**
Structural Grade: **0**
O&M Grade: **0**
Clock Start/From: **9**
Clock To:
1st Value: **4.000**
2nd Value:
Value Percent:
Continuous Index:
Within 8" of Joint:
Remarks:

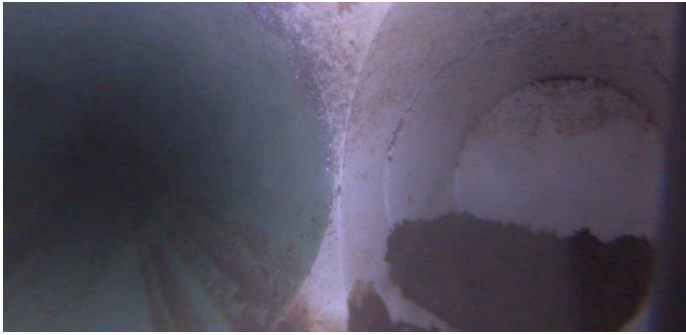
Code: **TFC**
Description: **Tap Factory Capped**

Distance (ft): **113.9**
Structural Grade: **0**
O&M Grade: **0**
Clock Start/From: **3**
Clock To:
1st Value: **4.000**
2nd Value:
Value Percent:
Continuous Index:
Within 8" of Joint:
Remarks:

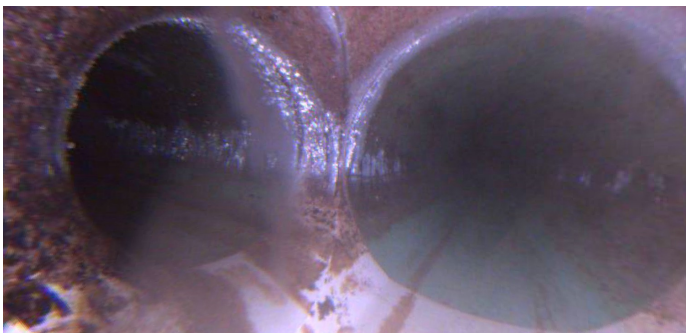
Code: **TFA**
Description: **Tap Factory Active**

Distance (ft): **164.8**
Structural Grade: **0**
O&M Grade: **0**
Clock Start/From: **9**
Clock To:
1st Value: **4.000**
2nd Value:
Value Percent:
Continuous Index:
Within 8" of Joint:
Remarks:

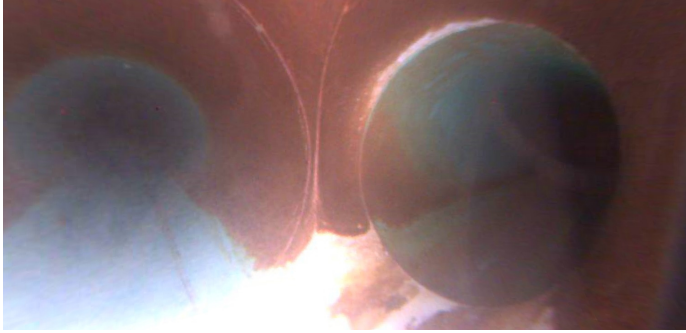
Code: **TF**
Description: **Tap Factory**

Distance (ft): **177.9**
Structural Grade: **0**
O&M Grade: **0**
Clock Start/From: **3**
Clock To:
1st Value: **4.000**
2nd Value:
Value Percent:
Continuous Index:
Within 8" of Joint:
Remarks:

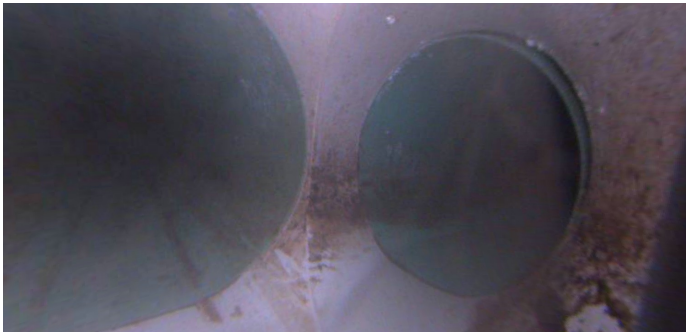
Code: **TFA**
Description: **Tap Factory Active**

Distance (ft): **228.7**
Structural Grade: **0**
O&M Grade: **0**
Clock Start/From: **3**
Clock To:
1st Value: **4.000**
2nd Value:
Value Percent:
Continuous Index:
Within 8" of Joint:
Remarks:

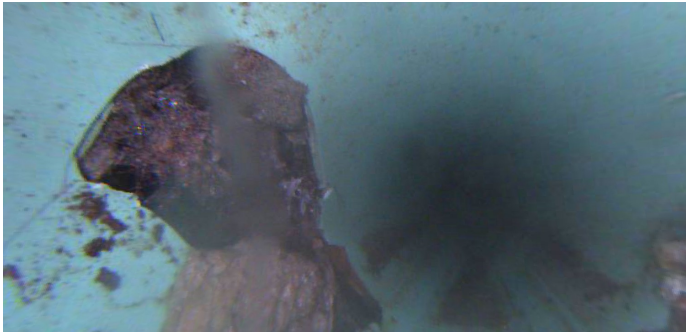
| | Position | Code | Observation | Video (sec) | Grade |
|--|---|---|---|---|---|
| | 234.9 | HVV | Hole Void Visible | 610 | S 5 |

Code: **HVV**
Description: **Hole Void Visible**

Distance (ft): **234.9**
Structural Grade: **5**
O&M Grade: **0**
Clock Start/From: **8**
Clock To: **9**
1st Value:
2nd Value:
Value Percent:
Continuous Index:
Within 8" of Joint:
Remarks:

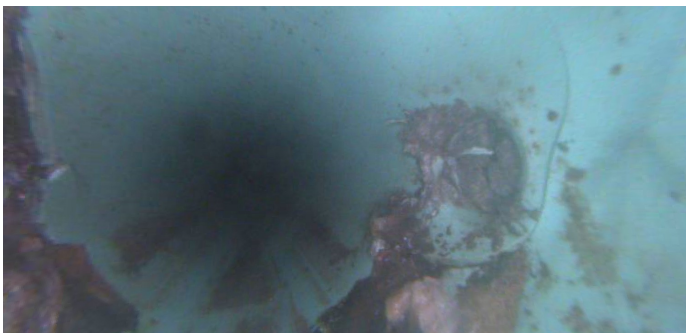
| | Position | Code | Observation | Video (sec) | Grade |
|--|---|---|---|---|---|
| | 234.9 | FC | Fracture Circumferential | 622 | S 2 |

Code: **FC**
Description: **Fracture Circumferential**

Distance (ft): **234.9**
Structural Grade: **2**
O&M Grade: **0**
Clock Start/From: **2**
Clock To: **4**
1st Value:
2nd Value:
Value Percent:
Continuous Index:
Within 8" of Joint:
Remarks:

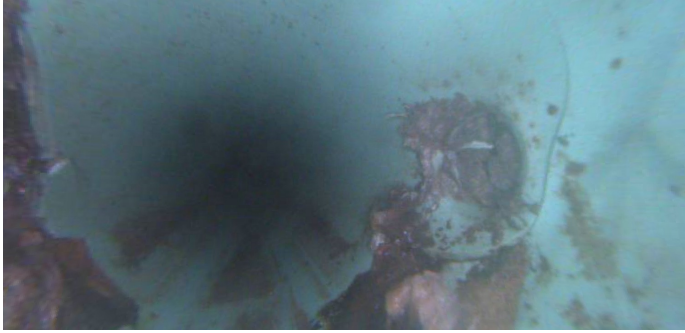
| | Position | Code | Observation | Video (sec) | Grade |
|--|---|---|---|---|---|
| | 234.9 | HVV | Hole Void Visible | 633 | S 5 |

Code: **HVV**
Description: **Hole Void Visible**

Distance (ft): **234.9**
Structural Grade: **5**
O&M Grade: **0**
Clock Start/From: **3**
Clock To:
1st Value:
2nd Value:
Value Percent:
Continuous Index:
Within 8" of Joint:
Remarks:

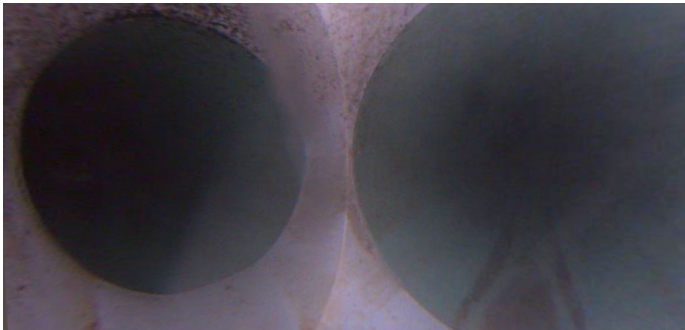
Code: **TF**
Description: **Tap Factory**

Distance (ft): **241.9**
Structural Grade: **0**
O&M Grade: **0**
Clock Start/From: **9**
Clock To:
1st Value: **4.000**
2nd Value:
Value Percent:
Continuous Index:
Within 8" of Joint:
Remarks:

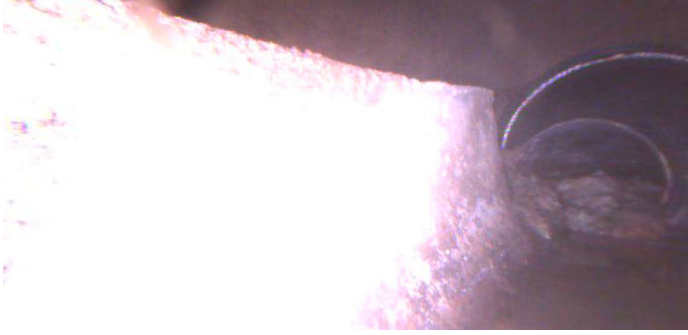
| Code: | AMH |
| Description: | Manhole |
| Distance (ft): | 274.5 |
| Remarks: | M-303-067 |
