Profile/Photo Observation Report

Street:	E HANSEN BLVD & S HANSEN BLVD	Flow Control:	Not Controlled
City:	Hobart, IN	Year Renewed:	
Location:	Other	Tape/Media #:	
Purpose:	Not Known	Dia/Height:	10"
Use:	Sanitary	Material:	PVC
Drain Area:	NA	Lining:	
Category:	NA		
Comment:

Location Details:		Direction of Survey:	Downstream
US MH:	M-303-068	DS MH:	M-303-064
		Total Length Surveyed (ft):	83.7

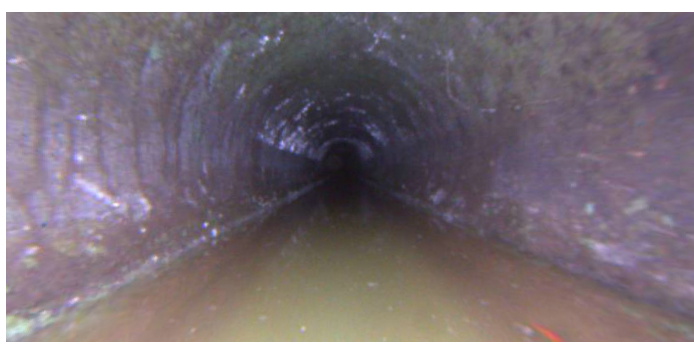
Code: **AMH**
Description: **Manhole**

Distance (ft): **.0**
Structural Grade: **0**
O&M Grade: **0**
Clock Start/From:
Clock To:
1st Value:
2nd Value:
Value Percent:
Continuous Index:
Within 8" of Joint: **NO**
Remarks: **M-303-068**

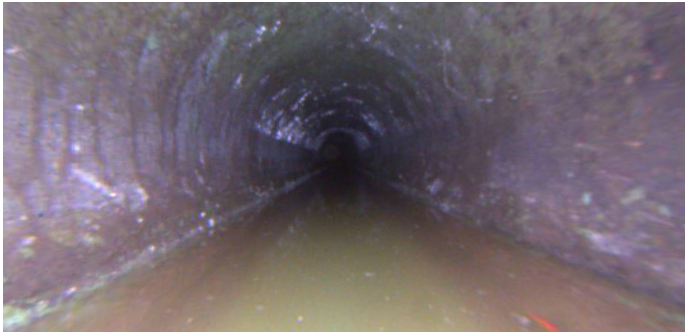
Code:	MWL
Description:	Water Level

Distance (ft):	.0
Structural Grade:	0
O&M Grade:	0
Clock Start/From:	
Clock To:	
1st Value:	
2nd Value:	
Value Percent:	30.000
Continuous Index:	
Within 8" of Joint:	NO
Remarks:

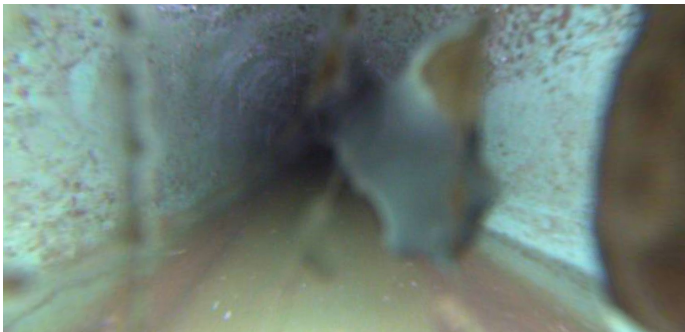
Code:	MSA
Description:	Abandoned Survey

Distance (ft):	83.7
Structural Grade:	0
O&M Grade:	0
Clock Start/From:	
Clock To:	
1st Value:	
2nd Value:	
Value Percent:	
Continuous Index:	
Within 8" of Joint:	NO
Remarks:	UNKNOWN
