## Profile/Photo Observation Report

Street:	<b>E HANSEN BLVD &amp; S HANSEN BLVD</b>	Flow Control:	<b>Not Controlled</b>
City:	<b>Hobart, IN</b>	Year Renewed:	
Location:	<b>Light Highway</b>	Tape/Media #:	
Purpose:	<b>Routine Assessment</b>	Dia/Height:	<b>10"</b>
Use:	<b>Sanitary</b>	Material:	<b>PVC</b>
Drain Area:	<b>NA</b>	Lining:	
Category:	<b>NA</b>		
Comment:

Location Details:		Direction of Survey:	<b>Downstream</b>
US MH:	<b>M-303-068</b>	DS MH:	<b>M-303-064</b>
		Total Length Surveyed (ft):	<b>191.1</b>

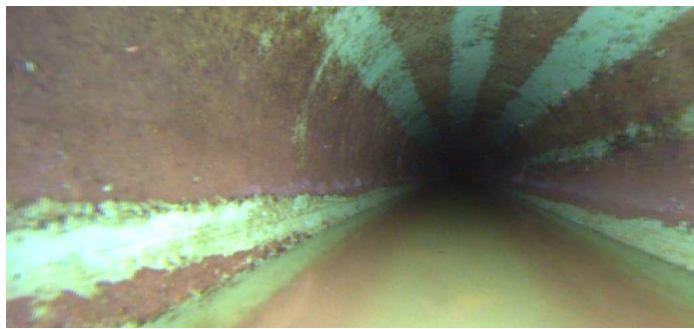
Code: **AMH**  
Description: **Manhole**

Distance (ft): **.0**  
Structural Grade: **0**  
O&M Grade: **0**  
Clock Start/From:  
Clock To:  
1st Value:  
2nd Value:  
Value Percent:  
Continuous Index:  
Within 8" of Joint: **NO**  
Remarks: **M-303-068**

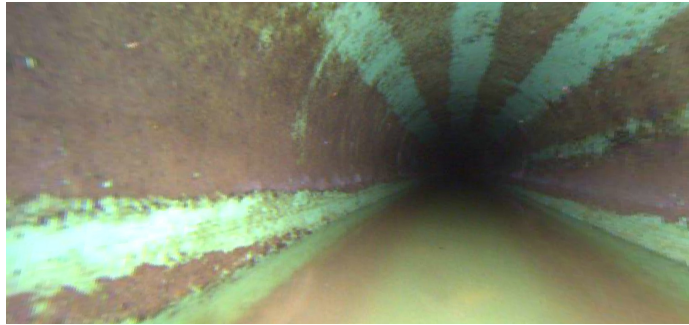
Code:	<b>MWL</b>
Description:	<b>Water Level</b>
Distance (ft):	<b>.0</b>
Structural Grade:	<b>0</b>
O&M Grade:	<b>0</b>
Clock Start/From:	
Clock To:	
1st Value:	
2nd Value:	
Value Percent:	<b>5.000</b>
Continuous Index:	
Within 8" of Joint:	<b>NO</b>
Remarks:

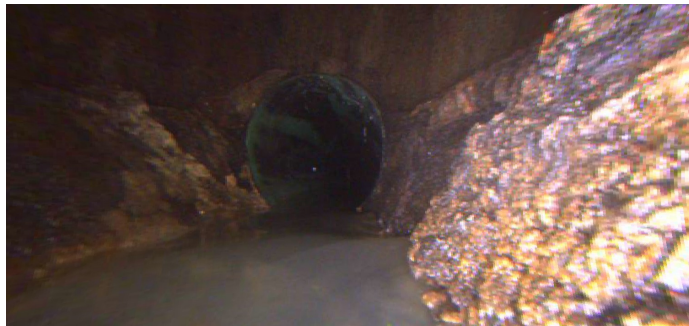
Code:	<b>AMH</b>
Description:	<b>Manhole</b>
Distance (ft):	<b>191.1</b>
Structural Grade:	<b>0</b>
O&M Grade:	<b>0</b>
Clock Start/From:	
Clock To:	
1st Value:	
2nd Value:	
Value Percent:	
Continuous Index:	
Within 8" of Joint:	<b>NO</b>
Remarks:	<b>M-303-064</b>
