## Profile/Photo Observation Report

| P.O.#: | <b>34-1</b> | Surveyor: | <b>M. Pielacha</b> | PSR: | <b>M-303-072-M-303-020</b> |

| Street: | <b>Ridgelawn Drive</b> | Flow Control: | <b>Not Controlled</b> |
| City: | <b>Hobart, IN</b> | Year Renewed: | |

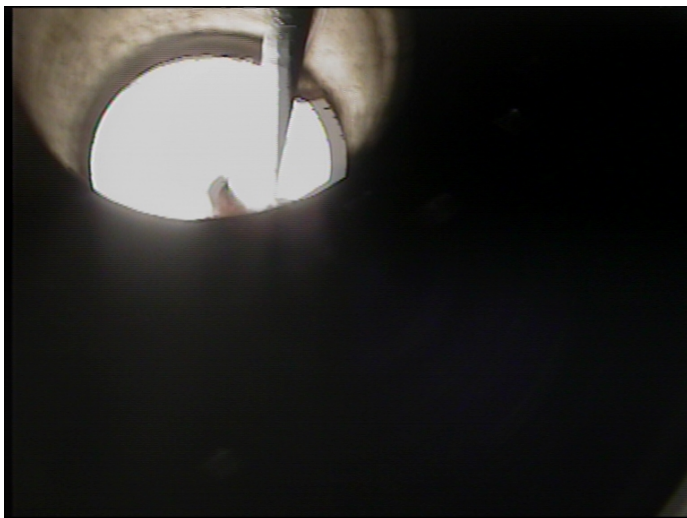
Code: **AMH**  
 Description: **Manhole**

Distance (ft): **.0**  
 Structural Grade: **0**  
 O&M Grade: **0**  
 Clock Start/From:  
 Clock To:  
 1st Value:  
 2nd Value:  
 Value Percent:  
 Continuous Index:  
 Within 8" of Joint: **NO**  
 Remarks: **M-303-020**

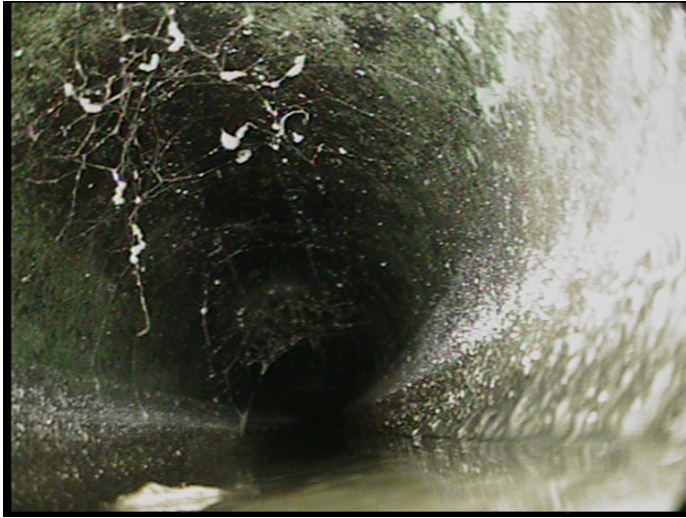
Code: **MWL**  
Description: **Water Level**

Distance (ft): **.0**  
Structural Grade: **0**  
O&M Grade: **0**  
Clock Start/From:  
Clock To:  
1st Value:  
2nd Value:  
Value Percent: **10.000**  
Continuous Index:  
Within 8" of Joint: **NO**  
Remarks:

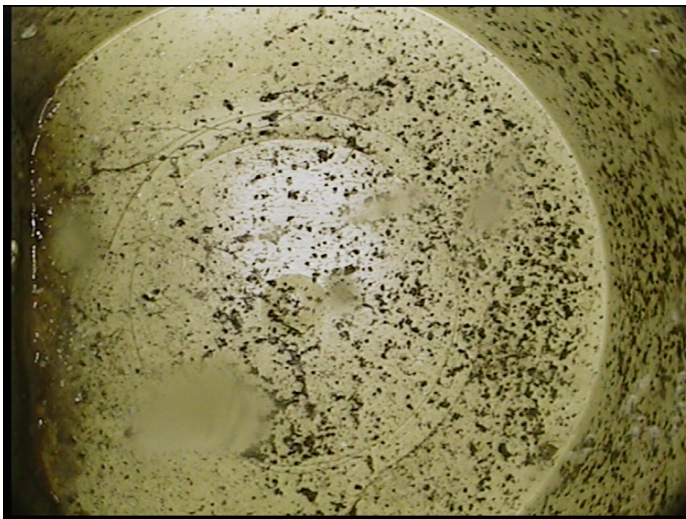
Code: **TFC**  
Description: **Tap Factory Capped**

Distance (ft): **17.0**  
Structural Grade: **0**  
O&M Grade: **0**  
Clock Start/From: **9**  
Clock To:  
1st Value: **6.000**  
2nd Value:  
Value Percent:  
Continuous Index:  
Within 8" of Joint: **NO**  
Remarks:

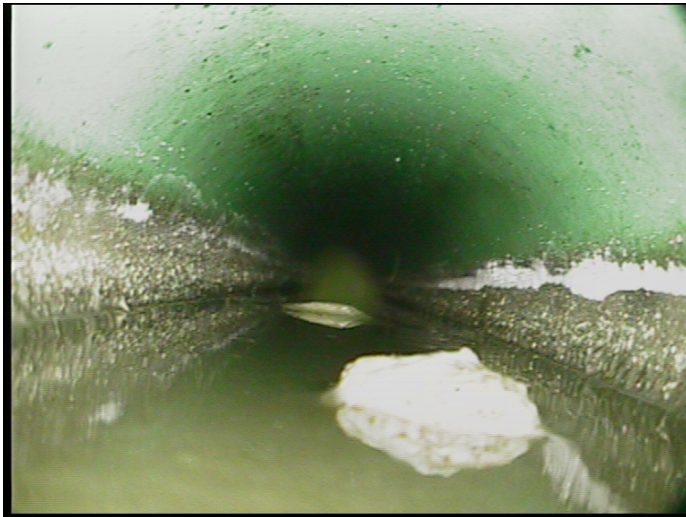
| | Position | Code | Observation | Video (sec) | Grade |
|--|---|---|---|---|---|
| | 25.0 | DSF | Deposits Settled Fine | 196 | M 2 |

Code: **DSF**  
 Description: **Deposits Settled Fine**

Distance (ft): **25.0**  
 Structural Grade: **0**  
 O&M Grade: **2**  
 Clock Start/From: **5**  
 Clock To: **7**  
 1st Value:  
 2nd Value:  
 Value Percent: **10.000**  
 Continuous Index:  
 Within 8" of Joint: **YES**  
 Remarks:

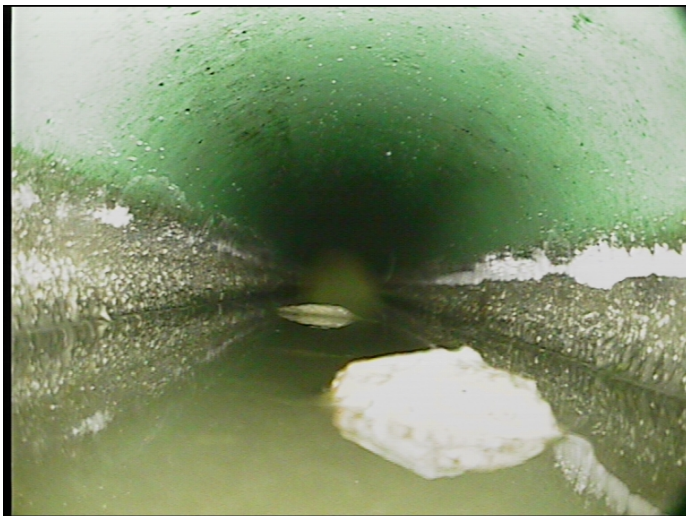
Code: **MSA**  
 Description: **Abandoned Survey**

Distance (ft): **25.4**  
 Structural Grade: **0**  
 O&M Grade: **0**  
 Clock Start/From:  
 Clock To:  
 1st Value:  
 2nd Value:  
 Value Percent:  
 Continuous Index:  
 Within 8" of Joint: **NO**  
 Remarks: **sediment**
