Profile/Photo Observation Report

Date:	04/12/2018	Weather:		Coding:	PACP 6.0
Pipe Length (ft):		Owner:	City of Hobart	Pre Clean:	No Pre-Cleaning
P.O.#:	35-1	Surveyor:	M. Pielacha	PSR:	M-303-072-M-303-020
Customer:	City of Hobart	Clean Date:		Shape:	C

Street:	Ridgelawn Drive	Flow Control:	Not Controlled
City:	Hobart, IN	Year Renewed:	
Location:	Light Highway	Tape/Media #:	DEP 35
Purpose:	Routine Assessment	Dia/Height:	6"
Use:	Sanitary	Material:	PVC
Drain Area:		Lining:	
Category:	NA		
Comment:

Location Details:		Direction of Survey:	Downstream
US MH:	M-303-072	DS MH:	M-303-020
		Total Length Surveyed (ft):	55.7

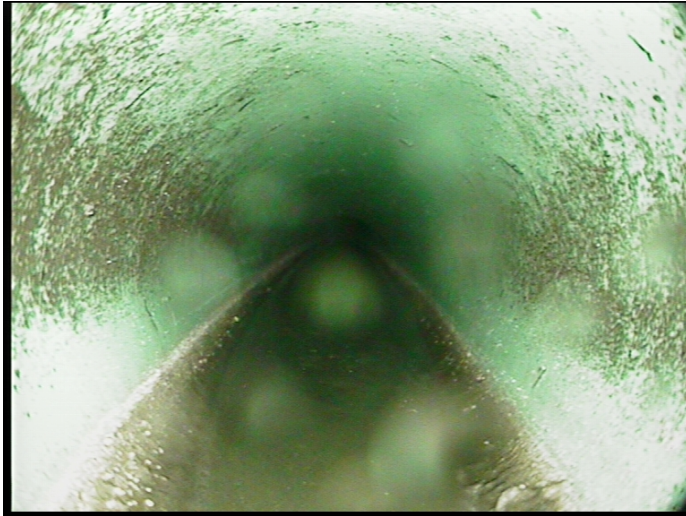
Code:	AMH
Description:	Manhole
Distance (ft):	.0
Structural Grade:	0
O&M Grade:	0
Clock Start/From:	
Clock To:	
1st Value:	
2nd Value:	
Value Percent:	
Continuous Index:	
Within 8" of Joint:	NO
Remarks:	M-303-072

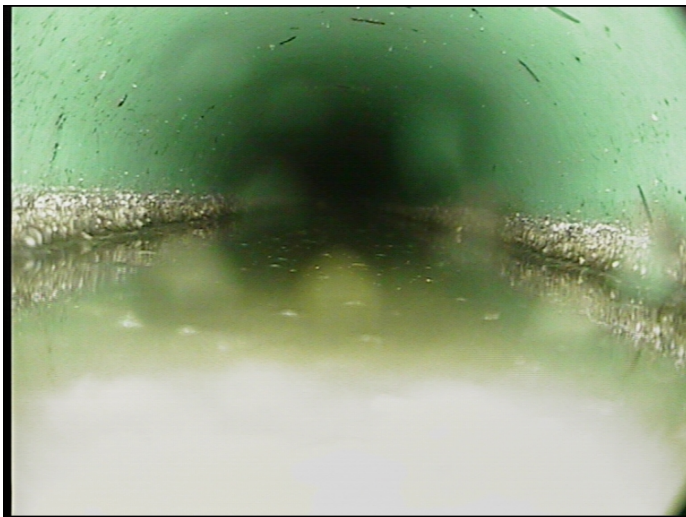
Code: **MWL**
Description: **Water Level**

Distance (ft): **.0**
Structural Grade: **0**
O&M Grade: **0**
Clock Start/From:
Clock To:
1st Value:
2nd Value:
Value Percent: **10.000**
Continuous Index:
Within 8" of Joint: **NO**
Remarks:

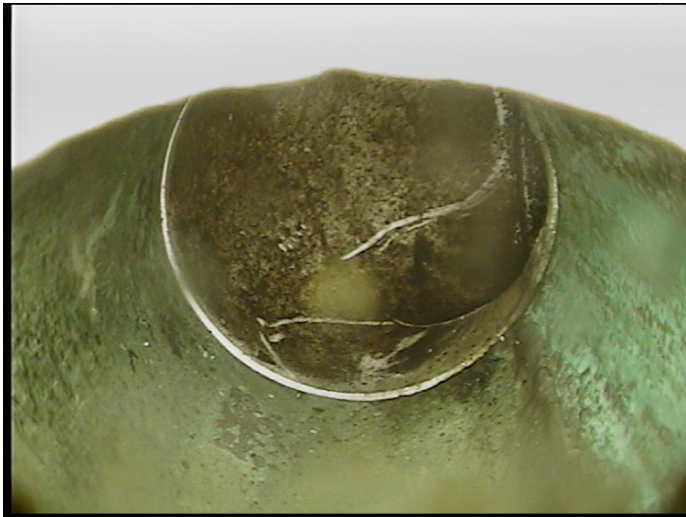
Code: **DSF**
Description: **Deposits Settled Fine**

Distance (ft): **7.0**
Structural Grade: **0**
O&M Grade: **2**
Clock Start/From: **5**
Clock To: **7**
1st Value:
2nd Value:
Value Percent: **10.000**
Continuous Index:
Within 8" of Joint: **NO**
Remarks:

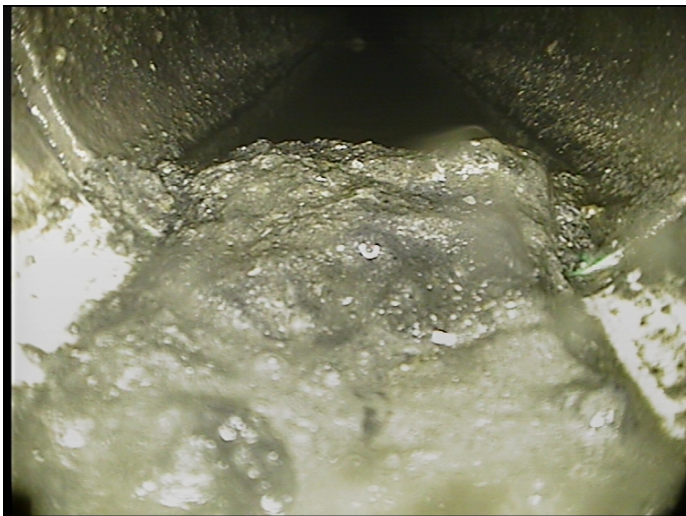
Code: **TF**
Description: **Tap Factory**

Distance (ft): **54.1**
Structural Grade: **0**
O&M Grade: **0**
Clock Start/From: **12**
Clock To:
1st Value: **6.000**
2nd Value:
Value Percent:
Continuous Index:
Within 8" of Joint: **NO**
Remarks:

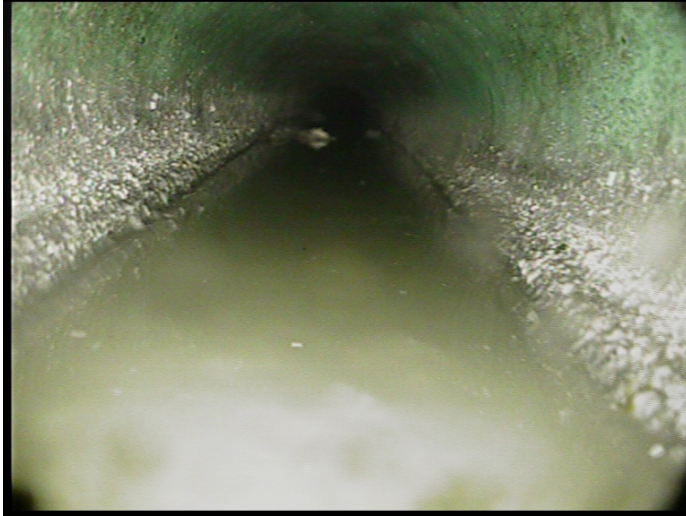
Code: **DSF**
Description: **Deposits Settled Fine**

Distance (ft): **55.0**
Structural Grade: **0**
O&M Grade: **2**
Clock Start/From: **5**
Clock To: **7**
1st Value:
2nd Value:
Value Percent: **10.000**
Continuous Index:
Within 8" of Joint: **NO**
Remarks:

Code:	MSA
Description:	Abandoned Survey
Distance (ft):	55.0
Structural Grade:	0
O&M Grade:	0
Clock Start/From:	
Clock To:	
1st Value:	
2nd Value:	
Value Percent:	
Continuous Index:	
Within 8" of Joint:	NO
Remarks:	debris
