Profile/Photo Observation Report

Date:	09/18/2021	Weather:		Coding:	PACP 7.0
Pipe Length (ft):	295.0	Owner:	City of Hobart	Pre Clean:	Light Cleaning
P.O.#:	YES502259	Surveyor:	S. Bucklin	PSR:	P-303-072-020
Customer:	City of Hobart	Clean Date:	08/25/2021	Shape:	C

Street:	Ridgelawn Drive	Flow Control:	Not Controlled
City:	Hobart, IN	Year Renewed:	
Location:	Easement/Right of Way	Tape/Media #:	
Purpose:	Routine Assessment	Dia/Height:	6"
Use:	Sanitary Sewage Pipe	Material:	PVC
Drain Area:		Lining:	None
Category:	NA		
Comment:

Location Details:		Direction of Survey:	Downstream
US MH:	M-303-072	DS MH:	M-303-020
		Total Length Surveyed (ft):	135.4

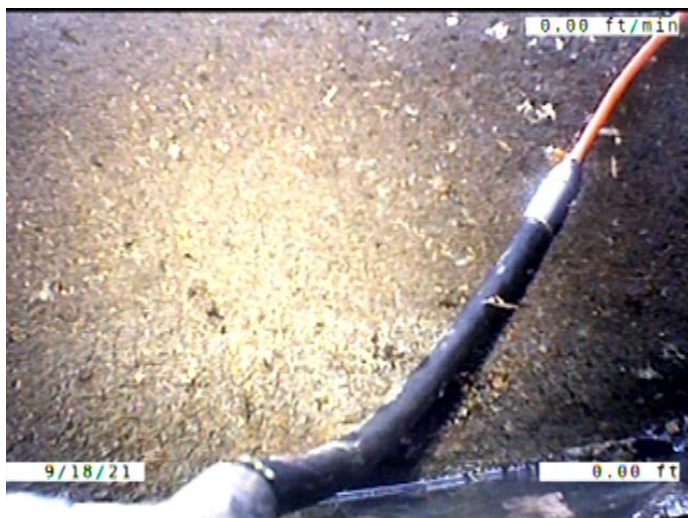
Code: **AMH**
 Description: **Manhole**

Distance (ft): **.0**
 Structural Grade: **0**
 O&M Grade: **0**
 Clock Start/From:
 Clock To:
 1st Value:
 2nd Value:
 Value Percent:
 Continuous Index:
 Within 8" of Joint: **NO**
 Remarks: **M-303-072**

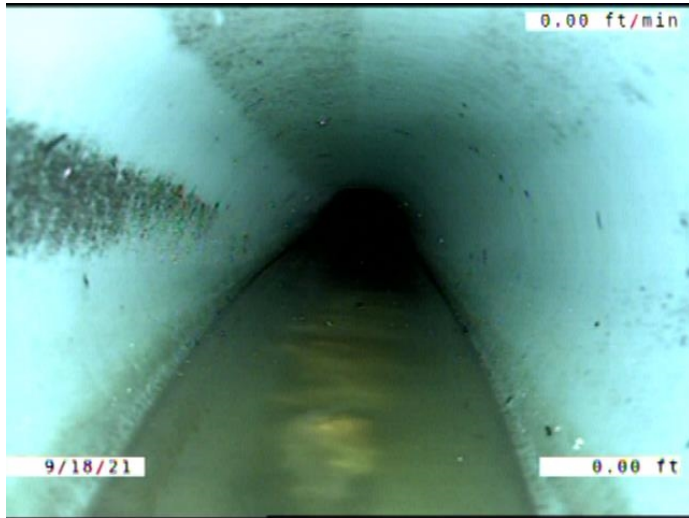
Code:	MWL
Description:	Miscellaneous Water Level
Distance (ft):	.0
Structural Grade:	0
O&M Grade:	0
Clock Start/From:	
Clock To:	
1st Value:	
2nd Value:	
Value Percent:	5.000
Continuous Index:	
Within 8" of Joint:	NO
Remarks:

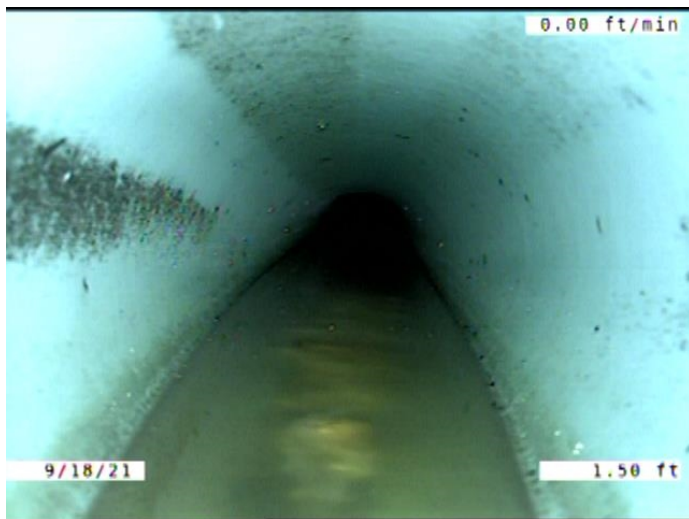
Code:	MGO
Description:	Miscellaneous General Observation
Distance (ft):	1.5
Structural Grade:	0
O&M Grade:	0
Clock Start/From:	
Clock To:	
1st Value:	
2nd Value:	
Value Percent:	
Continuous Index:	
Within 8" of Joint:	NO
Remarks:	DROP INTO THE MANHOLE. HAD TO START IN THE PIPE.

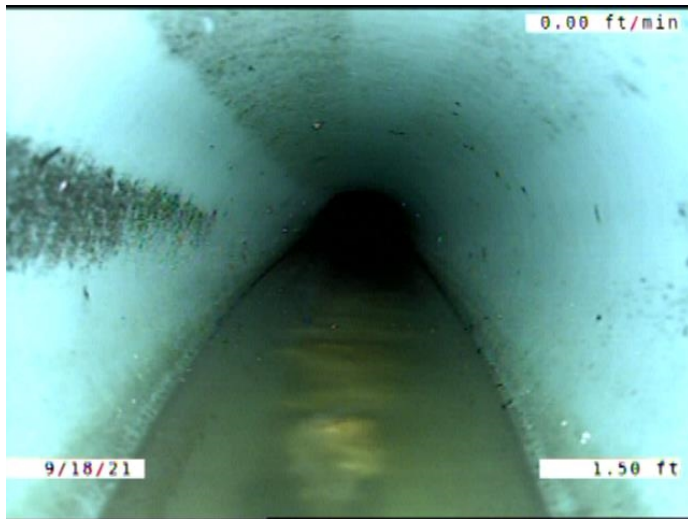
Code: **MWLS**
Description: **Miscellaneous Water Level Sag**

Distance (ft): **1.5**
Structural Grade: **2**
O&M Grade: **0**
Clock Start/From:
Clock To:
1st Value:
2nd Value:
Value Percent: **15.000**
Continuous Index: **S01**
Within 8" of Joint: **NO**
Remarks:

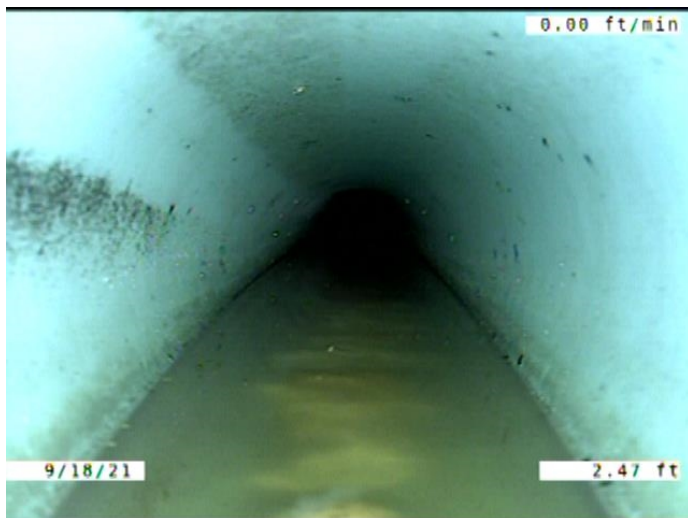
Code: **DSF**
Description: **Deposits Settled Fine**

Distance (ft): **2.5**
Structural Grade: **0**
O&M Grade: **2**
Clock Start/From: **5**
Clock To: **7**
1st Value:
2nd Value:
Value Percent: **5.000**
Continuous Index: **S02**
Within 8" of Joint: **YES**
Remarks:

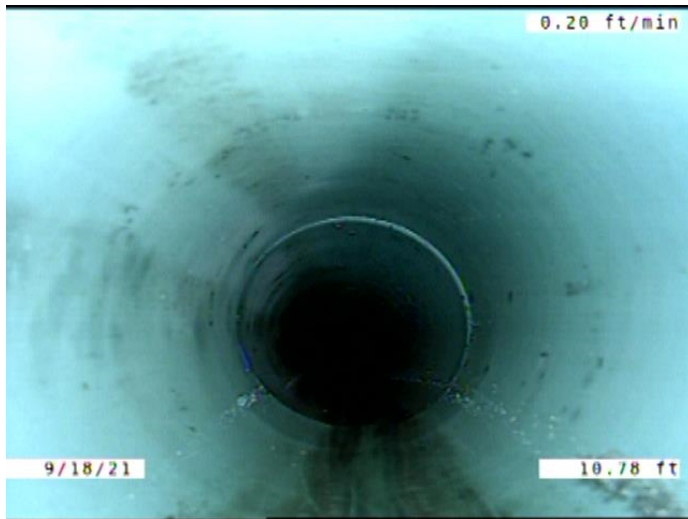
Code: **MWLS**
Description: **Miscellaneous Water Level Sag**

Distance (ft): **10.8**
Structural Grade: **2**
O&M Grade: **0**
Clock Start/From:
Clock To:
1st Value:
2nd Value:
Value Percent: **15.000**
Continuous Index: **F01**
Within 8" of Joint: **NO**
Remarks:

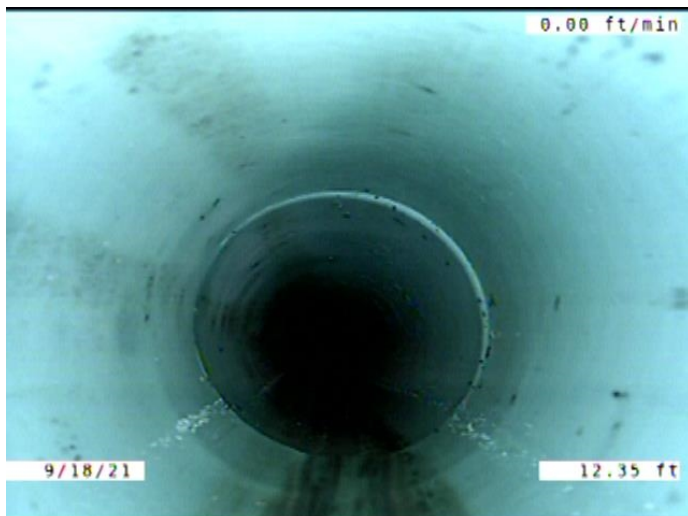
Code: **LD**
Description: **Line Down**

Distance (ft): **12.3**
Structural Grade: **0**
O&M Grade: **1**
Clock Start/From:
Clock To:
1st Value:
2nd Value:
Value Percent: **10.000**
Continuous Index:
Within 8" of Joint: **NO**
Remarks:

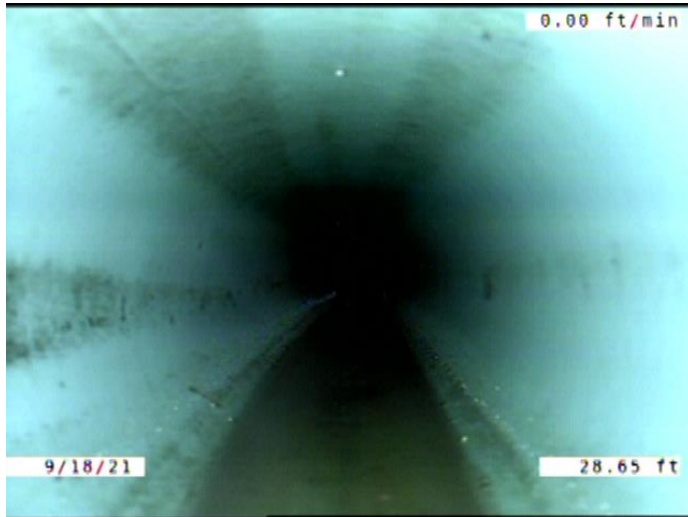
Code: **MWLS**
Description: **Miscellaneous Water Level Sag**

Distance (ft): **28.7**
Structural Grade: **2**
O&M Grade: **0**
Clock Start/From:
Clock To:
1st Value:
2nd Value:
Value Percent: **5.000**
Continuous Index:
Within 8" of Joint: **NO**
Remarks:

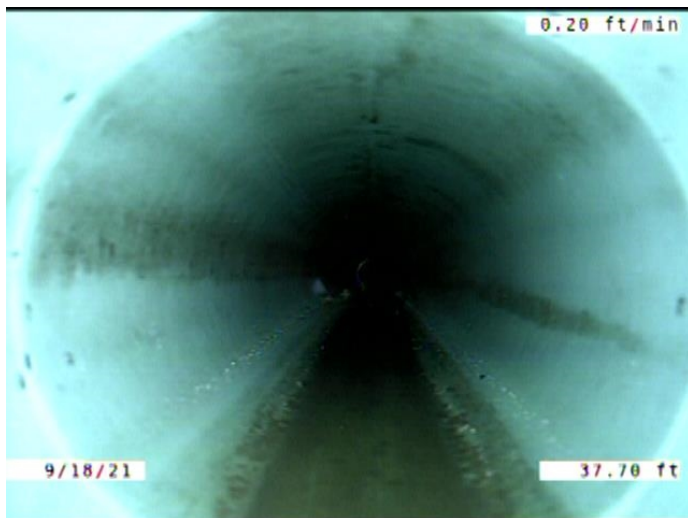
Code: **MWLS**
Description: **Miscellaneous Water Level Sag**

Distance (ft): **37.7**
Structural Grade: **2**
O&M Grade: **0**
Clock Start/From:
Clock To:
1st Value:
2nd Value:
Value Percent: **5.000**
Continuous Index:
Within 8" of Joint: **NO**
Remarks:

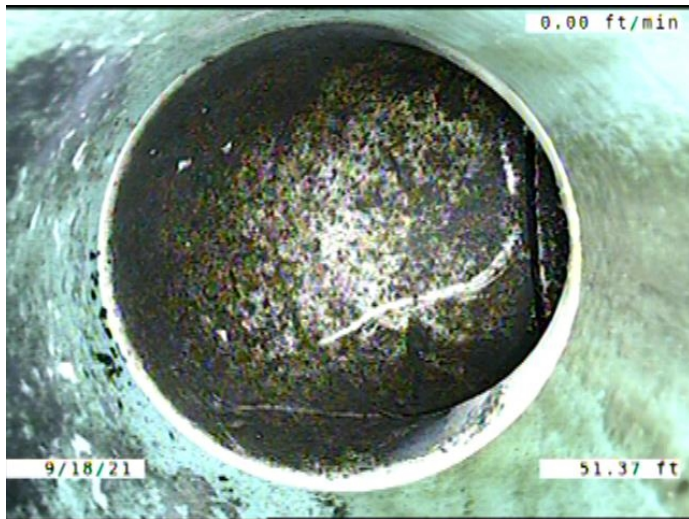
Code: **TF**
 Description: **Tap Factory**

Distance (ft): **51.4**
 Structural Grade: **0**
 O&M Grade: **0**
 Clock Start/From: **12**
 Clock To:
 1st Value: **4.000**
 2nd Value:
 Value Percent:
 Continuous Index:
 Within 8" of Joint: **YES**
 Remarks:

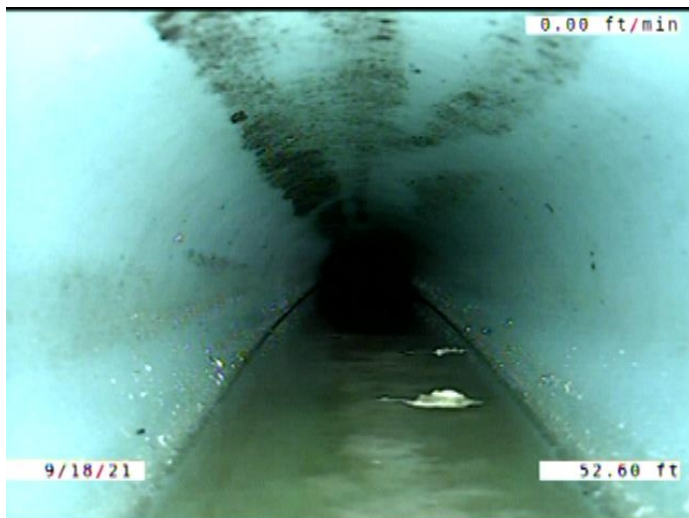
Code: **MWLS**
 Description: **Miscellaneous Water Level Sag**

Distance (ft): **52.6**
 Structural Grade: **2**
 O&M Grade: **0**
 Clock Start/From:
 Clock To:
 1st Value:
 2nd Value:
 Value Percent: **15.000**
 Continuous Index: **S03**
 Within 8" of Joint: **NO**
 Remarks:

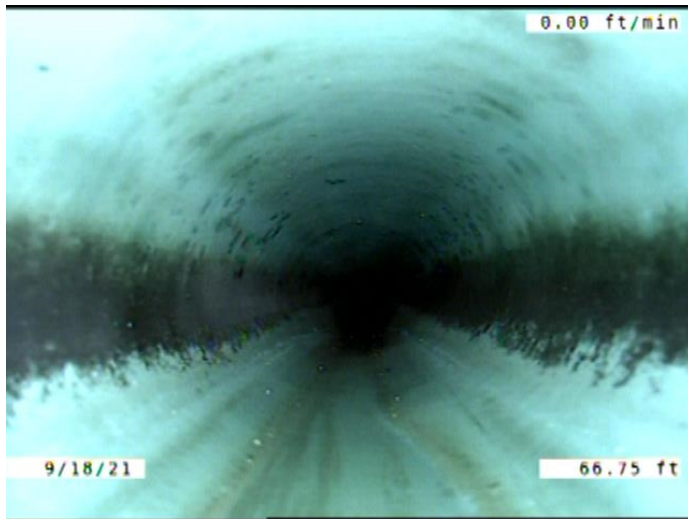
Code: **MWLS**
Description: **Miscellaneous Water Level Sag**

Distance (ft): **66.7**
Structural Grade: **2**
O&M Grade: **0**
Clock Start/From:
Clock To:
1st Value:
2nd Value:
Value Percent: **15.000**
Continuous Index: **F03**
Within 8" of Joint: **NO**
Remarks:

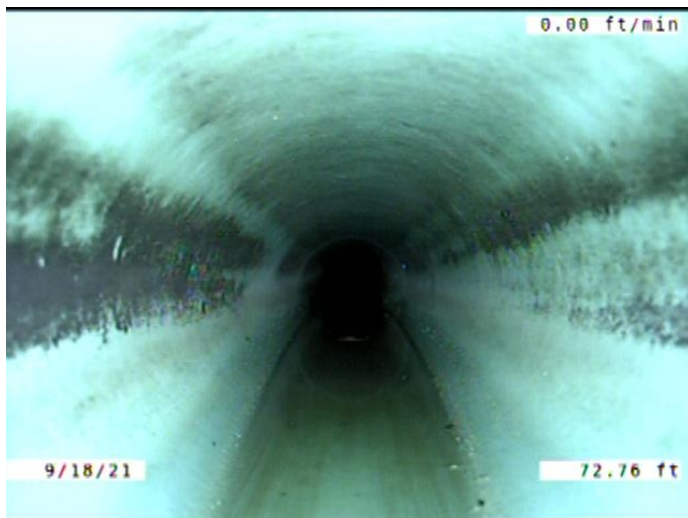
Code: **MWLS**
Description: **Miscellaneous Water Level Sag**

Distance (ft): **72.8**
Structural Grade: **2**
O&M Grade: **0**
Clock Start/From:
Clock To:
1st Value:
2nd Value:
Value Percent: **20.000**
Continuous Index: **S04**
Within 8" of Joint: **NO**
Remarks:

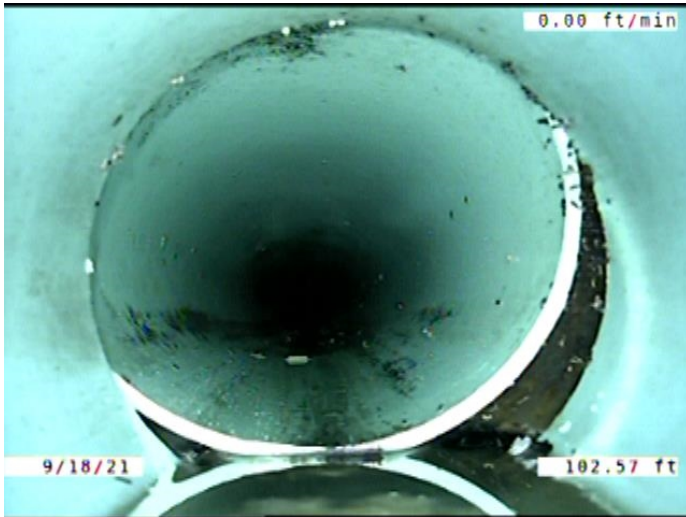
Code: **JOLD**
 Description: **Joint Offset Large Defective**

Distance (ft): **102.6**
 Structural Grade: **4**
 O&M Grade: **0**
 Clock Start/From:
 Clock To:
 1st Value:
 2nd Value:
 Value Percent:
 Continuous Index:
 Within 8" of Joint: **NO**
 Remarks:

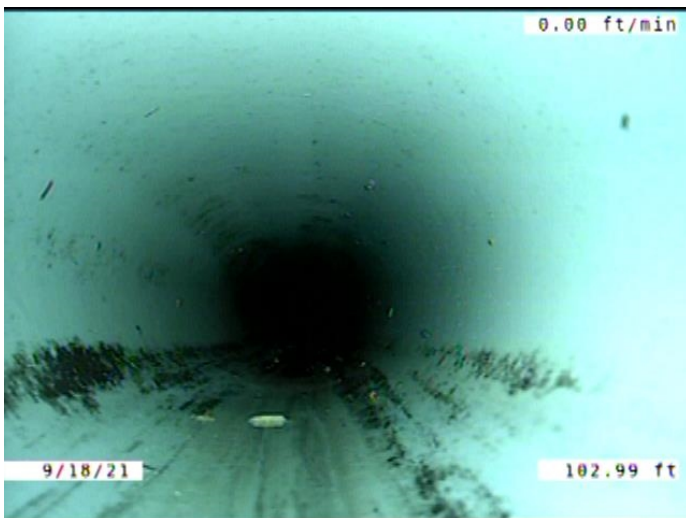
Code: **MWLS**
 Description: **Miscellaneous Water Level Sag**

Distance (ft): **103.0**
 Structural Grade: **2**
 O&M Grade: **0**
 Clock Start/From:
 Clock To:
 1st Value:
 2nd Value:
 Value Percent: **20.000**
 Continuous Index: **F04**
 Within 8" of Joint: **NO**
 Remarks:

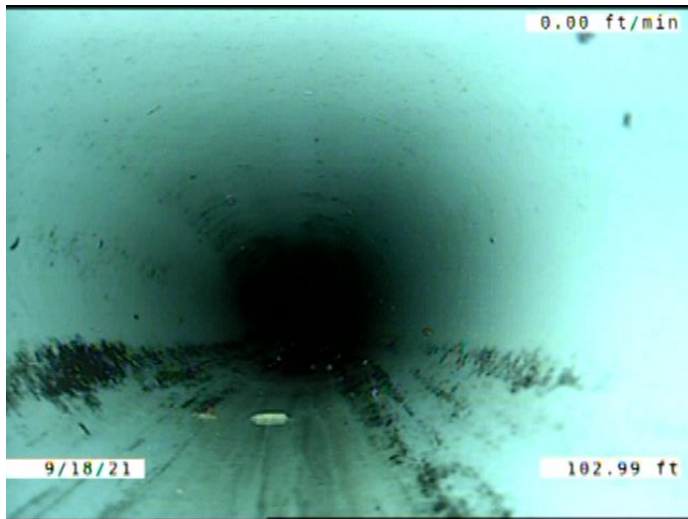
Code: **LD**
 Description: **Line Down**

Distance (ft): **103.0**
 Structural Grade: **0**
 O&M Grade: **2**
 Clock Start/From:
 Clock To:
 1st Value:
 2nd Value:
 Value Percent: **15.000**
 Continuous Index:
 Within 8" of Joint: **NO**
 Remarks:

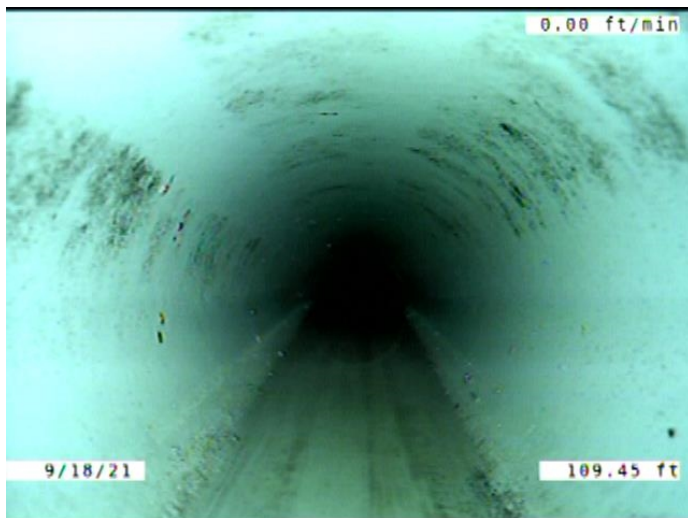
Code: **MWLS**
 Description: **Miscellaneous Water Level Sag**

Distance (ft): **109.5**
 Structural Grade: **2**
 O&M Grade: **0**
 Clock Start/From:
 Clock To:
 1st Value:
 2nd Value:
 Value Percent: **15.000**
 Continuous Index: **S05**
 Within 8" of Joint: **NO**
 Remarks:

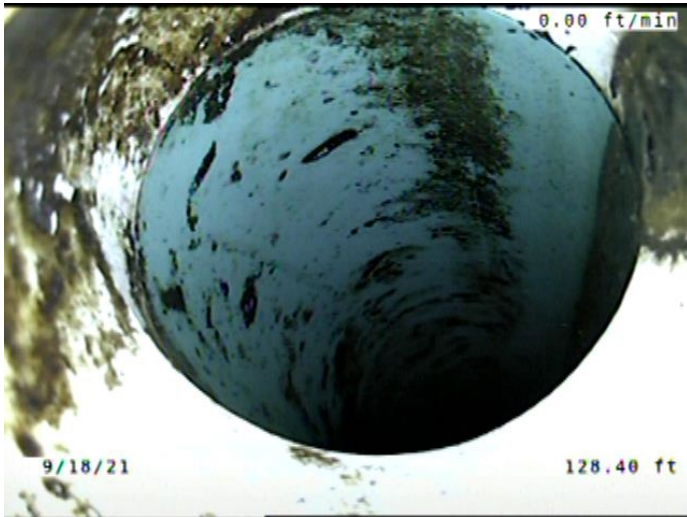
Code: **TF**
 Description: **Tap Factory**

Distance (ft): **128.4**
 Structural Grade: **0**
 O&M Grade: **0**
 Clock Start/From: **3**
 Clock To:
 1st Value: **3.000**
 2nd Value:
 Value Percent:
 Continuous Index:
 Within 8" of Joint: **YES**
 Remarks:

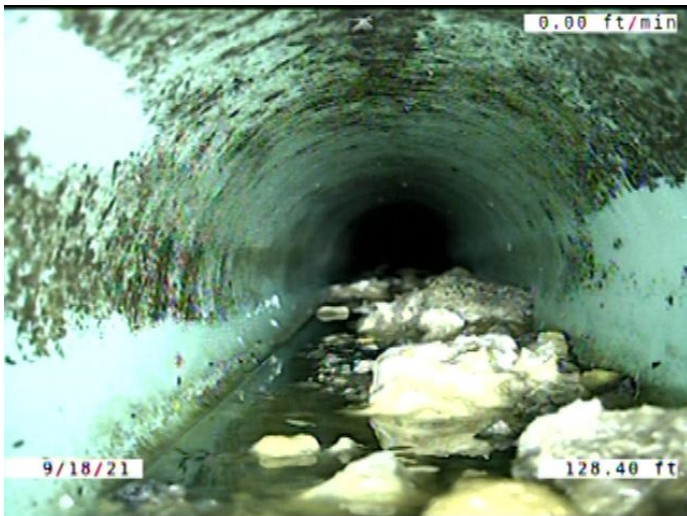
Code: **DSZ**
 Description: **Deposits Settled Other**

Distance (ft): **128.4**
 Structural Grade: **0**
 O&M Grade: **3**
 Clock Start/From: **4**
 Clock To: **8**
 1st Value:
 2nd Value:
 Value Percent: **20.000**
 Continuous Index: **S06**
 Within 8" of Joint: **YES**
 Remarks: **FINE, TP, SEWER DEBRIS**

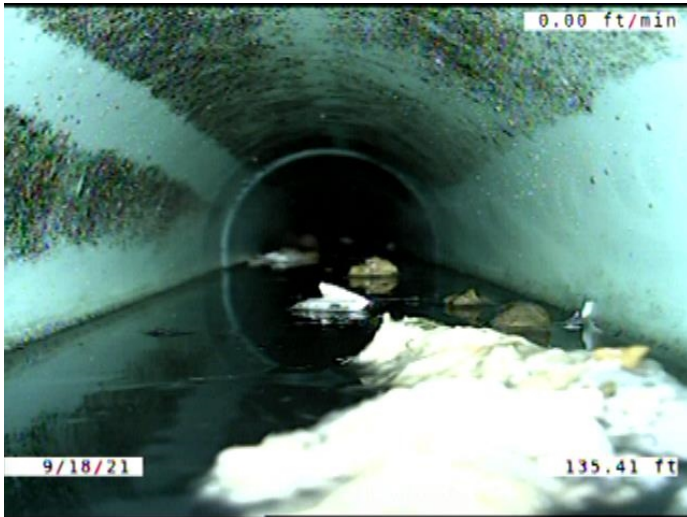
Code: **DSF**
 Description: **Deposits Settled Fine**

Distance (ft): **135.4**
 Structural Grade: **0**
 O&M Grade: **2**
 Clock Start/From: **5**
 Clock To: **7**
 1st Value:
 2nd Value:
 Value Percent: **5.000**
 Continuous Index: **F02**
 Within 8" of Joint: **YES**
 Remarks:

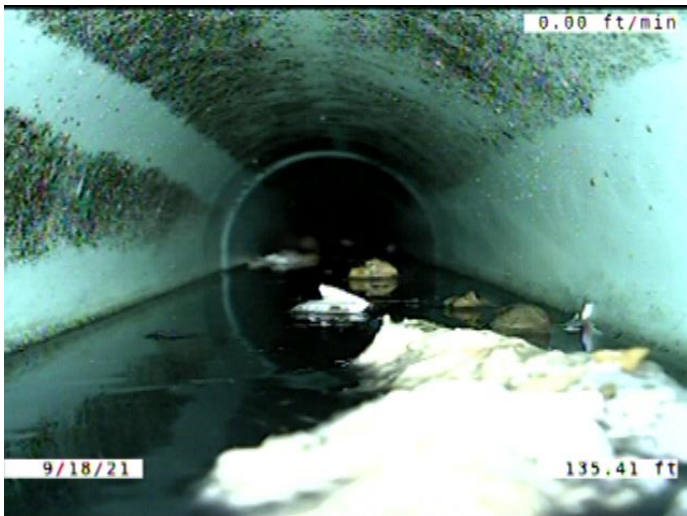
Code: **DSZ**
 Description: **Deposits Settled Other**

Distance (ft): **135.4**
 Structural Grade: **0**
 O&M Grade: **3**
 Clock Start/From: **4**
 Clock To: **8**
 1st Value:
 2nd Value:
 Value Percent: **20.000**
 Continuous Index: **F06**
 Within 8" of Joint: **YES**
 Remarks: **FINE, TP, SEWER DEBRIS**

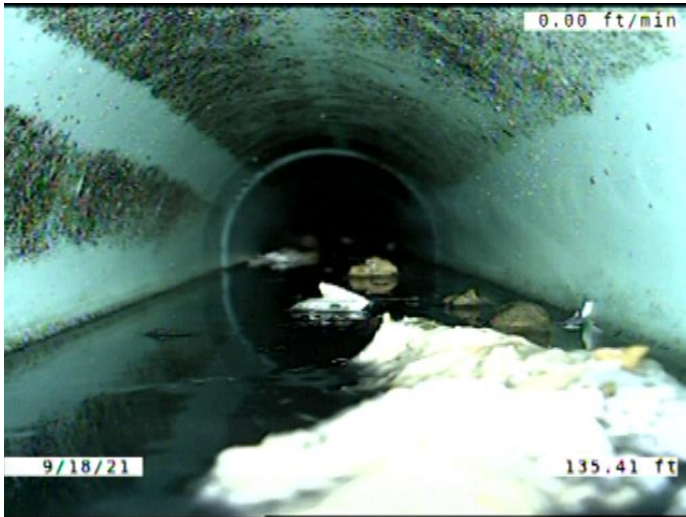
Code: **MWLS**
 Description: **Miscellaneous Water Level Sag**

Distance (ft): **135.4**
 Structural Grade: **2**
 O&M Grade: **0**
 Clock Start/From:
 Clock To:
 1st Value:
 2nd Value:
 Value Percent: **15.000**
 Continuous Index: **F05**
 Within 8" of Joint: **NO**
 Remarks:

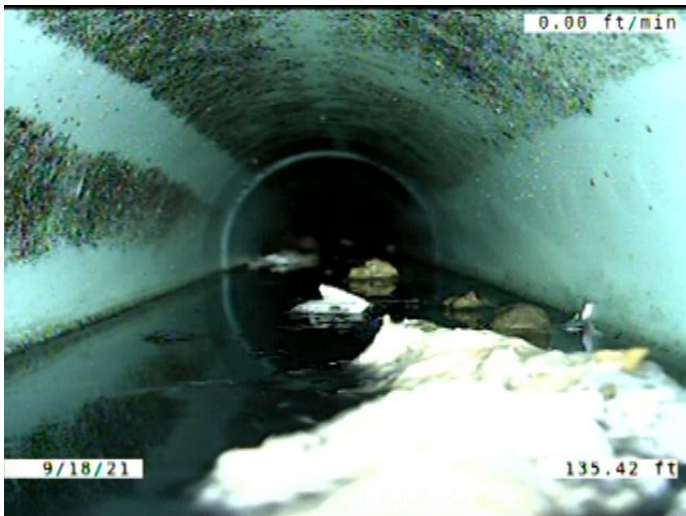
Code: **MSA**
 Description: **Miscellaneous Survey Abandoned**

Distance (ft): **135.4**
 Structural Grade: **0**
 O&M Grade: **0**
 Clock Start/From:
 Clock To:
 1st Value:
 2nd Value:
 Value Percent:
 Continuous Index:
 Within 8" of Joint: **NO**
 Remarks: **CAMERA CANT MAKE IT PAST DEBRIS**
