Profile/Photo Observation Report

Date:	04/07/2018	Weather:		Coding:	PACP 6.0
Pipe Length (ft):		Owner:	City of Hobart	Pre Clean:	No Pre-Cleaning
P.O.#:	6-1	Surveyor:	M. Pielacha	PSR:	M-303-073-M-303-021
Customer:	City of Hobart	Clean Date:		Shape:	C

Street:	Ridgelawn Drive	Flow Control:	Not Controlled
City:	Hobart, IN	Year Renewed:	
Location:	Light Highway	Tape/Media #:	DEP 6
Purpose:	Routine Assessment	Dia/Height:	18"
Use:	Sanitary	Material:	VCP
Drain Area:		Lining:	
Category:	NA		
Comment:			
Location Details:		Direction of Survey:	Upstream
US MH:	M-303-073	DS MH:	M-303-021
		Total Length Surveyed (ft):	20.6

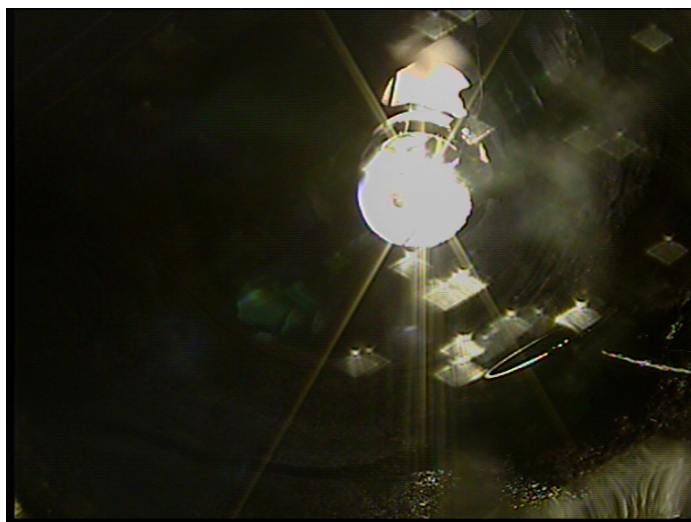
Code: **AMH**
Description: **Manhole**

Distance (ft): **.0**
Structural Grade: **0**
O&M Grade: **0**
Clock Start/From:
Clock To:
1st Value:
2nd Value:
Value Percent:
Continuous Index:
Within 8" of Joint: **NO**
Remarks: **M-303-021**

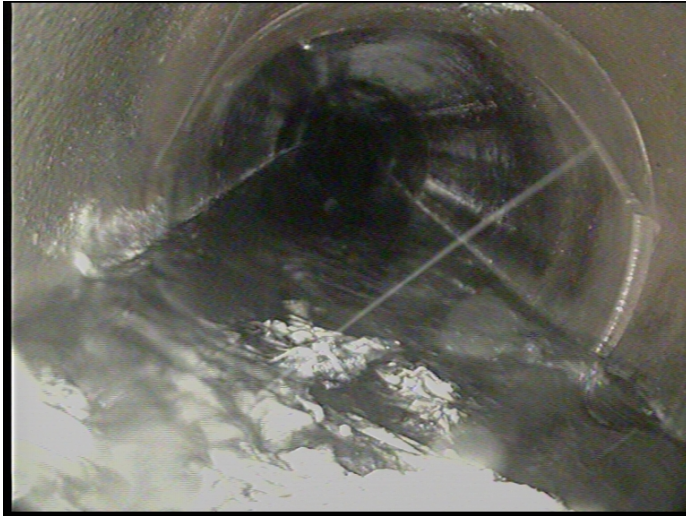
Code: **MWL**
Description: **Water Level**

Distance (ft): **.0**
Structural Grade: **0**
O&M Grade: **0**
Clock Start/From:
Clock To:
1st Value:
2nd Value:
Value Percent: **15.000**
Continuous Index:
Within 8" of Joint: **NO**
Remarks:

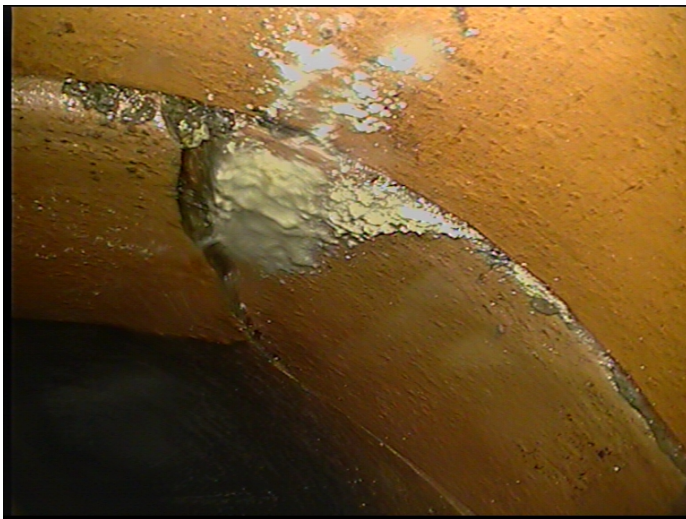
Code: **FL**
Description: **Fracture Longitudinal**

Distance (ft): **.0**
Structural Grade: **3**
O&M Grade: **0**
Clock Start/From: **12**
Clock To:
1st Value:
2nd Value:
Value Percent:
Continuous Index:
Within 8" of Joint: **YES**
Remarks:

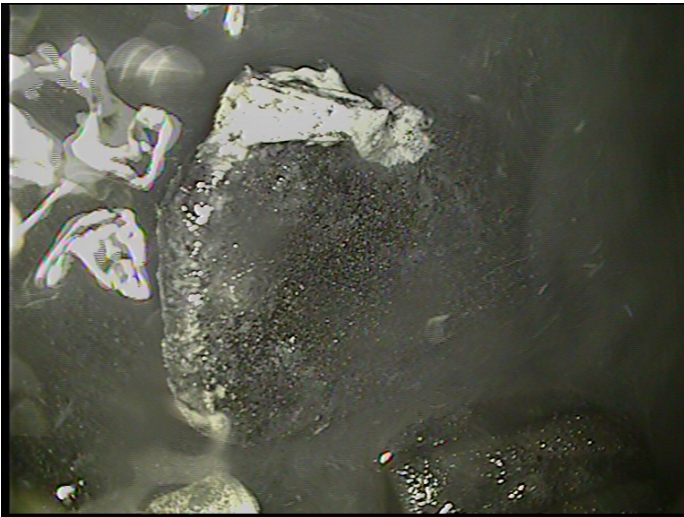
Code: **OBR**
Description: **Obstacle Rocks**

Distance (ft): **11.2**
Structural Grade: **0**
O&M Grade: **3**
Clock Start/From: **5**
Clock To: **7**
1st Value:
2nd Value:
Value Percent: **15.000**
Continuous Index:
Within 8" of Joint: **NO**
Remarks:

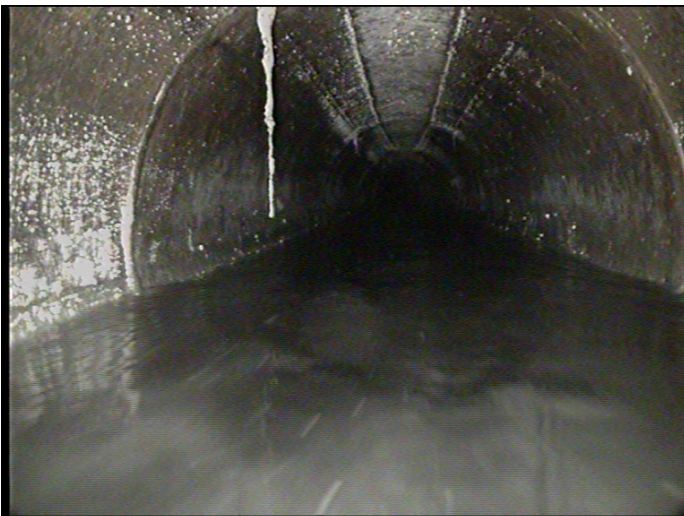
Code: **MSA**
Description: **Abandoned Survey**

Distance (ft): **20.6**
Structural Grade: **0**
O&M Grade: **0**
Clock Start/From:
Clock To:
1st Value:
2nd Value:
Value Percent:
Continuous Index:
Within 8" of Joint: **NO**
Remarks: **debris**
