## Profile/Photo Observation Report

Date:	<b>04/07/2018</b>	Weather:		Coding:	<b>PACP 6.0</b>
Pipe Length (ft):		Owner:	<b>City of Hobart</b>	Pre Clean:	<b>No Pre-Cleaning</b>
P.O.#:	<b>6-1</b>	Surveyor:	<b>M. Pielacha</b>	PSR:	<b>M-303-073-M-303-021</b>
Customer:	<b>City of Hobart</b>	Clean Date:		Shape:	<b>C</b>

Street:	<b>Ridgelawn Drive</b>	Flow Control:	<b>Not Controlled</b>
City:	<b>Hobart, IN</b>	Year Renewed:	
Location:	<b>Light Highway</b>	Tape/Media #:	<b>DEP 6</b>
Purpose:	<b>Routine Assessment</b>	Dia/Height:	<b>18"</b>
Use:	<b>Sanitary</b>	Material:	<b>VCP</b>
Drain Area:		Lining:	
Category:	<b>NA</b>		
Comment:			
Location Details:		Direction of Survey:	<b>Upstream</b>
US MH:	<b>M-303-073</b>	DS MH:	<b>M-303-021</b>
		Total Length Surveyed (ft):	<b>20.6</b>

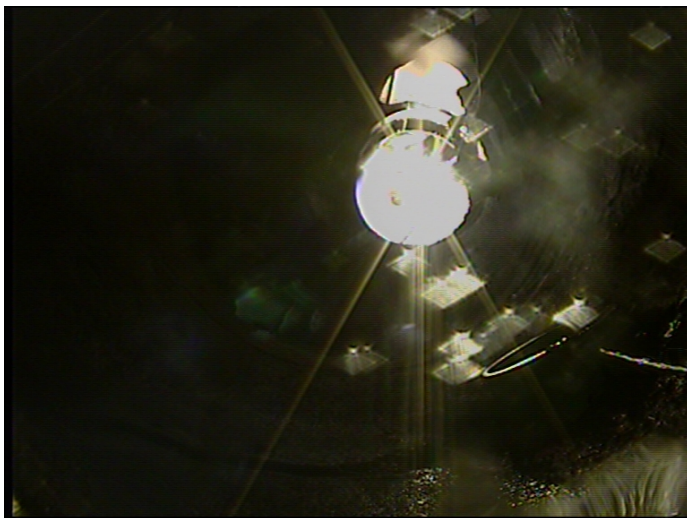
Code:	AMH
Description:	Manhole
Distance (ft):	.0
Structural Grade:	0
O&M Grade:	0
Clock Start/From:	
Clock To:	
1st Value:	
2nd Value:	
Value Percent:	
Continuous Index:	
Within 8" of Joint:	NO
Remarks:	M-303-021

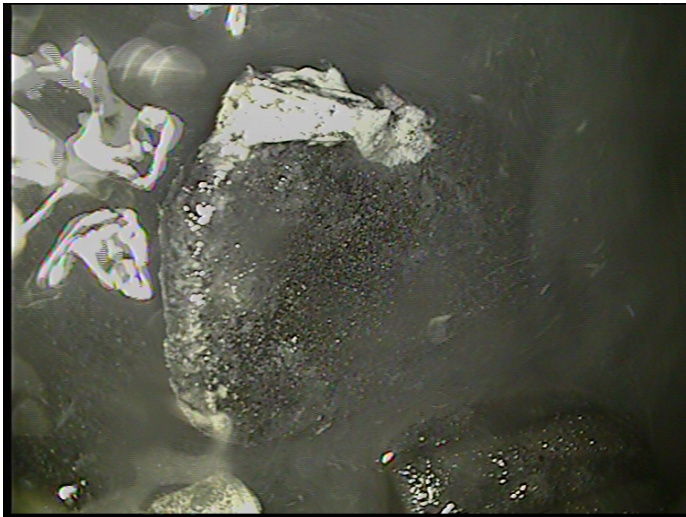
Code: **OBR**  
Description: **Obstacle Rocks**

Distance (ft): **11.2**  
Structural Grade: **0**  
O&M Grade: **3**  
Clock Start/From: **5**  
Clock To: **7**  
1st Value:  
2nd Value:  
Value Percent: **15.000**  
Continuous Index:  
Within 8" of Joint: **NO**  
Remarks:

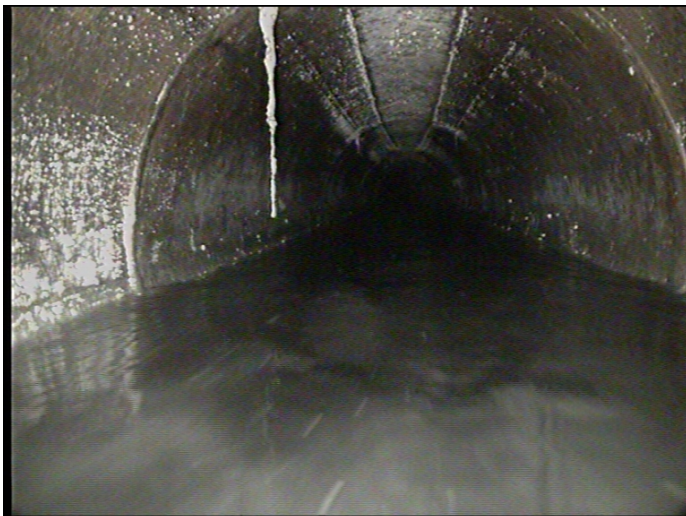
Code: **MSA**  
Description: **Abandoned Survey**

Distance (ft): **20.6**  
Structural Grade: **0**  
O&M Grade: **0**  
Clock Start/From:  
Clock To:  
1st Value:  
2nd Value:  
Value Percent:  
Continuous Index:  
Within 8" of Joint: **NO**  
Remarks: **debris**
