Profile/Photo Observation Report

Street:	Ridgelawn Drive	Flow Control:	Not Controlled
City:	Hobart, IN	Year Renewed:	
Location:	Light Highway	Tape/Media #:	DEP 7
Purpose:	Routine Assessment	Dia/Height:	18"
Use:	Sanitary	Material:	VCP
Drain Area:		Lining:

US MH: **M-303-073** DS MH: **M-303-021** Total Length Surveyed (ft): **2.6**

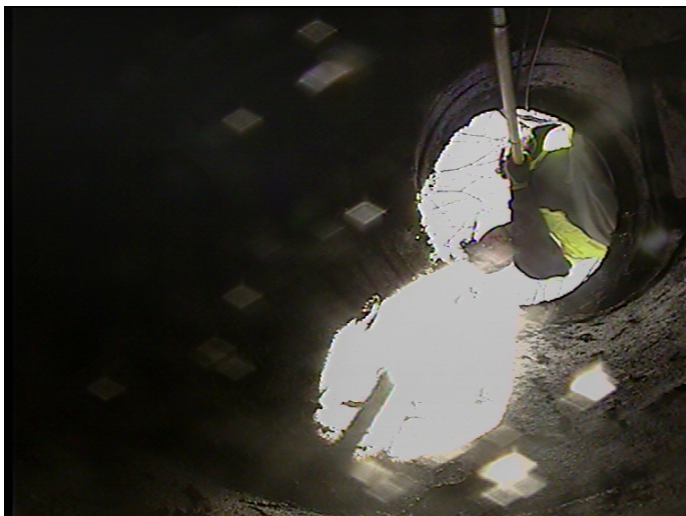
Code: **AMH**
 Description: **Manhole**

Distance (ft): **.0**
 Structural Grade: **0**
 O&M Grade: **0**
 Clock Start/From:
 Clock To:
 1st Value:
 2nd Value:
 Value Percent:
 Continuous Index:
 Within 8" of Joint: **NO**
 Remarks: **M-303-073**

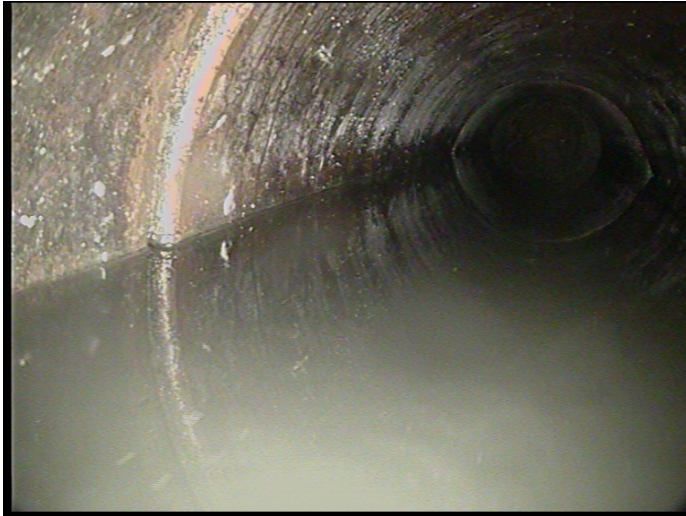
Code: **MWL**
Description: **Water Level**

Distance (ft): **.0**
Structural Grade: **0**
O&M Grade: **0**
Clock Start/From:
Clock To:
1st Value:
2nd Value:
Value Percent: **25.000**
Continuous Index:
Within 8" of Joint: **NO**
Remarks:

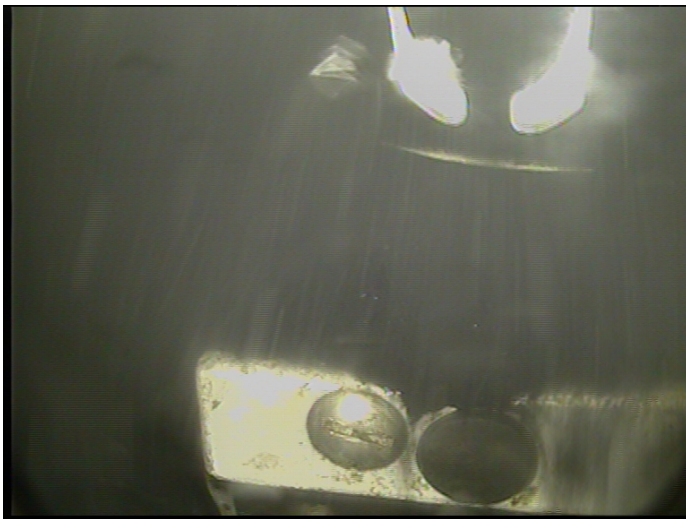
Code: **DSF**
Description: **Deposits Settled Fine**

Distance (ft): **2.3**
Structural Grade: **0**
O&M Grade: **3**
Clock Start/From: **5**
Clock To: **7**
1st Value:
2nd Value:
Value Percent: **20.000**
Continuous Index:
Within 8" of Joint: **YES**
Remarks:

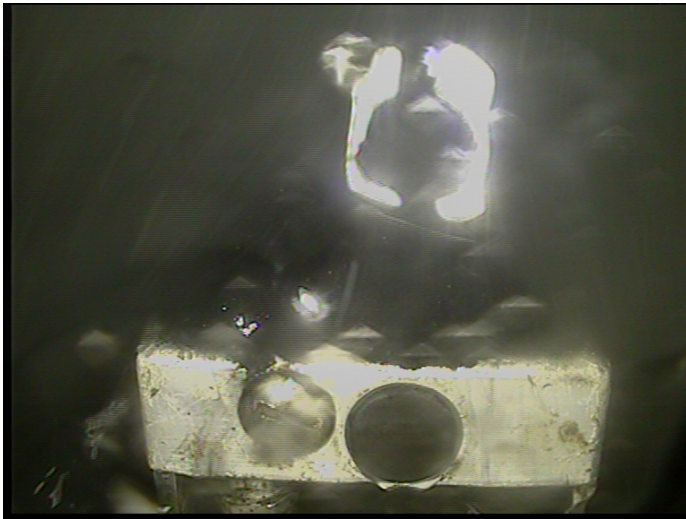
Code:	MSA
Description:	Abandoned Survey
Distance (ft):	2.6
Structural Grade:	0
O&M Grade:	0
Clock Start/From:	
Clock To:	
1st Value:	
2nd Value:	
Value Percent:	
Continuous Index:	
Within 8" of Joint:	NO
Remarks:	sediment
