## Profile/Photo Observation Report

Street:	<b>Old Ridge Road</b>	Flow Control:	<b>Not Controlled</b>
City:	<b>Hobart, IN</b>	Year Renewed:	
Location:	<b>Light Highway</b>	Tape/Media #:	<b>DEP 15</b>
Purpose:	<b>Routine Assessment</b>	Dia/Height:	<b>18"</b>
Use:	<b>Sanitary</b>	Material:	<b>VCP</b>
Drain Area:		Lining:	
Category:	<b>NA</b>		
Comment:

Location Details:		Direction of Survey:	<b>Downstream</b>
US MH:	<b>M-304-001</b>	DS MH:	<b>M-404-035</b>
		Total Length Surveyed (ft):	<b>161.6</b>

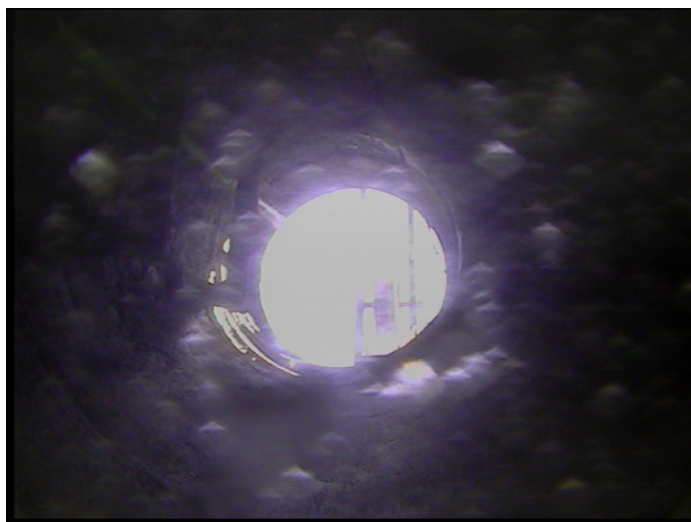
Code: **AMH**  
Description: **Manhole**

Distance (ft): **.0**  
Structural Grade: **0**  
O&M Grade: **0**  
Clock Start/From:  
Clock To:  
1st Value:  
2nd Value:  
Value Percent:  
Continuous Index:  
Within 8" of Joint: **NO**  
Remarks: **M-304-001**

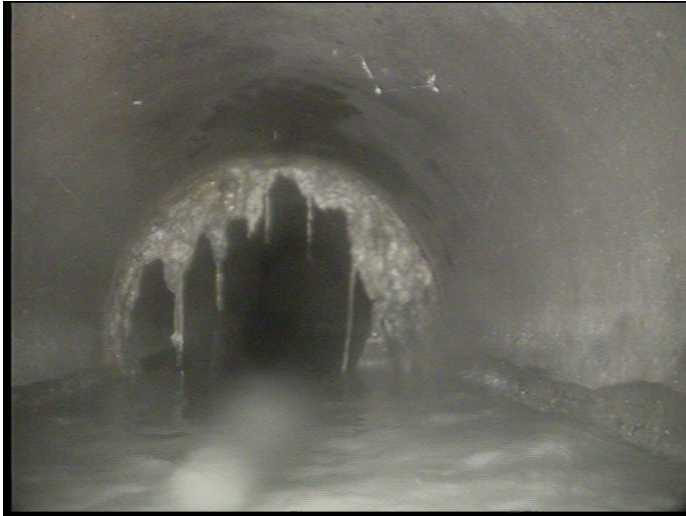
Code: **MWL**  
Description: **Water Level**

Distance (ft): **.0**  
Structural Grade: **0**  
O&M Grade: **0**  
Clock Start/From:  
Clock To:  
1st Value:  
2nd Value:  
Value Percent: **15.000**  
Continuous Index:  
Within 8" of Joint: **NO**  
Remarks:

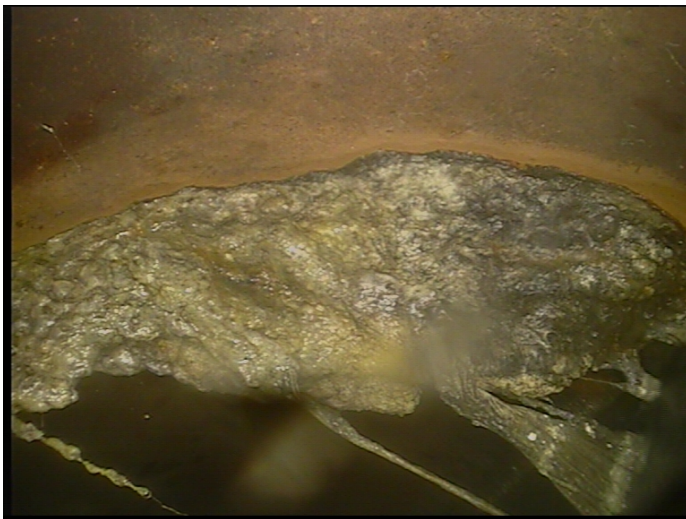
Code: **DAE**  
Description: **Deposits Attached Encrustation**

Distance (ft): **3.1**  
Structural Grade: **0**  
O&M Grade: **3**  
Clock Start/From: **7**  
Clock To: **5**  
1st Value:  
2nd Value:  
Value Percent: **15.000**  
Continuous Index:  
Within 8" of Joint: **YES**  
Remarks:

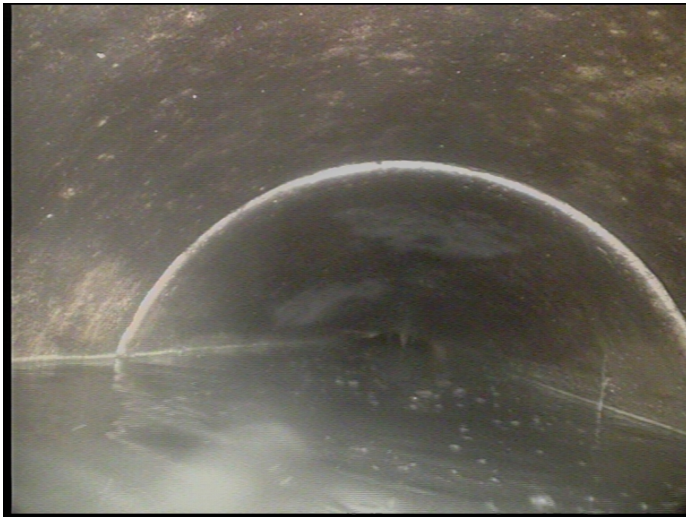
Code: **MWL**  
Description: **Water Level**

Distance (ft): **161.1**  
Structural Grade: **0**  
O&M Grade: **0**  
Clock Start/From:  
Clock To:  
1st Value:  
2nd Value:  
Value Percent: **65.000**  
Continuous Index:  
Within 8" of Joint: **NO**  
Remarks:

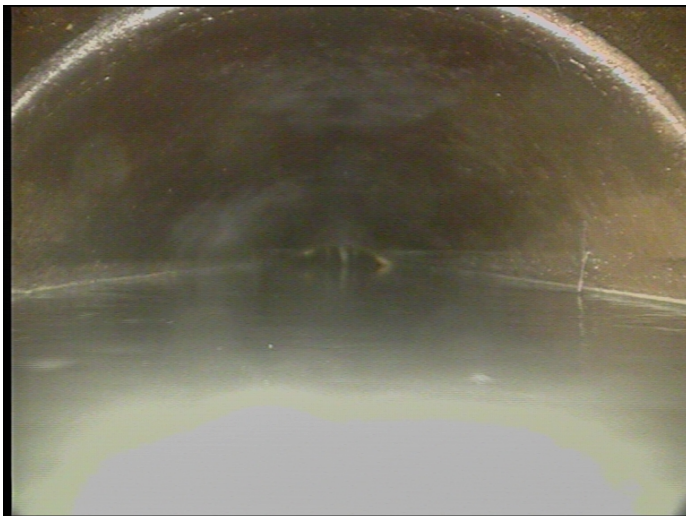
Code: **MSA**  
Description: **Abandoned Survey**

Distance (ft): **161.6**  
Structural Grade: **0**  
O&M Grade: **0**  
Clock Start/From:  
Clock To:  
1st Value:  
2nd Value:  
Value Percent:  
Continuous Index:  
Within 8" of Joint: **NO**  
Remarks: **under water debris**
