Profile/Photo Observation Report

Date:	04/07/2018	Weather:		Coding:	PACP 6.0
Pipe Length (ft):		Owner:	City of Hobart	Pre Clean:	No Pre-Cleaning
P.O.#:	13-2	Surveyor:	M. Pielacha	PSR:	M-304-003-M-304-002
Customer:	City of Hobart	Clean Date:		Shape:	C

Street:	Old Ridge Road	Flow Control:	Not Controlled
City:	Hobart, IN	Year Renewed:	
Location:	Light Highway	Tape/Media #:	DEP 13
Purpose:	Routine Assessment	Dia/Height:	18"
Use:	Sanitary	Material:	VCP
Drain Area:		Lining:	
Category:	NA		
Comment:			
Location Details:		Direction of Survey:	Downstream
US MH:	M-304-003	DS MH:	M-304-002
		Total Length Surveyed (ft):	318.8

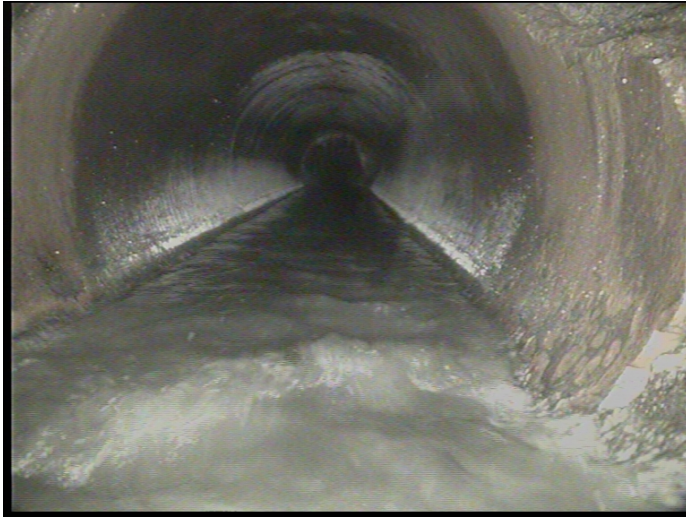
Code: **MWL**
Description: **Water Level**

Distance (ft): **.0**
Structural Grade: **0**
O&M Grade: **0**
Clock Start/From:
Clock To:
1st Value:
2nd Value:
Value Percent: **5.000**
Continuous Index:
Within 8" of Joint: **NO**
Remarks:

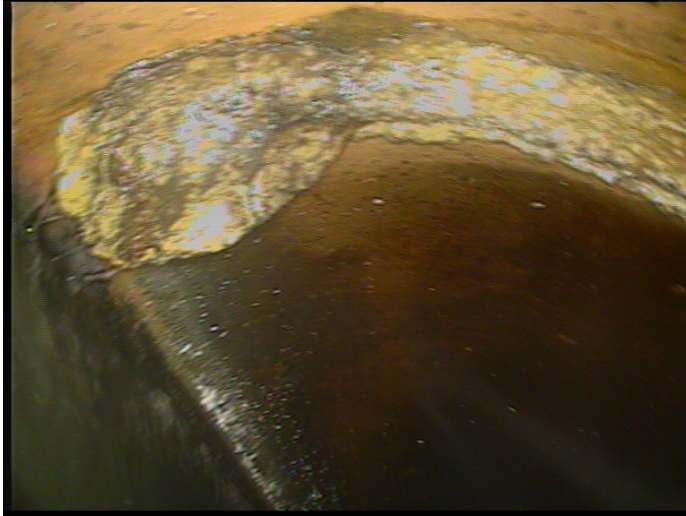
Code:	DAE
Description:	Deposits Attached Encrustation
Distance (ft):	70.7
Structural Grade:	0
O&M Grade:	2
Clock Start/From:	7
Clock To:	5
1st Value:	
2nd Value:	
Value Percent:	5.000
Continuous Index:	
Within 8" of Joint:	YES
Remarks:

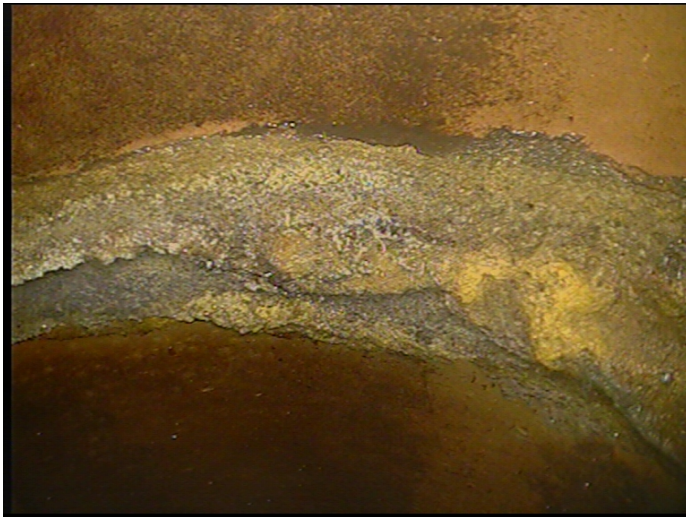
Code:	DAE
Description:	Deposits Attached Encrustation
Distance (ft):	201.7
Structural Grade:	0
O&M Grade:	2
Clock Start/From:	7
Clock To:	5
1st Value:	
2nd Value:	
Value Percent:	5.000
Continuous Index:	S01
Within 8" of Joint:	YES
Remarks:

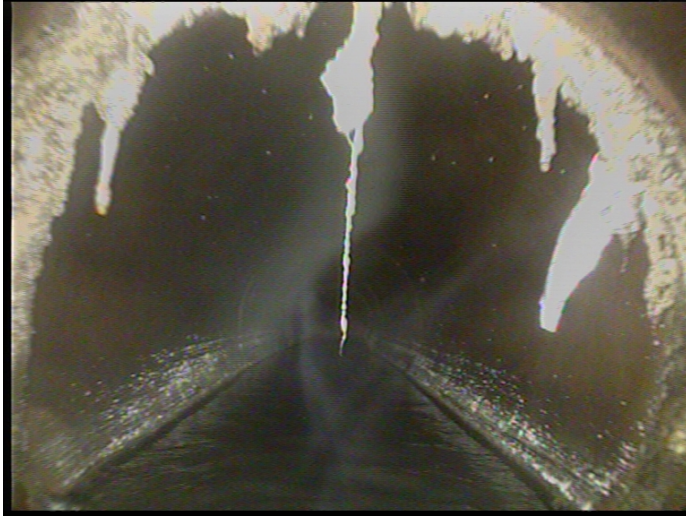
Code: **DAE**
Description: **Deposits Attached Encrustation**

Distance (ft): **251.2**
Structural Grade: **0**
O&M Grade: **2**
Clock Start/From: **7**
Clock To: **5**
1st Value:
2nd Value:
Value Percent: **5.000**
Continuous Index: **F01**
Within 8" of Joint: **NO**
Remarks:

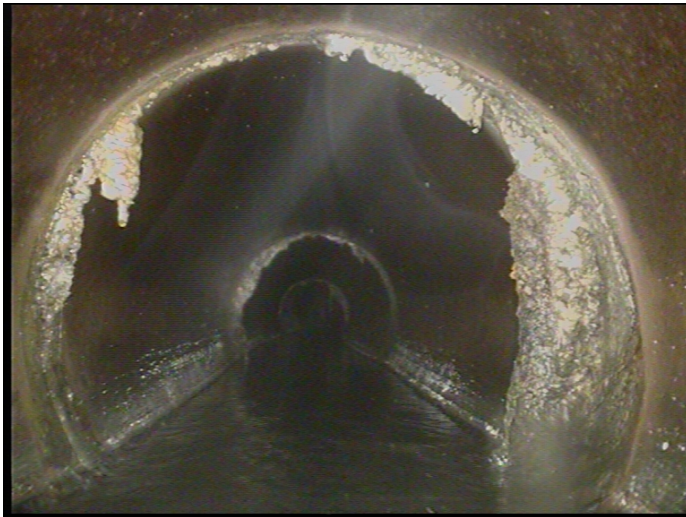
Code: **DAE**
Description: **Deposits Attached Encrustation**

Distance (ft): **285.9**
Structural Grade: **0**
O&M Grade: **2**
Clock Start/From: **7**
Clock To: **5**
1st Value:
2nd Value:
Value Percent: **5.000**
Continuous Index: **S02**
Within 8" of Joint: **YES**
Remarks:
