## Profile/Photo Observation Report

Date:	<b>04/07/2018</b>	Weather:		Coding:	<b>PACP 6.0</b>
Pipe Length (ft):		Owner:	<b>City of Hobart</b>	Pre Clean:	<b>No Pre-Cleaning</b>
P.O.#:	<b>13-2</b>	Surveyor:	<b>M. Pielacha</b>	PSR:	<b>M-304-003-M-304-002</b>
Customer:	<b>City of Hobart</b>	Clean Date:		Shape:	<b>C</b>

Location Details:		Direction of Survey:	<b>Downstream</b>
US MH:	<b>M-304-003</b>	DS MH:	<b>M-304-002</b>
		Total Length Surveyed (ft):	<b>318.8</b>

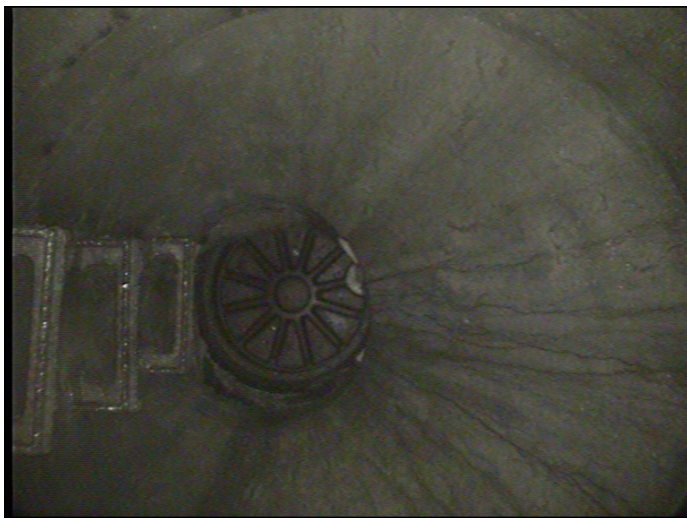
Code: **AMH**  
 Description: **Manhole**

Distance (ft): **.0**  
 Structural Grade: **0**  
 O&M Grade: **0**  
 Clock Start/From:  
 Clock To:  
 1st Value:  
 2nd Value:  
 Value Percent:  
 Continuous Index:  
 Within 8" of Joint: **NO**  
 Remarks: **M-304-003**

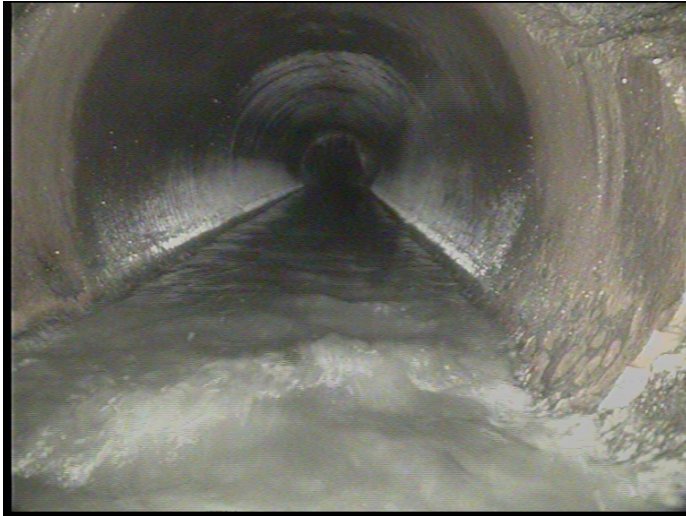
Code: **MWL**  
Description: **Water Level**

Distance (ft): **.0**  
Structural Grade: **0**  
O&M Grade: **0**  
Clock Start/From:  
Clock To:  
1st Value:  
2nd Value:  
Value Percent: **5.000**  
Continuous Index:  
Within 8" of Joint: **NO**  
Remarks:

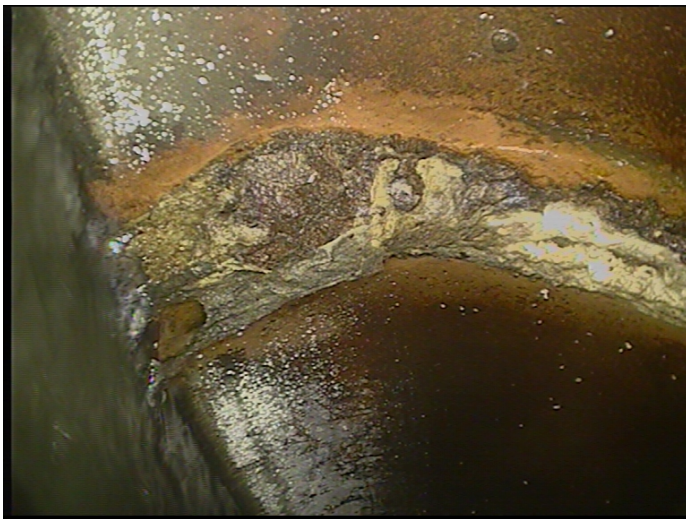
Code: **DAE**  
Description: **Deposits Attached Encrustation**

Distance (ft): **15.3**  
Structural Grade: **0**  
O&M Grade: **2**  
Clock Start/From: **7**  
Clock To: **5**  
1st Value:  
2nd Value:  
Value Percent: **5.000**  
Continuous Index:  
Within 8" of Joint: **YES**  
Remarks:

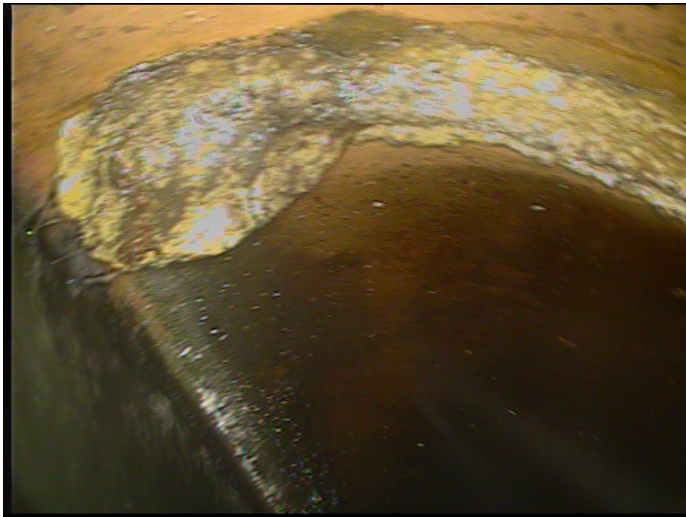
Code: **DAE**  
Description: **Deposits Attached Encrustation**

Distance (ft): **70.7**  
Structural Grade: **0**  
O&M Grade: **2**  
Clock Start/From: **7**  
Clock To: **5**  
1st Value:  
2nd Value:  
Value Percent: **5.000**  
Continuous Index:  
Within 8" of Joint: **YES**  
Remarks:

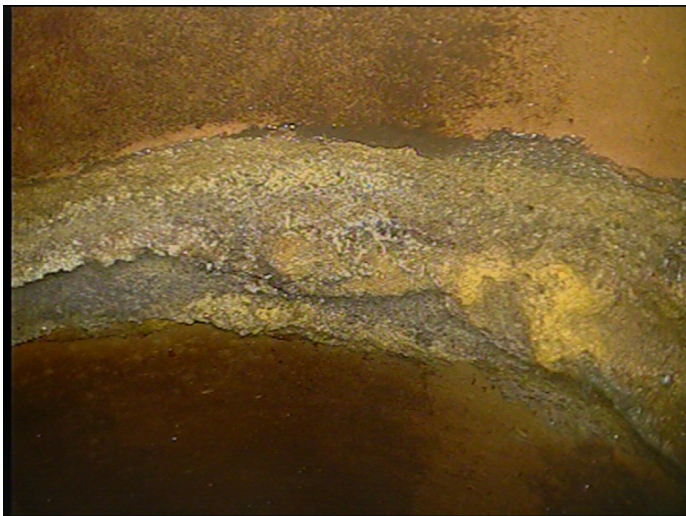
Code: **DAE**  
Description: **Deposits Attached Encrustation**

Distance (ft): **201.7**  
Structural Grade: **0**  
O&M Grade: **2**  
Clock Start/From: **7**  
Clock To: **5**  
1st Value:  
2nd Value:  
Value Percent: **5.000**  
Continuous Index: **S01**  
Within 8" of Joint: **YES**  
Remarks:

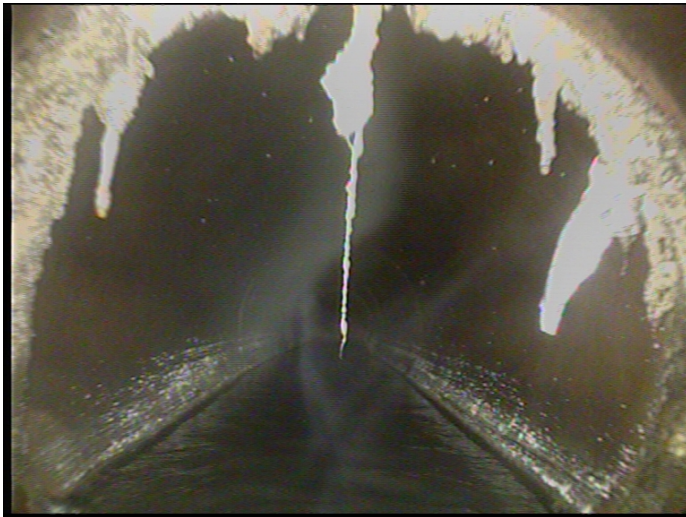
Code: **DAE**  
Description: **Deposits Attached Encrustation**

Distance (ft): **251.2**  
Structural Grade: **0**  
O&M Grade: **2**  
Clock Start/From: **7**  
Clock To: **5**  
1st Value:  
2nd Value:  
Value Percent: **5.000**  
Continuous Index: **F01**  
Within 8" of Joint: **NO**  
Remarks:

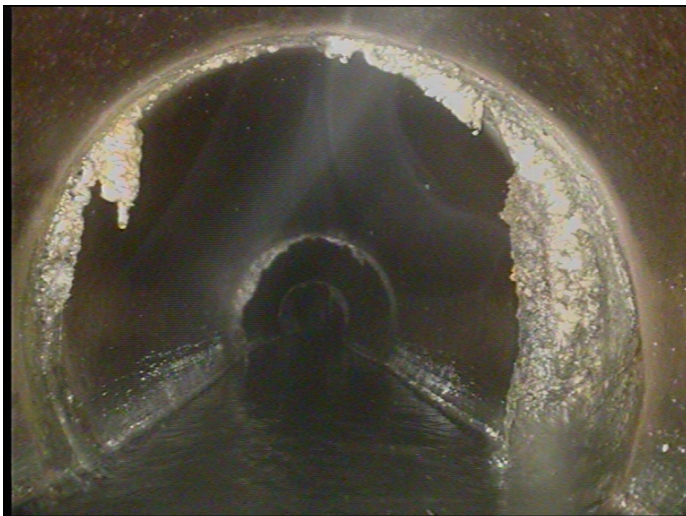
Code: **DAE**  
Description: **Deposits Attached Encrustation**

Distance (ft): **285.9**  
Structural Grade: **0**  
O&M Grade: **2**  
Clock Start/From: **7**  
Clock To: **5**  
1st Value:  
2nd Value:  
Value Percent: **5.000**  
Continuous Index: **S02**  
Within 8" of Joint: **YES**  
Remarks:

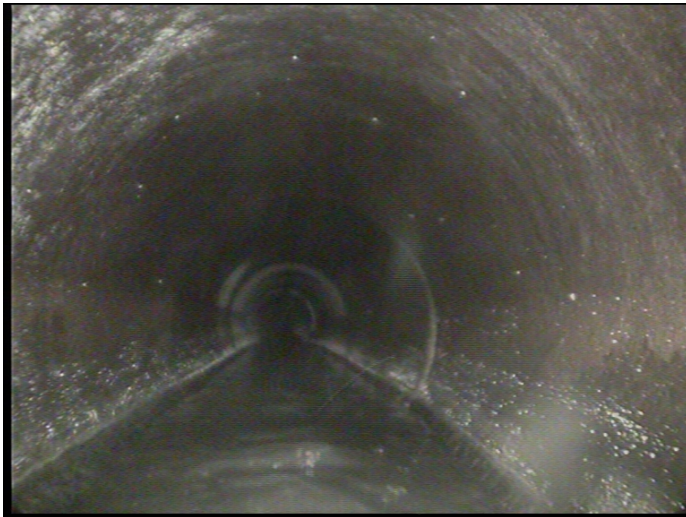
Code: **DAE**  
Description: **Deposits Attached Encrustation**

Distance (ft): **318.8**  
Structural Grade: **0**  
O&M Grade: **2**  
Clock Start/From: **7**  
Clock To: **5**  
1st Value:  
2nd Value:  
Value Percent: **5.000**  
Continuous Index: **F02**  
Within 8" of Joint: **NO**  
Remarks:

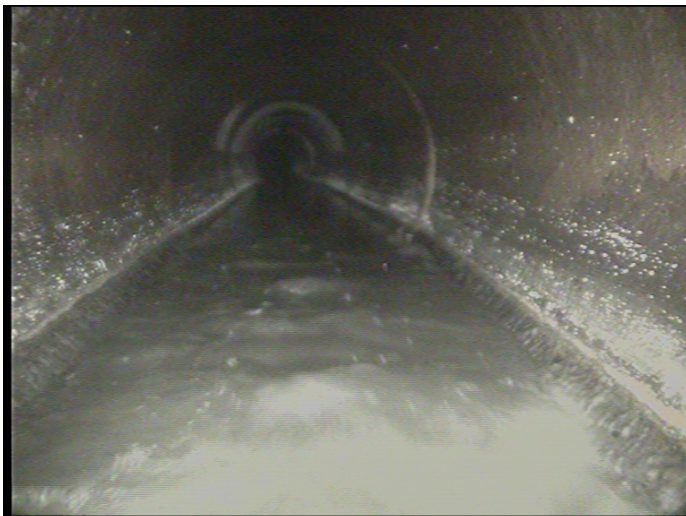
Code: **MSA**  
Description: **Abandoned Survey**

Distance (ft): **318.8**  
Structural Grade: **0**  
O&M Grade: **0**  
Clock Start/From:  
Clock To:  
1st Value:  
2nd Value:  
Value Percent:  
Continuous Index:  
Within 8" of Joint: **NO**  
Remarks: **out of tether**
