Profile/Photo Observation Report

Profile/Photo Observation Report							
Date: Pipe Length (f P.O.#: Customer:	04/07/2018 it): 14-2 City of Hobart	Weather: Owner: Surveyor: Clean Date	City of Ho M. Pielac		Pre Clean: PSR:	PACP 6.0 No Pre-Cleaning M-304-003-M-304-002 C	
Street: City:	Old Ridge Road Hobart, IN		Flow Contr Year Renev	-	Not Controlled		
Location: Purpose:	Light Highway Reversal		Tape/Med Dia/Height		DEP 14 18"		
Use: Drain Area:	Sanitary		Material: Lining:		VCP		
Category: Comment:	NA						
Location Deta	ils:		Direction o	of Survey:	Upstream		
US MH:	M-304-003	DS MH:	M-304-002		Total Length Surveyed (ft):	37.6	
O&M Index:	0.00	O&M Quick	:	0000	O&M Rating:	0.00	
Structural Index	o.00	 Structural O	uick:	0000	Structural Rating:	0.00	
Overall Index:	0.00	Overall Quid	ck:	0000	Overall Rating:	0.00

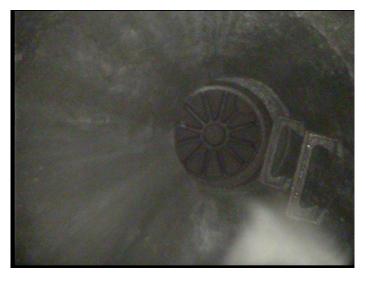
AMH

Description: Manhole Distance (ft): .0 Structural Grade: 0 O&M Grade: 0 Clock Start/From: Clock To: 1st Value: 2nd Value: Value Percent: Continuous Index: Within 8" of Joint: NO Remarks: M-304-002

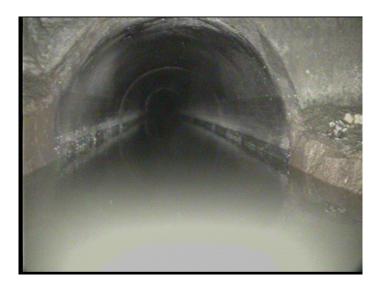
Code: MWL

Description: **Water Level**

Distance (ft): .0 Structural Grade: 0 O&M Grade: 0

15.000

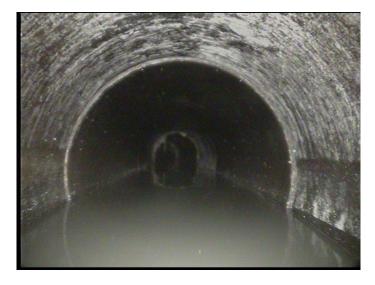
MSA

Description: **Abandoned Survey**

Distance (ft): 37.6 Structural Grade: 0 O&M Grade: 0 Clock Start/From:

Remarks: reverse complete
