Profile/Photo Observation Report

Street:	CRESTWOOD DR	Flow Control:	Not Controlled
City:	Hobart, IN	Year Renewed:	
Location:	Yard	Tape/Media #:	
Purpose:	Routine Assessment	Dia/Height:	10"
Use:	Sanitary	Material:	PVC
Drain Area:	NA	Lining:	Cured in Place
Category:	NA		
Comment:

Location Details:		Direction of Survey:	Downstream
US MH:	M-305-001	DS MH:	M-405-031
		Total Length Surveyed (ft):	16.1

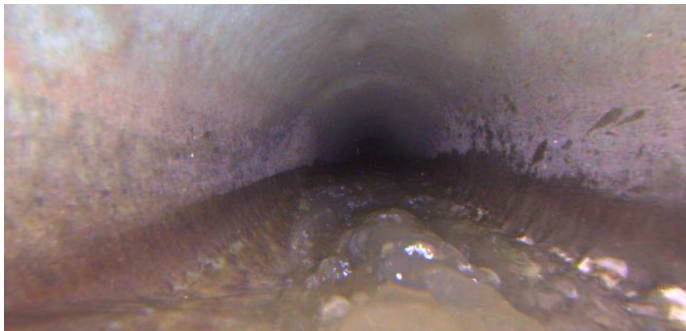
Code: **AMH**
Description: **Manhole**

Distance (ft): **.0**
Structural Grade: **0**
O&M Grade: **0**
Clock Start/From:
Clock To:
1st Value:
2nd Value:
Value Percent:
Continuous Index:
Within 8" of Joint: **NO**
Remarks: **M-305-001**

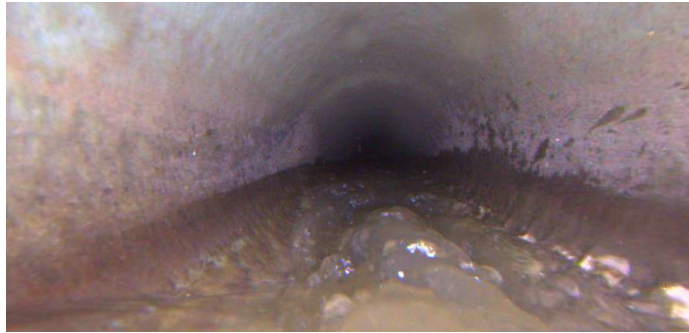
Code:	MWL
Description:	Water Level
Distance (ft):	.0
Structural Grade:	0
O&M Grade:	0
Clock Start/From:	
Clock To:	
1st Value:	
2nd Value:	
Value Percent:	10.000
Continuous Index:	
Within 8" of Joint:	NO
Remarks:

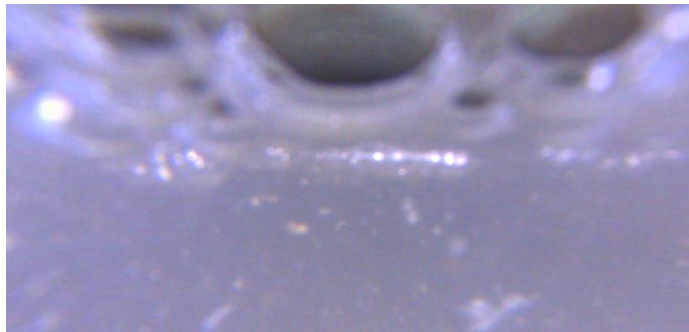
Code:	MWL
Description:	Water Level
Distance (ft):	8.5
Structural Grade:	0
O&M Grade:	0
Clock Start/From:	
Clock To:	
1st Value:	
2nd Value:	
Value Percent:	50.000
Continuous Index:	
Within 8" of Joint:	NO
Remarks:

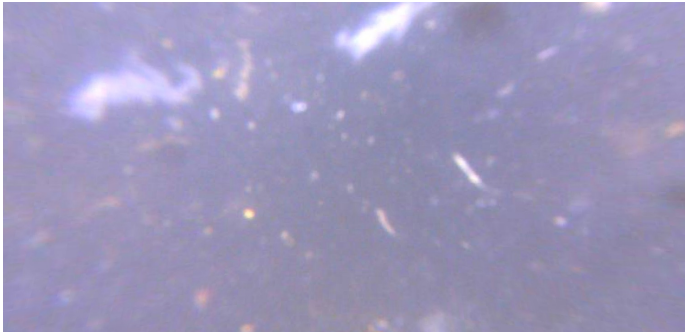
Code: **MSA**
Description: **Abandoned Survey**

Distance (ft): **16.1**
Structural Grade: **0**
O&M Grade: **0**
Clock Start/From:
Clock To:
1st Value:
2nd Value:
Value Percent:
Continuous Index:
Within 8" of Joint: **NO**
Remarks: **mcu**

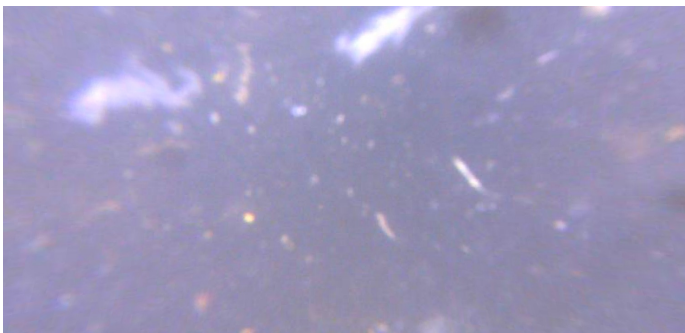
Code: **MCU**
Description: **Camera Underwater**

Distance (ft): **16.1**
Structural Grade: **0**
O&M Grade: **4**
Clock Start/From:
Clock To:
1st Value:
2nd Value:
Value Percent:
Continuous Index:
Within 8" of Joint: **NO**
Remarks:
