Profile/Photo Observation Report

Date:	04/19/2018	Weather:		Coding:	PACP 6.0
Pipe Length (ft):	290.4	Owner:	NA	Pre Clean:	No Pre-Cleaning
P.O.#:		Surveyor:	Justin Gonzales	PSR:	P-305-001-031
Customer:		Clean Date:	01/01/1900	Shape:	C

Street:	CRESTWOOD DR	Flow Control:	Not Controlled
City:	Hobart, IN	Year Renewed:	
Location:	Yard	Tape/Media #:	
Purpose:	Routine Assessment	Dia/Height:	10"
Use:	Sanitary	Material:	PVC
Drain Area:	NA	Lining:	Cured in Place
Category:	NA		
Comment:

Location Details:		Direction of Survey:	Downstream
US MH:	M-305-001	DS MH:	M-405-031
		Total Length Surveyed (ft):	288.1

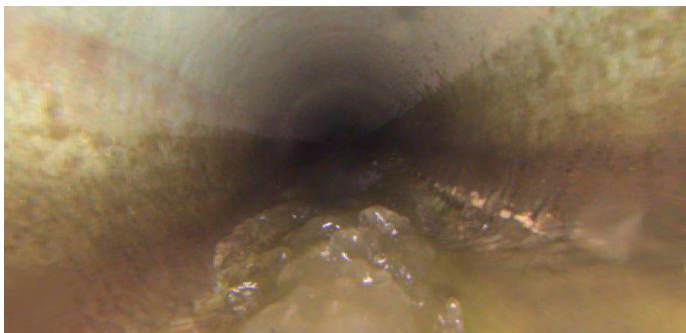
Code: **AMH**
Description: **Manhole**

Distance (ft): **.0**
Structural Grade: **0**
O&M Grade: **0**
Clock Start/From:
Clock To:
1st Value:
2nd Value:
Value Percent:
Continuous Index:
Within 8" of Joint: **NO**
Remarks: **M-305-001**

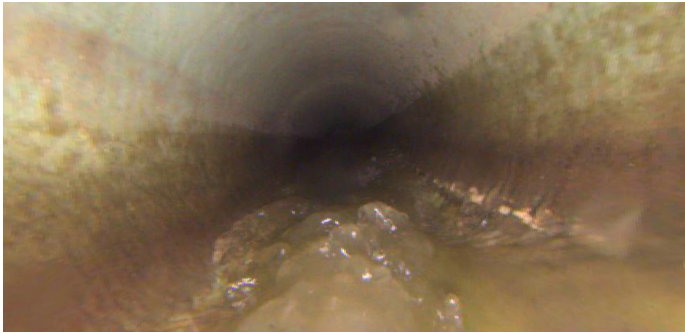
Code:	MWL
Description:	Water Level

Distance (ft):	.0
Structural Grade:	0
O&M Grade:	0
Clock Start/From:	
Clock To:	
1st Value:	
2nd Value:	
Value Percent:	10.000
Continuous Index:	
Within 8" of Joint:	NO
Remarks:

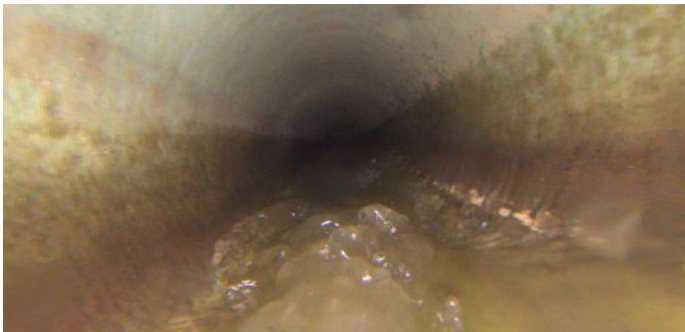
Code:	DAZ
Description:	Deposits Attached Other

Distance (ft):	.0
Structural Grade:	0
O&M Grade:	2
Clock Start/From:	7
Clock To:	5
1st Value:	
2nd Value:	
Value Percent:	5.000
Continuous Index:	S01
Within 8" of Joint:	YES
Remarks:	WANDER

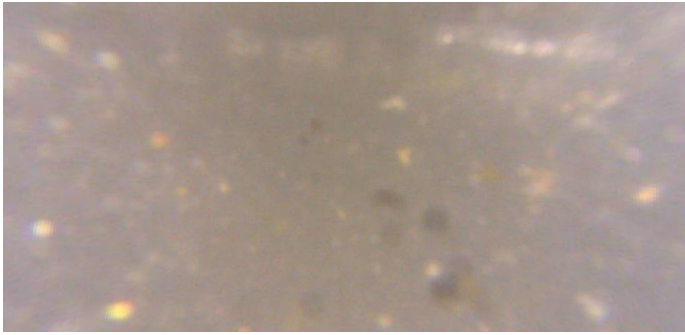
Code: **MCU**
Description: **Camera Underwater**

Distance (ft): **8.9**
Structural Grade: **0**
O&M Grade: **4**
Clock Start/From:
Clock To:
1st Value:
2nd Value:
Value Percent:
Continuous Index: **S02**
Within 8" of Joint: **NO**
Remarks:

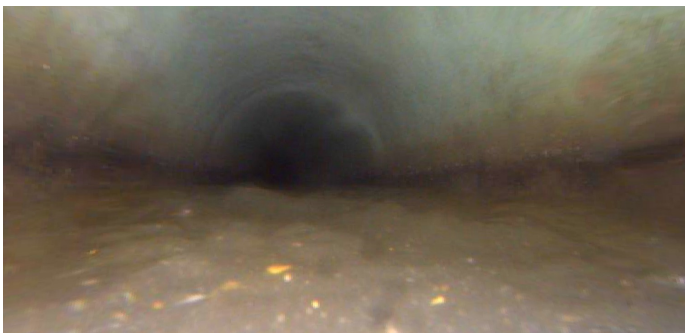
Code: **MCU**
Description: **Camera Underwater**

Distance (ft): **19.1**
Structural Grade: **0**
O&M Grade: **4**
Clock Start/From:
Clock To:
1st Value:
2nd Value:
Value Percent:
Continuous Index: **F02**
Within 8" of Joint: **NO**
Remarks: **CAMERA EMERGED**

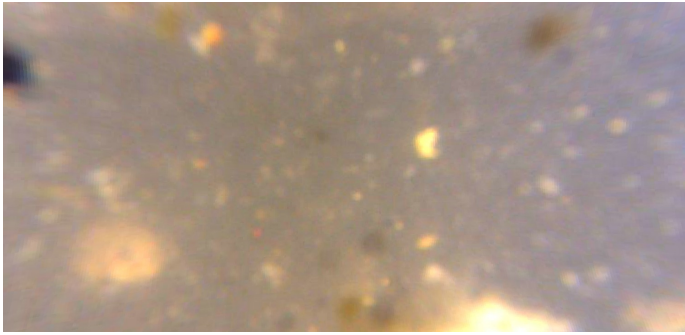
Code: **MCU**
Description: **Camera Underwater**

Distance (ft): **23.6**
Structural Grade: **0**
O&M Grade: **4**
Clock Start/From:
Clock To:
1st Value:
2nd Value:
Value Percent:
Continuous Index: **S03**
Within 8" of Joint: **NO**
Remarks:

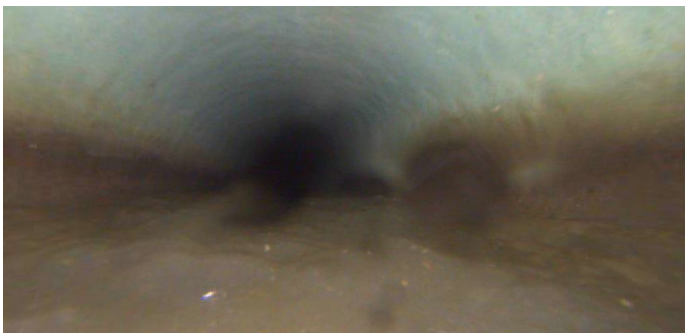
Code: **MCU**
Description: **Camera Underwater**

Distance (ft): **32.9**
Structural Grade: **0**
O&M Grade: **4**
Clock Start/From:
Clock To:
1st Value:
2nd Value:
Value Percent:
Continuous Index: **F03**
Within 8" of Joint: **NO**
Remarks: **CAMERA EMERGED**

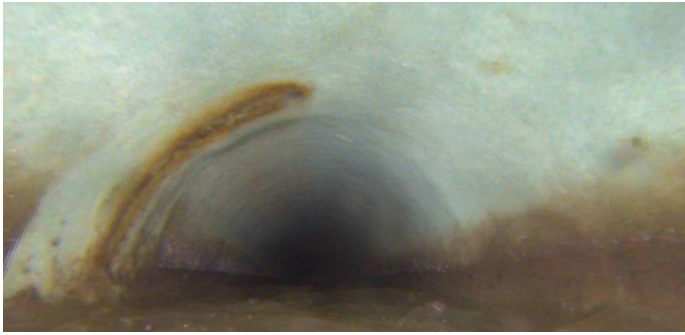
Code: **IS**
Description: **Infil Stain**

Distance (ft): **58.3**
Structural Grade: **0**
O&M Grade: **0**
Clock Start/From: **12**
Clock To: **5**
1st Value:
2nd Value:
Value Percent:
Continuous Index:
Within 8" of Joint:
Remarks:

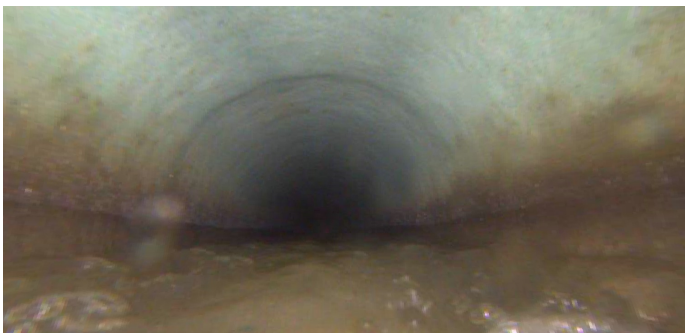
Code: **MWL**
Description: **Water Level**

Distance (ft): **61.3**
Structural Grade: **0**
O&M Grade: **0**
Clock Start/From:
Clock To:
1st Value:
2nd Value:
Value Percent: **15.000**
Continuous Index:
Within 8" of Joint: **NO**
Remarks:

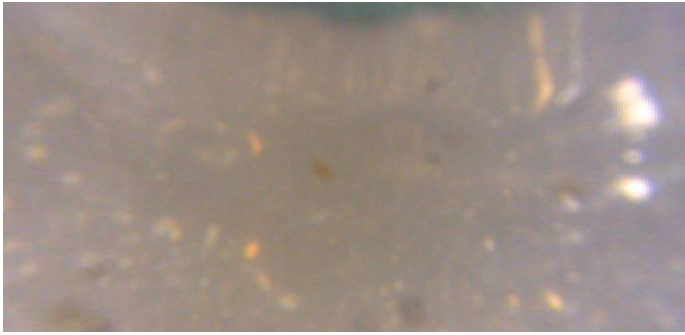
Code: **MCU**
Description: **Camera Underwater**

Distance (ft): **80.3**
Structural Grade: **0**
O&M Grade: **4**
Clock Start/From:
Clock To:
1st Value:
2nd Value:
Value Percent:
Continuous Index: **S04**
Within 8" of Joint: **NO**
Remarks:

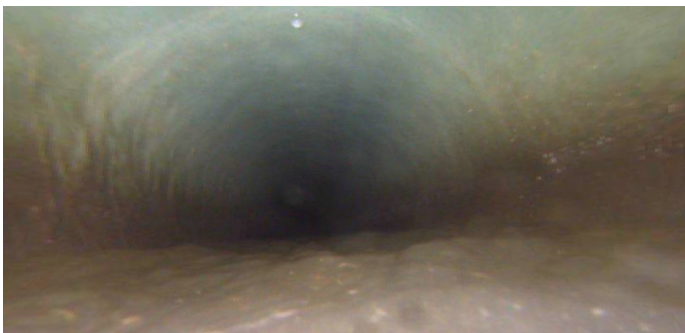
Code: **MCU**
Description: **Camera Underwater**

Distance (ft): **88.5**
Structural Grade: **0**
O&M Grade: **4**
Clock Start/From:
Clock To:
1st Value:
2nd Value:
Value Percent:
Continuous Index: **F04**
Within 8" of Joint: **NO**
Remarks: **CAMERA EMERGED**

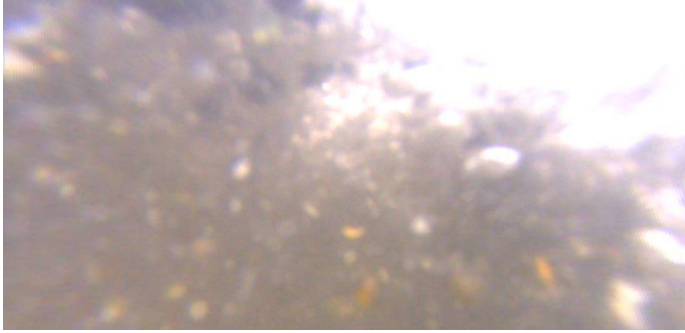
Code: **MCU**
Description: **Camera Underwater**

Distance (ft): **118.0**
Structural Grade: **0**
O&M Grade: **4**
Clock Start/From:
Clock To:
1st Value:
2nd Value:
Value Percent:
Continuous Index: **S05**
Within 8" of Joint: **NO**
Remarks:

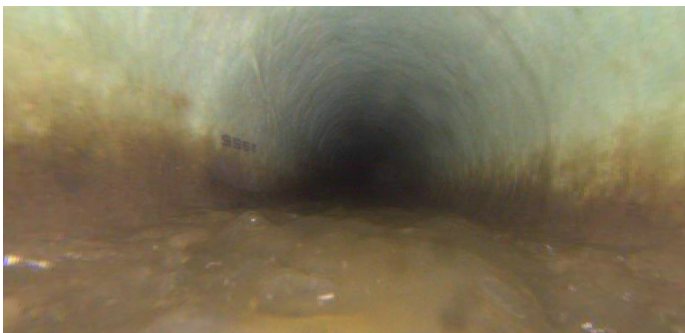
Code: **MCU**
Description: **Camera Underwater**

Distance (ft): **122.1**
Structural Grade: **0**
O&M Grade: **4**
Clock Start/From:
Clock To:
1st Value:
2nd Value:
Value Percent:
Continuous Index: **F05**
Within 8" of Joint: **NO**
Remarks:

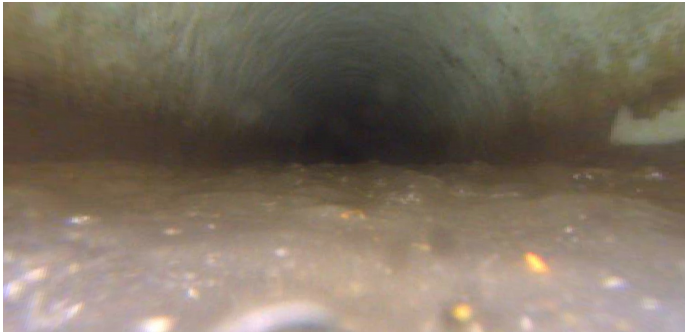
Code: **MWL**
Description: **Water Level**

Distance (ft): **134.6**
Structural Grade: **0**
O&M Grade: **0**
Clock Start/From:
Clock To:
1st Value:
2nd Value:
Value Percent: **20.000**
Continuous Index:
Within 8" of Joint: **NO**
Remarks:

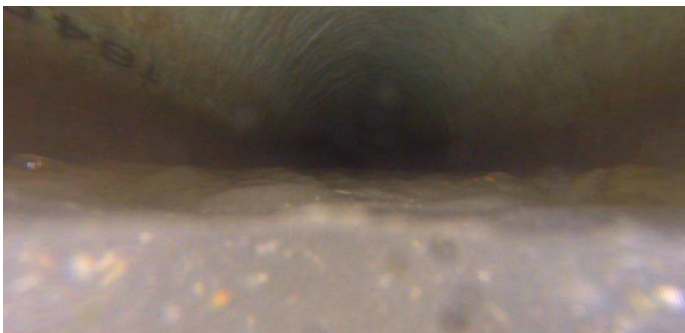
Code: **MWL**
Description: **Water Level**

Distance (ft): **149.6**
Structural Grade: **0**
O&M Grade: **0**
Clock Start/From:
Clock To:
1st Value:
2nd Value:
Value Percent: **30.000**
Continuous Index:
Within 8" of Joint: **NO**
Remarks:

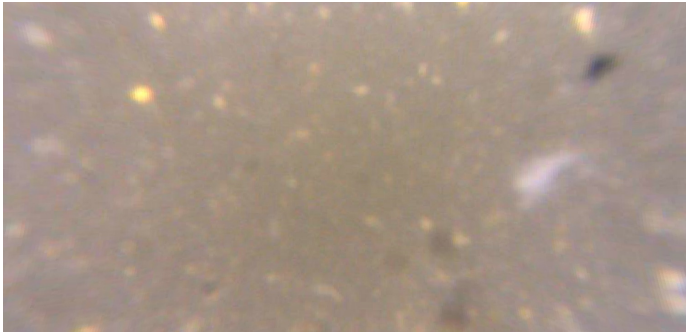
Code: **MCU**
Description: **Camera Underwater**

Distance (ft): **194.8**
Structural Grade: **0**
O&M Grade: **4**
Clock Start/From:
Clock To:
1st Value:
2nd Value:
Value Percent:
Continuous Index: **S06**
Within 8" of Joint: **NO**
Remarks:

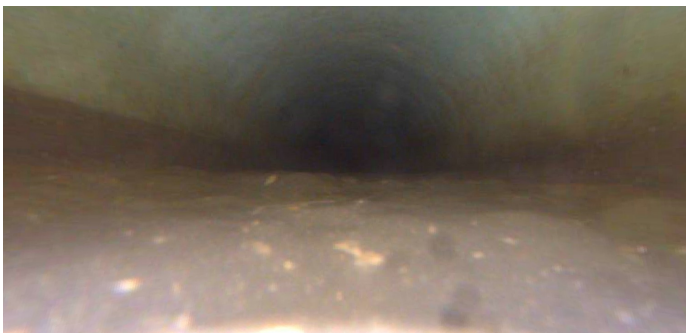
Code: **MCU**
Description: **Camera Underwater**

Distance (ft): **201.8**
Structural Grade: **0**
O&M Grade: **4**
Clock Start/From:
Clock To:
1st Value:
2nd Value:
Value Percent:
Continuous Index: **F06**
Within 8" of Joint: **NO**
Remarks: **WANDER**

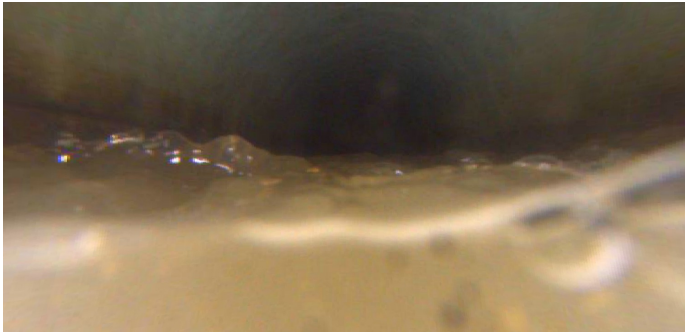
Code: **MWL**
Description: **Water Level**

Distance (ft): **231.1**
Structural Grade: **0**
O&M Grade: **0**
Clock Start/From:
Clock To:
1st Value:
2nd Value:
Value Percent: **50.000**
Continuous Index:
Within 8" of Joint: **NO**
Remarks:

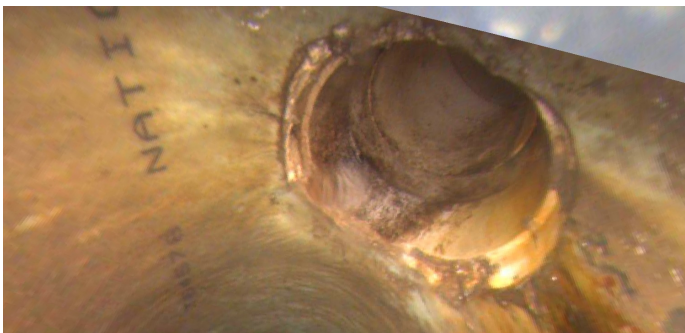
Code: **TF**
Description: **Tap Factory**

Distance (ft): **249.5**
Structural Grade: **0**
O&M Grade: **0**
Clock Start/From: **11**
Clock To:
1st Value: **4.000**
2nd Value:
Value Percent:
Continuous Index:
Within 8" of Joint:
Remarks:

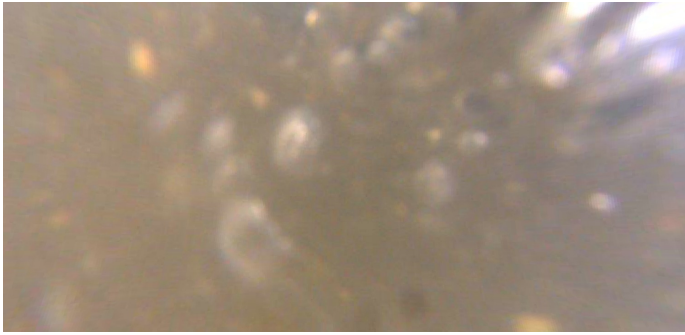
Code: **MCU**
Description: **Camera Underwater**

Distance (ft): **279.3**
Structural Grade: **0**
O&M Grade: **4**
Clock Start/From:
Clock To:
1st Value:
2nd Value:
Value Percent:
Continuous Index: **S07**
Within 8" of Joint: **NO**
Remarks:

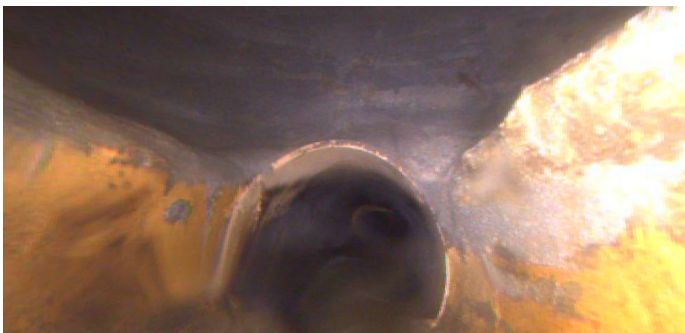
Code: **MCU**
Description: **Camera Underwater**

Distance (ft): **288.1**
Structural Grade: **0**
O&M Grade: **4**
Clock Start/From:
Clock To:
1st Value:
2nd Value:
Value Percent:
Continuous Index: **F07**
Within 8" of Joint: **NO**
Remarks:

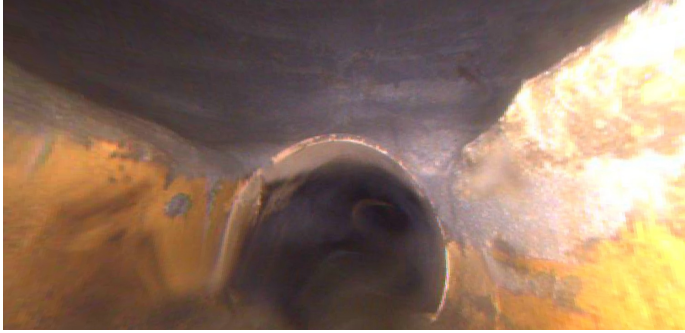
Code: **DAZ**
Description: **Deposits Attached Other**

Distance (ft): **288.1**
Structural Grade: **0**
O&M Grade: **2**
Clock Start/From: **7**
Clock To: **5**
1st Value:
2nd Value:
Value Percent: **5.000**
Continuous Index: **F01**
Within 8" of Joint: **YES**
Remarks: **WANDER**

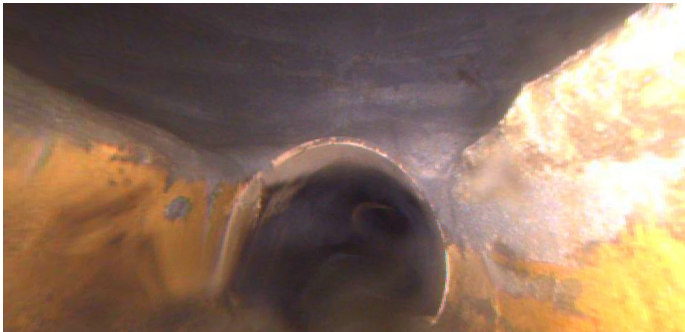
Code: **AMH**
Description: **Manhole**

Distance (ft): **288.1**
Structural Grade: **0**
O&M Grade: **0**
Clock Start/From:
Clock To:
1st Value:
2nd Value:
Value Percent:
Continuous Index:
Within 8" of Joint: **NO**
Remarks: **M-405-031**
