# Profile/Photo Observation Report

| Street: | <b>FOXCROFT STREET</b> | Flow Control: | <b>Not Controlled</b> |
| US MH: | <b>M-305-001</b> | DS MH: | <b>M-405-031</b> |

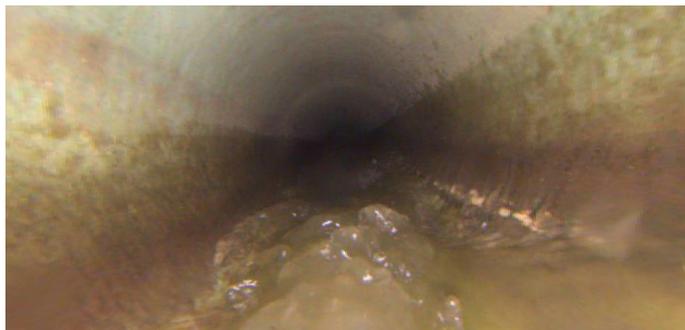
Code: **AMH**  
 Description: **Manhole**  
 Distance (ft): **.0**  
 Structural Grade: **0**  
 O&M Grade: **0**  
 Clock Start/From:  
 Clock To:  
 1st Value:  
 2nd Value:  
 Value Percent:  
 Continuous Index:  
 Within 8" of Joint: **NO**  
 Remarks: **M-305-001**

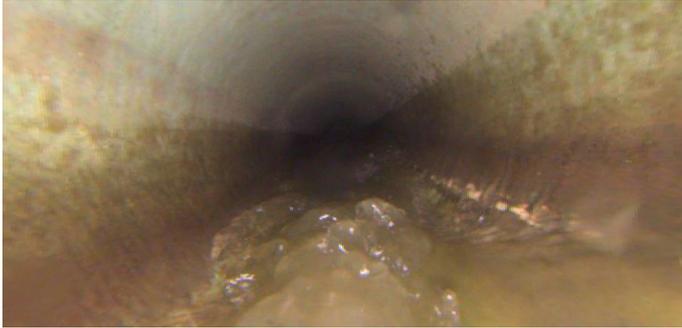
Code: **MWL**  
Description: **Water Level**

Distance (ft): **.0**  
Structural Grade: **0**  
O&M Grade: **0**  
Clock Start/From:  
Clock To:  
1st Value:  
2nd Value:  
Value Percent: **10.000**  
Continuous Index:  
Within 8" of Joint: **NO**  
Remarks:

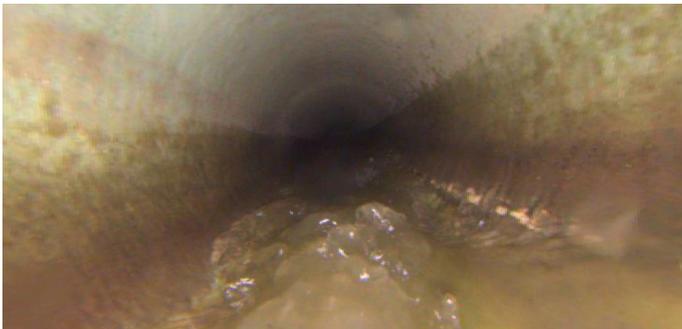
Code: **DAZ**  
Description: **Deposits Attached Other**

Distance (ft): **.0**  
Structural Grade: **0**  
O&M Grade: **2**  
Clock Start/From: **7**  
Clock To: **5**  
1st Value:  
2nd Value:  
Value Percent: **5.000**  
Continuous Index: **S01**  
Within 8" of Joint: **YES**  
Remarks: **WANDER**

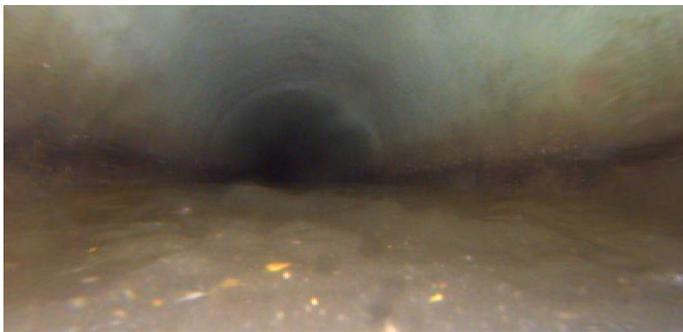
Code: **MCU**  
Description: **Camera Underwater**

Distance (ft): **19.1**  
Structural Grade: **0**  
O&M Grade: **4**  
Clock Start/From:  
Clock To:  
1st Value:  
2nd Value:  
Value Percent:  
Continuous Index: **F02**  
Within 8" of Joint: **NO**  
Remarks: **CAMERA EMERGED**

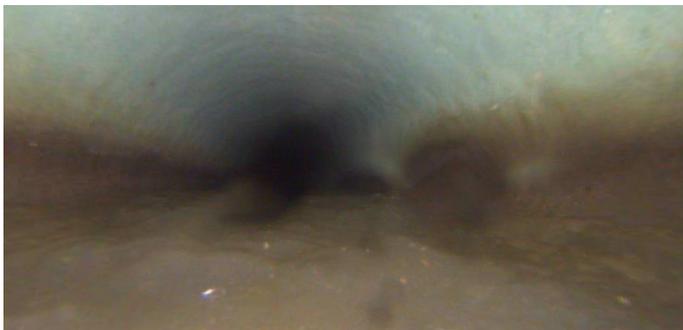
Code: **MCU**  
Description: **Camera Underwater**

Distance (ft): **32.9**  
Structural Grade: **0**  
O&M Grade: **4**  
Clock Start/From:  
Clock To:  
1st Value:  
2nd Value:  
Value Percent:  
Continuous Index: **F03**  
Within 8" of Joint: **NO**  
Remarks: **CAMERA EMERGED**

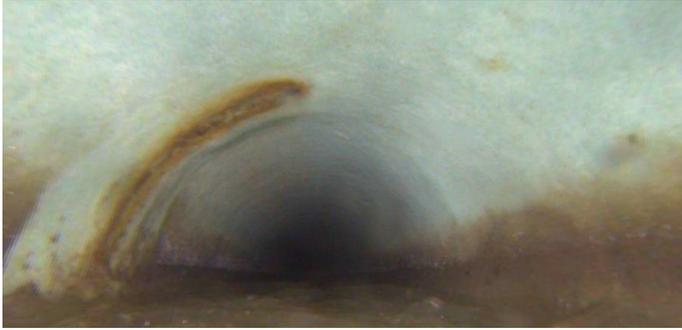
Code: **IS**  
Description: **Infil Stain**

Distance (ft): **58.3**  
Structural Grade: **0**  
O&M Grade: **0**  
Clock Start/From: **12**  
Clock To: **5**  
1st Value:  
2nd Value:  
Value Percent:  
Continuous Index:  
Within 8" of Joint:  
Remarks:

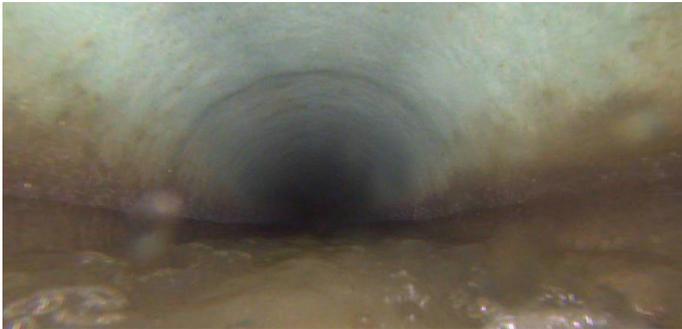
Code: **MWL**  
Description: **Water Level**

Distance (ft): **61.3**  
Structural Grade: **0**  
O&M Grade: **0**  
Clock Start/From:  
Clock To:  
1st Value:  
2nd Value:  
Value Percent: **15.000**  
Continuous Index:  
Within 8" of Joint: **NO**  
Remarks:

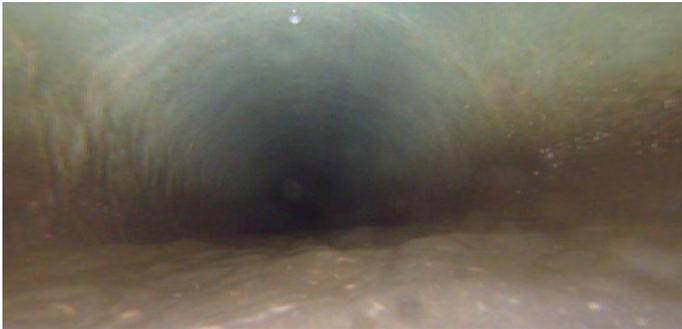
Code: **MCU**  
Description: **Camera Underwater**

Distance (ft): **88.5**  
Structural Grade: **0**  
O&M Grade: **4**  
Clock Start/From:  
Clock To:  
1st Value:  
2nd Value:  
Value Percent:  
Continuous Index: **F04**  
Within 8" of Joint: **NO**  
Remarks: **CAMERA EMERGED**

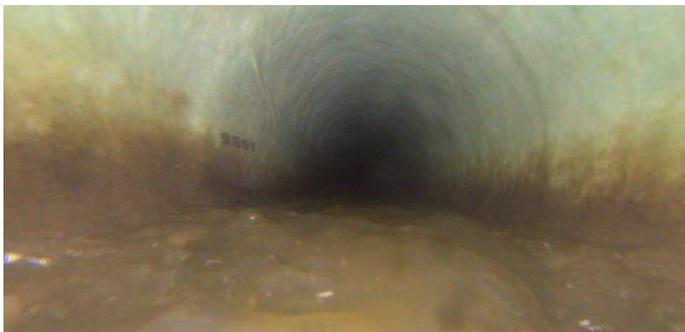
Code: **MCU**  
Description: **Camera Underwater**

Distance (ft): **122.1**  
Structural Grade: **0**  
O&M Grade: **4**  
Clock Start/From:  
Clock To:  
1st Value:  
2nd Value:  
Value Percent:  
Continuous Index: **F05**  
Within 8" of Joint: **NO**  
Remarks:

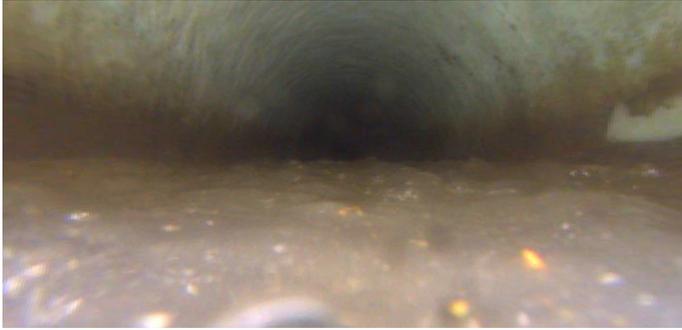
Code: **MWL**  
Description: **Water Level**

Distance (ft): **134.6**  
Structural Grade: **0**  
O&M Grade: **0**  
Clock Start/From:  
Clock To:  
1st Value:  
2nd Value:  
Value Percent: **20.000**  
Continuous Index:  
Within 8" of Joint: **NO**  
Remarks:

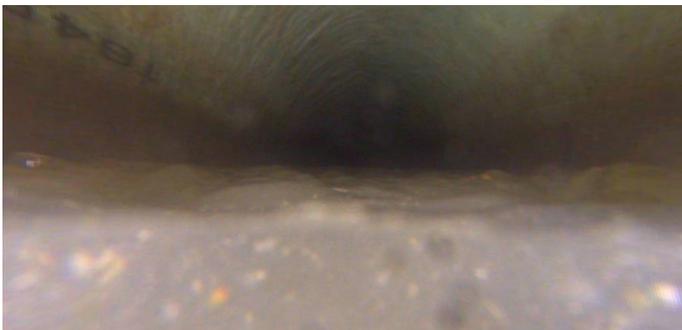
Code: **MWL**  
Description: **Water Level**

Distance (ft): **149.6**  
Structural Grade: **0**  
O&M Grade: **0**  
Clock Start/From:  
Clock To:  
1st Value:  
2nd Value:  
Value Percent: **30.000**  
Continuous Index:  
Within 8" of Joint: **NO**  
Remarks:

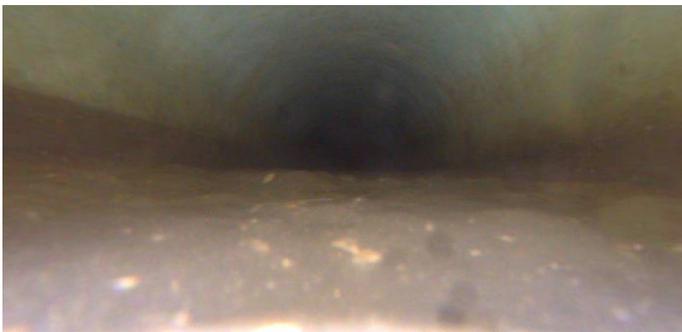
Code: **MCU**  
Description: **Camera Underwater**

Distance (ft): **201.8**  
Structural Grade: **0**  
O&M Grade: **4**  
Clock Start/From:  
Clock To:  
1st Value:  
2nd Value:  
Value Percent:  
Continuous Index: **F06**  
Within 8" of Joint: **NO**  
Remarks: **WANDER**

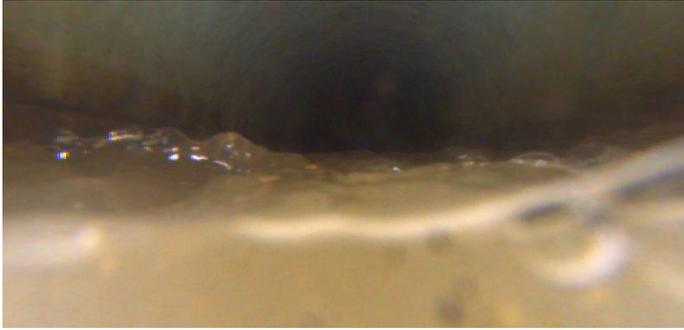
Code: **MWL**  
Description: **Water Level**

Distance (ft): **231.1**  
Structural Grade: **0**  
O&M Grade: **0**  
Clock Start/From:  
Clock To:  
1st Value:  
2nd Value:  
Value Percent: **50.000**  
Continuous Index:  
Within 8" of Joint: **NO**  
Remarks:

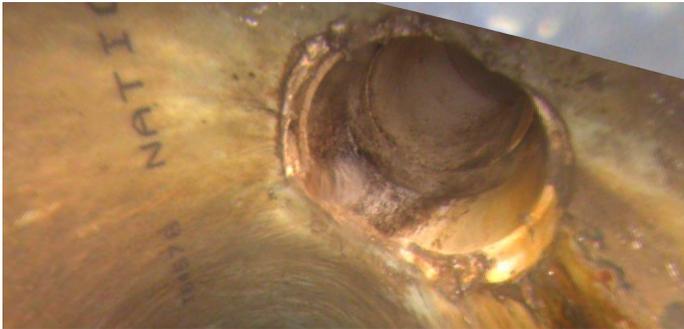
Code: **TF**  
Description: **Tap Factory**

Distance (ft): **249.5**  
Structural Grade: **0**  
O&M Grade: **0**  
Clock Start/From: **11**  
Clock To:  
1st Value: **4.000**  
2nd Value:  
Value Percent:  
Continuous Index:  
Within 8" of Joint:  
Remarks:

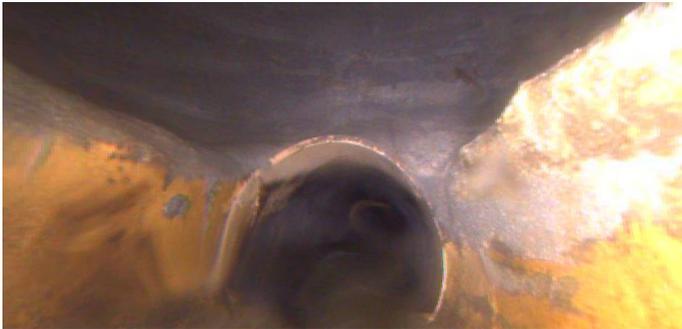
Code: **MCU**  
Description: **Camera Underwater**

Distance (ft): **288.1**  
Structural Grade: **0**  
O&M Grade: **4**  
Clock Start/From:  
Clock To:  
1st Value:  
2nd Value:  
Value Percent:  
Continuous Index: **F07**  
Within 8" of Joint: **NO**  
Remarks:

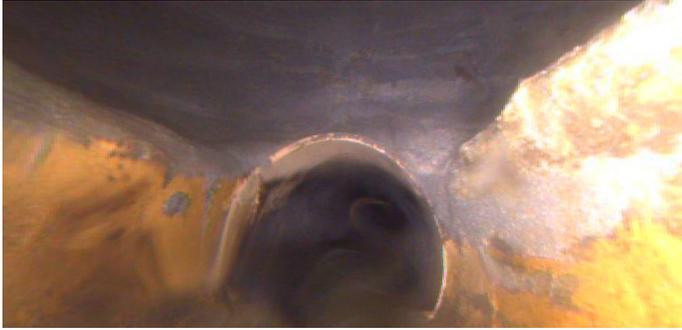
Code: **DAZ**  
Description: **Deposits Attached Other**

Distance (ft): **288.1**  
Structural Grade: **0**  
O&M Grade: **2**  
Clock Start/From: **7**  
Clock To: **5**  
1st Value:  
2nd Value:  
Value Percent: **5.000**  
Continuous Index: **F01**  
Within 8" of Joint: **YES**  
Remarks: **WANDER**

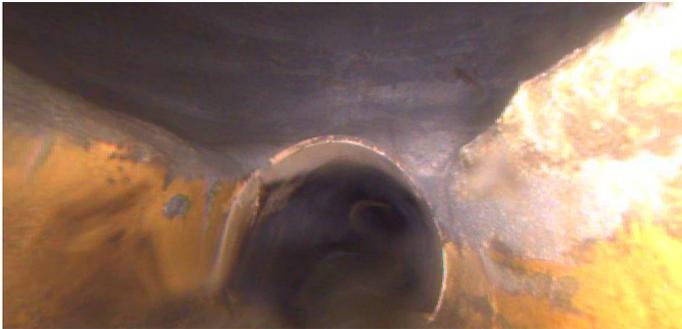
Code: **AMH**  
Description: **Manhole**

Distance (ft): **288.1**  
Structural Grade: **0**  
O&M Grade: **0**  
Clock Start/From:  
Clock To:  
1st Value:  
2nd Value:  
Value Percent:  
Continuous Index:  
Within 8" of Joint: **NO**  
Remarks: **M-405-031**
