Profile/Photo Observation Report

Date:	04/19/2018	Weather:		Coding:	PACP 6.0
Pipe Length (ft):	260.4	Owner:	NA	Pre Clean:	No Pre-Cleaning
P.O.#:		Surveyor:	Byrd Fitzgerald	PSR:	P-305-002-001
Customer:		Clean Date:	01/01/1900	Shape:	C

Street:	OFF W 49TH AVE	Flow Control:	Not Controlled
City:	Hobart, IN	Year Renewed:	
Location:	Yard	Tape/Media #:	
Purpose:	Routine Assessment	Dia/Height:	10"
Use:	Sanitary	Material:	XXX
Drain Area:	NA	Lining:	Cured in Place
Category:	NA		
Comment:

Location Details:		Direction of Survey:	Upstream
US MH:	M-305-002	DS MH:	M-305-001
		Total Length Surveyed (ft):	262.0

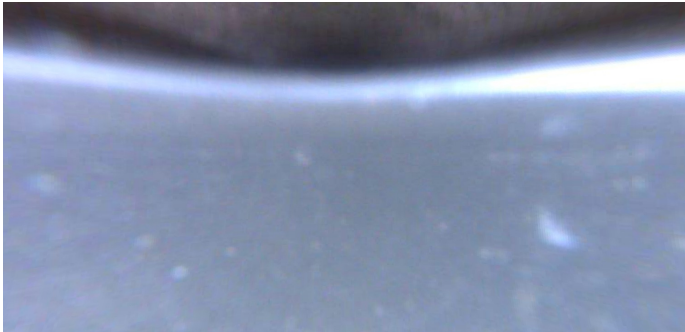
Code:	MWL
Description:	Water Level

Distance (ft):	.0
Structural Grade:	0
O&M Grade:	0
Clock Start/From:	
Clock To:	
1st Value:	
2nd Value:	
Value Percent:	75.000
Continuous Index:	
Within 8" of Joint:	NO
Remarks:

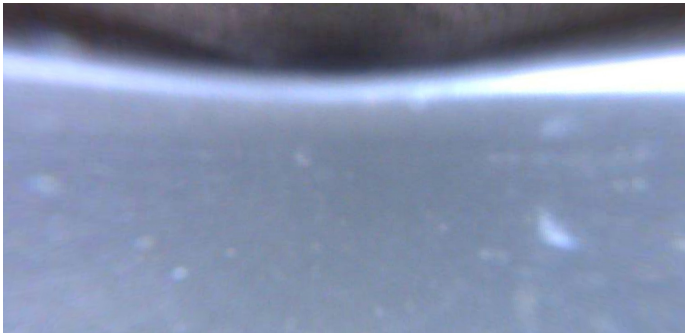
Code:	MCU
Description:	Camera Underwater

Distance (ft):	.0
Structural Grade:	0
O&M Grade:	4
Clock Start/From:	
Clock To:	
1st Value:	
2nd Value:	
Value Percent:	
Continuous Index:	S01
Within 8" of Joint:	NO
Remarks:	partially underwater

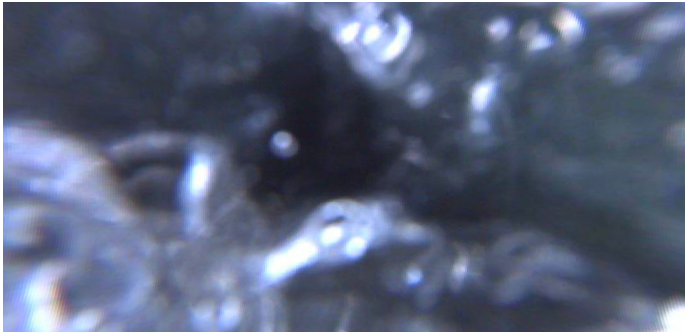
Code: **MCU**
Description: **Camera Underwater**

Distance (ft): **7.9**
Structural Grade: **0**
O&M Grade: **4**
Clock Start/From:
Clock To:
1st Value:
2nd Value:
Value Percent:
Continuous Index: **F01**
Within 8" of Joint: **NO**
Remarks: **partially underwater**

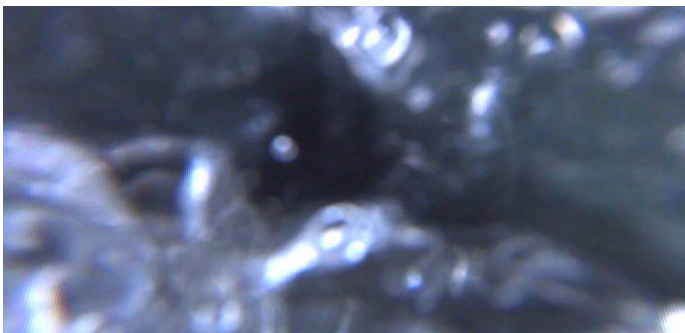
Code: **MGO**
Description: **General Observation**

Distance (ft): **7.9**
Structural Grade: **0**
O&M Grade: **0**
Clock Start/From:
Clock To:
1st Value:
2nd Value:
Value Percent:
Continuous Index:
Within 8" of Joint: **NO**
Remarks: **heavy splashing**

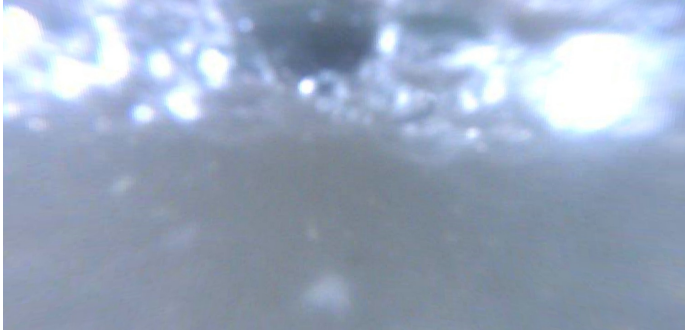
Code: **MCU**
Description: **Camera Underwater**

Distance (ft): **38.7**
Structural Grade: **0**
O&M Grade: **4**
Clock Start/From:
Clock To:
1st Value:
2nd Value:
Value Percent:
Continuous Index: **S02**
Within 8" of Joint: **NO**
Remarks:

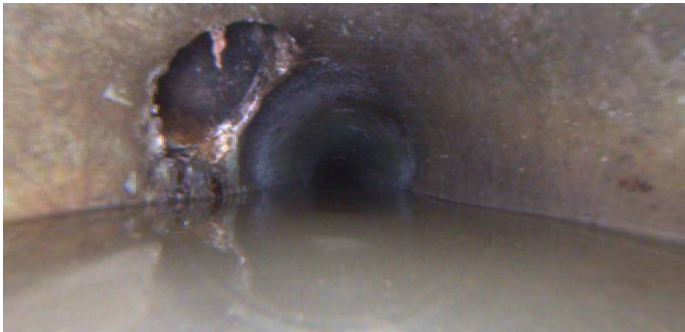
Code: **MCU**
Description: **Camera Underwater**

Distance (ft): **46.3**
Structural Grade: **0**
O&M Grade: **4**
Clock Start/From:
Clock To:
1st Value:
2nd Value:
Value Percent:
Continuous Index: **F02**
Within 8" of Joint: **NO**
Remarks:

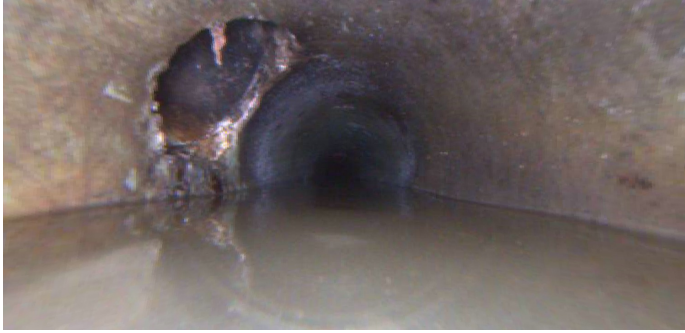
Code: **TB**
Description: **Tap Break-in**

Distance (ft): **46.3**
Structural Grade: **0**
O&M Grade: **0**
Clock Start/From: **10**
Clock To:
1st Value: **4.000**
2nd Value:
Value Percent:
Continuous Index:
Within 8" of Joint:
Remarks:

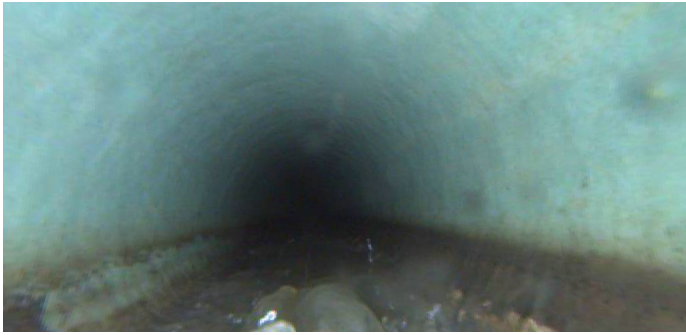
Code: **MGO**
Description: **General Observation**

Distance (ft): **59.3**
Structural Grade: **0**
O&M Grade: **0**
Clock Start/From:
Clock To:
1st Value:
2nd Value:
Value Percent:
Continuous Index:
Within 8" of Joint: **NO**
Remarks: **rear camera/mcu**

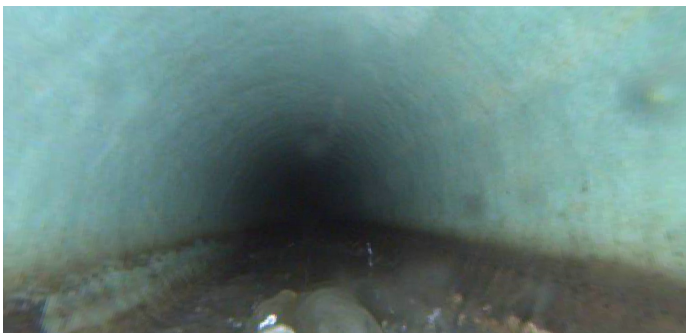
Code: **MCU**
Description: **Camera Underwater**

Distance (ft): **59.3**
Structural Grade: **0**
O&M Grade: **4**
Clock Start/From:
Clock To:
1st Value:
2nd Value:
Value Percent:
Continuous Index: **F03**
Within 8" of Joint: **NO**
Remarks:

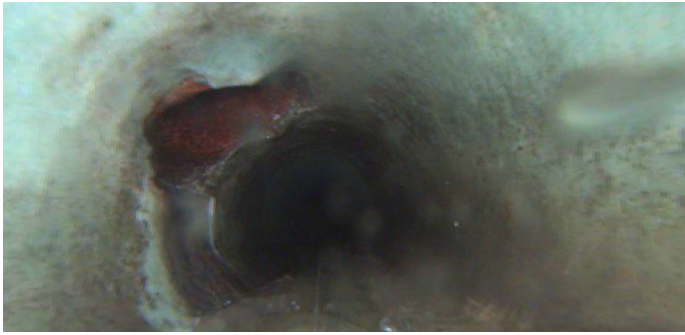
Code: **TB**
Description: **Tap Break-in**

Distance (ft): **108.8**
Structural Grade: **0**
O&M Grade: **0**
Clock Start/From: **10**
Clock To:
1st Value: **4.000**
2nd Value:
Value Percent:
Continuous Index:
Within 8" of Joint:
Remarks:

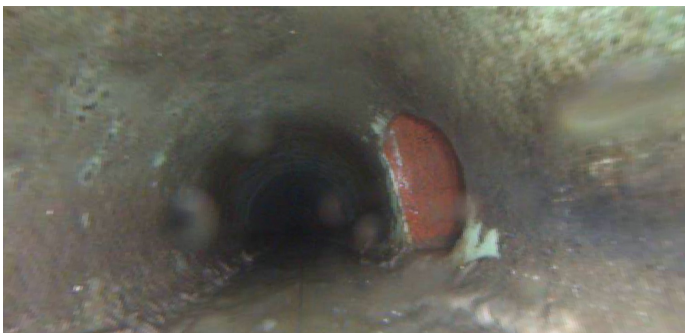
Code: **TB**
Description: **Tap Break-in**

Distance (ft): **121.0**
Structural Grade: **0**
O&M Grade: **0**
Clock Start/From: **3**
Clock To:
1st Value: **6.000**
2nd Value:
Value Percent:
Continuous Index:
Within 8" of Joint:
Remarks:

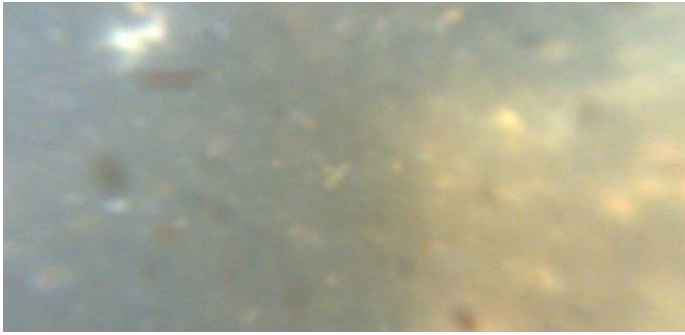
Code: **MCU**
Description: **Camera Underwater**

Distance (ft): **149.2**
Structural Grade: **0**
O&M Grade: **4**
Clock Start/From:
Clock To:
1st Value:
2nd Value:
Value Percent:
Continuous Index: **S04**
Within 8" of Joint: **NO**
Remarks: **front and rear**

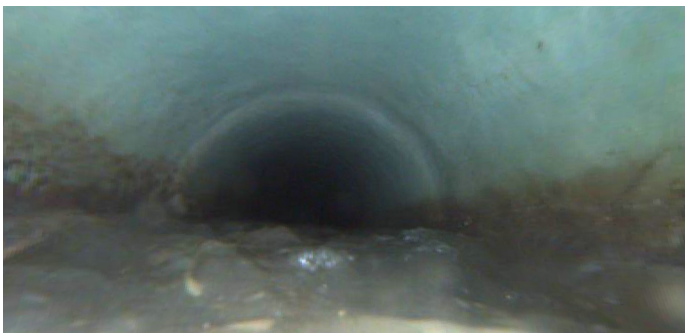
Code: **MCU**
Description: **Camera Underwater**

Distance (ft): **173.1**
Structural Grade: **0**
O&M Grade: **4**
Clock Start/From:
Clock To:
1st Value:
2nd Value:
Value Percent:
Continuous Index: **F04**
Within 8" of Joint: **NO**
Remarks: **front and rear**

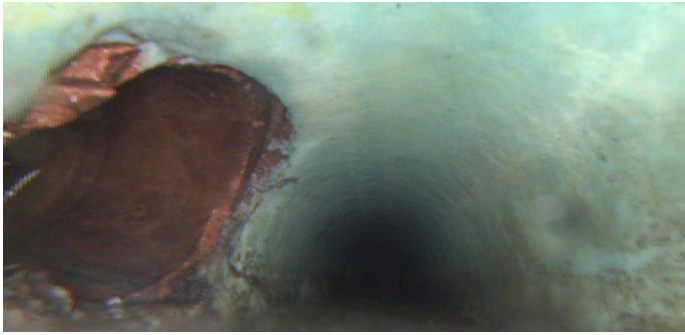
Code: **TB**
Description: **Tap Break-in**

Distance (ft): **210.0**
Structural Grade: **0**
O&M Grade: **0**
Clock Start/From: **2**
Clock To:
1st Value: **6.000**
2nd Value:
Value Percent:
Continuous Index:
Within 8" of Joint:
Remarks:

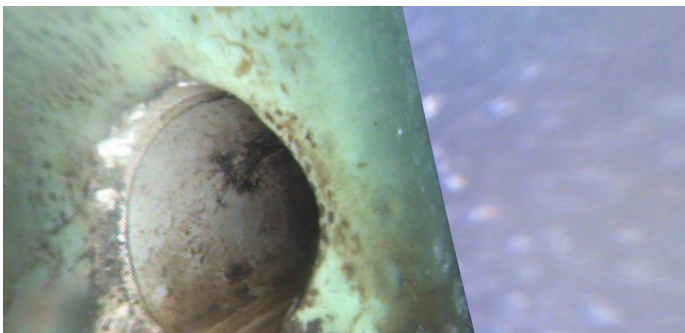
Code: **TB**
Description: **Tap Break-in**

Distance (ft): **228.2**
Structural Grade: **0**
O&M Grade: **0**
Clock Start/From: **10**
Clock To:
1st Value: **4.000**
2nd Value:
Value Percent:
Continuous Index:
Within 8" of Joint:
Remarks:
