## Profile/Photo Observation Report

Date:	<b>04/19/2018</b>	Weather:		Coding:	<b>PACP 6.0</b>
Pipe Length (ft):	<b>260.4</b>	Owner:	<b>NA</b>	Pre Clean:	<b>No Pre-Cleaning</b>
P.O.#:		Surveyor:	<b>Byrd Fitzgerald</b>	PSR:	<b>P-305-002-001</b>
Customer:		Clean Date:	<b>01/01/1900</b>	Shape:	<b>C</b>

Street:	<b>FOXCROFT STREET</b>	Flow Control:	<b>Not Controlled</b>
City:	<b>Hobart, IN</b>	Year Renewed:	
Location:	<b>Yard</b>	Tape/Media #:	
Purpose:	<b>Routine Assessment</b>	Dia/Height:	<b>10"</b>
Use:	<b>Sanitary</b>	Material:	<b>XXX</b>
Drain Area:	<b>NA</b>	Lining:	<b>Cured in Place</b>
Category:	<b>NA</b>		
Comment:

Location Details:		Direction of Survey:	<b>Upstream</b>
US MH:	<b>M-305-002</b>	DS MH:	<b>M-305-001</b>
		Total Length Surveyed (ft):	<b>262.0</b>

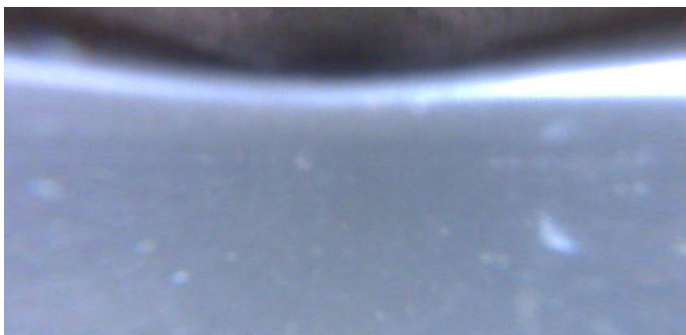
Code: **AMH**  
Description: **Manhole**

Distance (ft): **.0**  
Structural Grade: **0**  
O&M Grade: **0**  
Clock Start/From:  
Clock To:  
1st Value:  
2nd Value:  
Value Percent:  
Continuous Index:  
Within 8" of Joint: **NO**  
Remarks: **M-305-001**

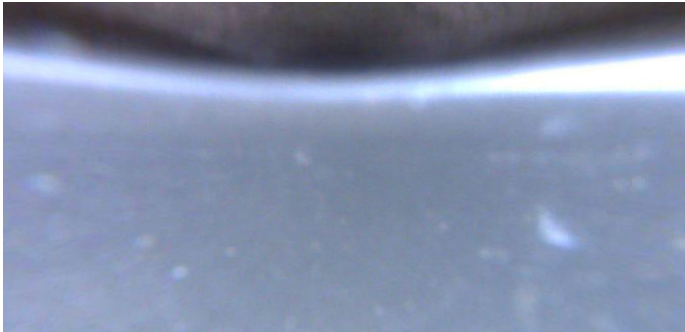
Code:	<b>MWL</b>
Description:	<b>Water Level</b>

Distance (ft):	<b>.0</b>
Structural Grade:	<b>0</b>
O&M Grade:	<b>0</b>
Clock Start/From:	
Clock To:	
1st Value:	
2nd Value:	
Value Percent:	<b>75.000</b>
Continuous Index:	
Within 8" of Joint:	<b>NO</b>
Remarks:

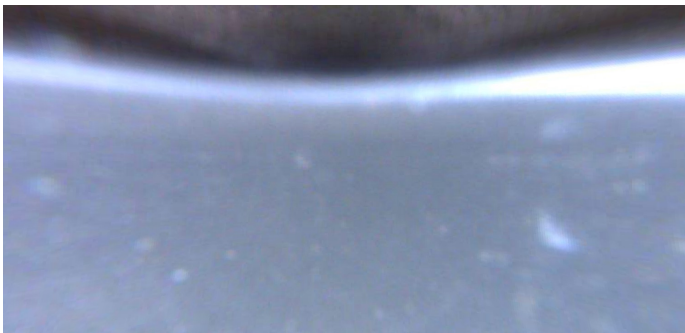
Code:	<b>MCU</b>
Description:	<b>Camera Underwater</b>

Distance (ft):	<b>.0</b>
Structural Grade:	<b>0</b>
O&M Grade:	<b>4</b>
Clock Start/From:	
Clock To:	
1st Value:	
2nd Value:	
Value Percent:	
Continuous Index:	<b>S01</b>
Within 8" of Joint:	<b>NO</b>
Remarks:	<b>partially underwater</b>

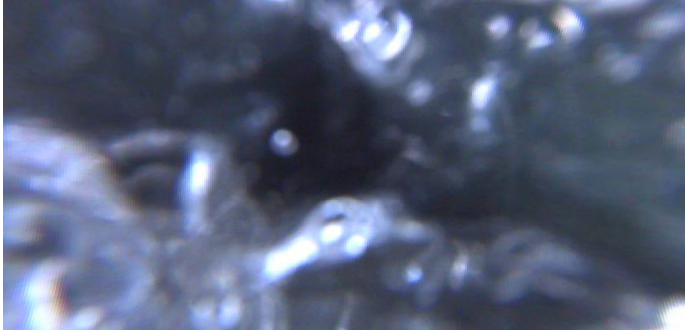
Code: **MCU**  
Description: **Camera Underwater**

Distance (ft): **7.9**  
Structural Grade: **0**  
O&M Grade: **4**  
Clock Start/From:  
Clock To:  
1st Value:  
2nd Value:  
Value Percent:  
Continuous Index: **F01**  
Within 8" of Joint: **NO**  
Remarks: **partially underwater**

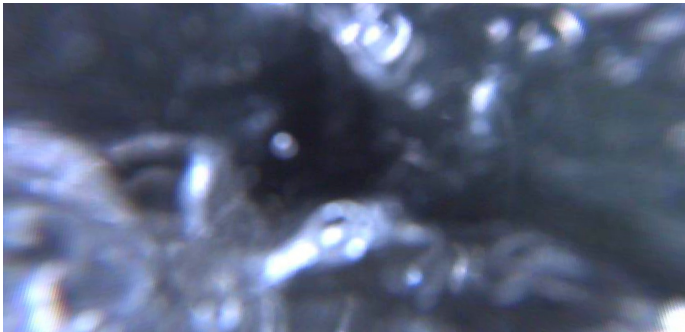
Code: **MGO**  
Description: **General Observation**

Distance (ft): **7.9**  
Structural Grade: **0**  
O&M Grade: **0**  
Clock Start/From:  
Clock To:  
1st Value:  
2nd Value:  
Value Percent:  
Continuous Index:  
Within 8" of Joint: **NO**  
Remarks: **heavy splashing**

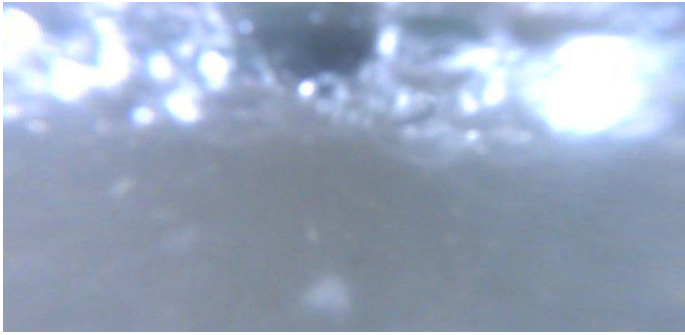
Code: **MCU**  
Description: **Camera Underwater**

Distance (ft): **38.7**  
Structural Grade: **0**  
O&M Grade: **4**  
Clock Start/From:  
Clock To:  
1st Value:  
2nd Value:  
Value Percent:  
Continuous Index: **S02**  
Within 8" of Joint: **NO**  
Remarks:

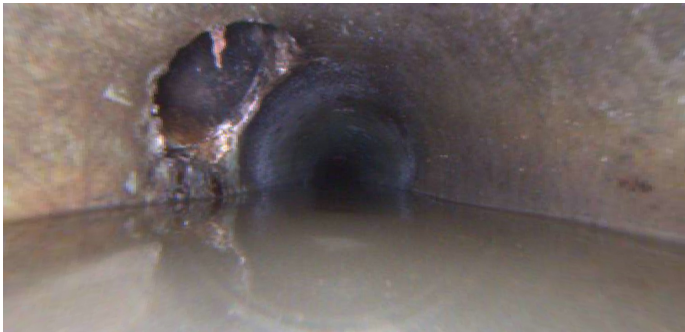
Code: **MCU**  
Description: **Camera Underwater**

Distance (ft): **46.3**  
Structural Grade: **0**  
O&M Grade: **4**  
Clock Start/From:  
Clock To:  
1st Value:  
2nd Value:  
Value Percent:  
Continuous Index: **F02**  
Within 8" of Joint: **NO**  
Remarks:

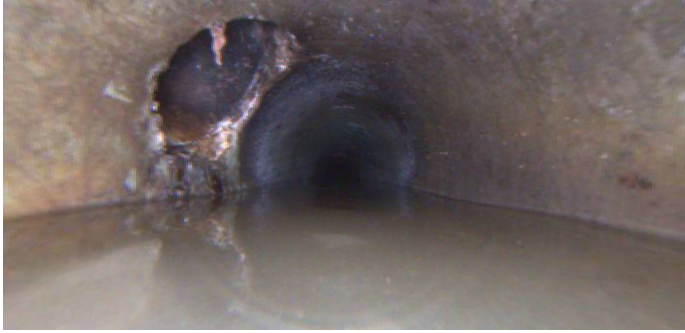
Code: **TB**  
Description: **Tap Break-in**

Distance (ft): **46.3**  
Structural Grade: **0**  
O&M Grade: **0**  
Clock Start/From: **10**  
Clock To:  
1st Value: **4.000**  
2nd Value:  
Value Percent:  
Continuous Index:  
Within 8" of Joint:  
Remarks:

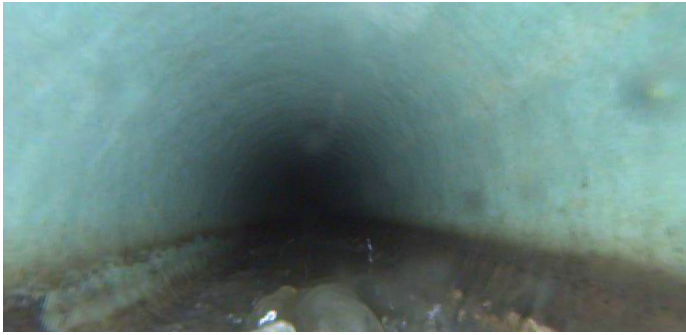
Code: **MGO**  
Description: **General Observation**

Distance (ft): **59.3**  
Structural Grade: **0**  
O&M Grade: **0**  
Clock Start/From:  
Clock To:  
1st Value:  
2nd Value:  
Value Percent:  
Continuous Index:  
Within 8" of Joint: **NO**  
Remarks: **rear camera/mcu**

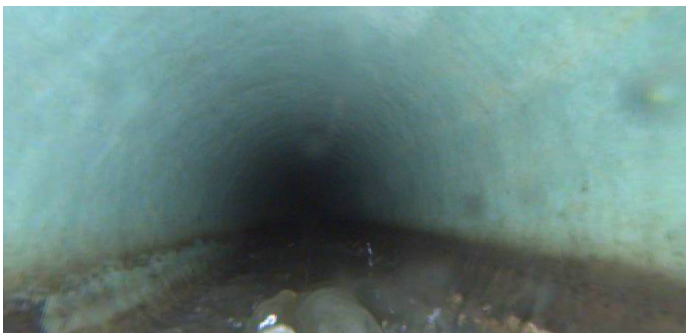
Code: **MCU**  
Description: **Camera Underwater**

Distance (ft): **59.3**  
Structural Grade: **0**  
O&M Grade: **4**  
Clock Start/From:  
Clock To:  
1st Value:  
2nd Value:  
Value Percent:  
Continuous Index: **F03**  
Within 8" of Joint: **NO**  
Remarks:

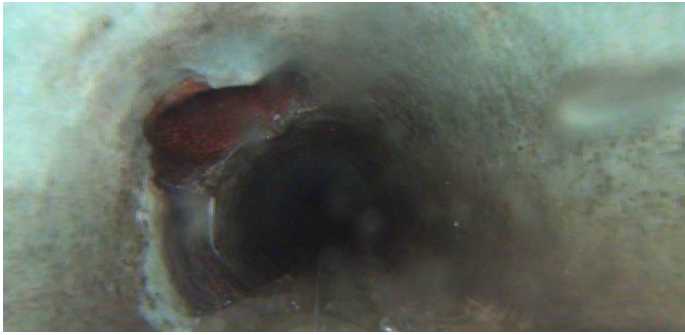
Code: **TB**  
Description: **Tap Break-in**

Distance (ft): **108.8**  
Structural Grade: **0**  
O&M Grade: **0**  
Clock Start/From: **10**  
Clock To:  
1st Value: **4.000**  
2nd Value:  
Value Percent:  
Continuous Index:  
Within 8" of Joint:  
Remarks:

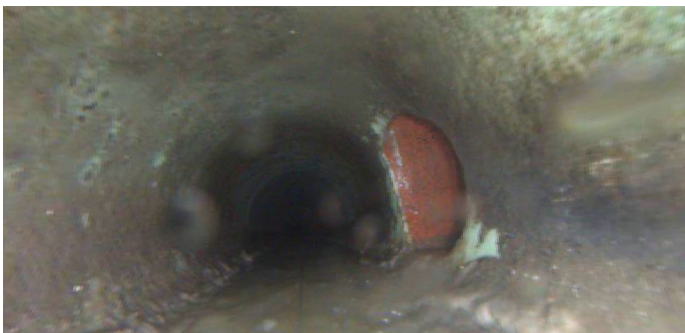
Code: **TB**  
Description: **Tap Break-in**

Distance (ft): **121.0**  
Structural Grade: **0**  
O&M Grade: **0**  
Clock Start/From: **3**  
Clock To:  
1st Value: **6.000**  
2nd Value:  
Value Percent:  
Continuous Index:  
Within 8" of Joint:  
Remarks:

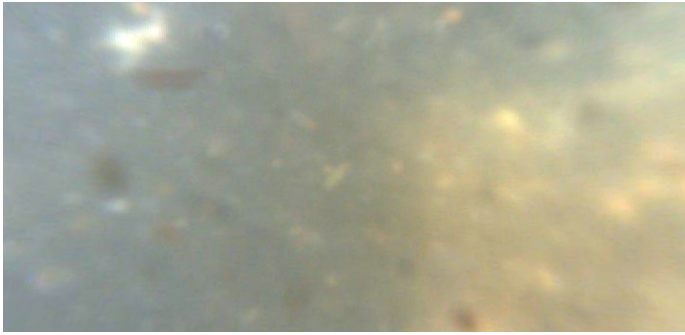
Code: **MCU**  
Description: **Camera Underwater**

Distance (ft): **149.2**  
Structural Grade: **0**  
O&M Grade: **4**  
Clock Start/From:  
Clock To:  
1st Value:  
2nd Value:  
Value Percent:  
Continuous Index: **S04**  
Within 8" of Joint: **NO**  
Remarks: **front and rear**

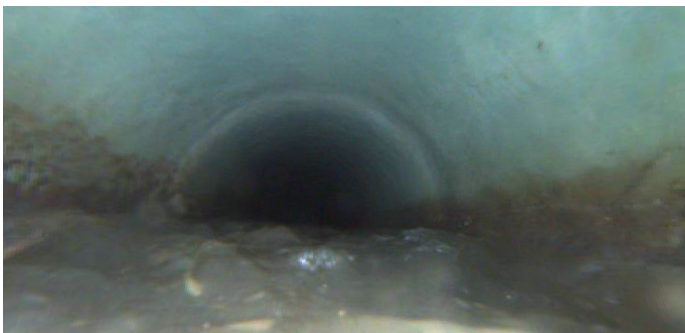
Code: **MCU**  
Description: **Camera Underwater**

Distance (ft): **173.1**  
Structural Grade: **0**  
O&M Grade: **4**  
Clock Start/From:  
Clock To:  
1st Value:  
2nd Value:  
Value Percent:  
Continuous Index: **F04**  
Within 8" of Joint: **NO**  
Remarks: **front and rear**

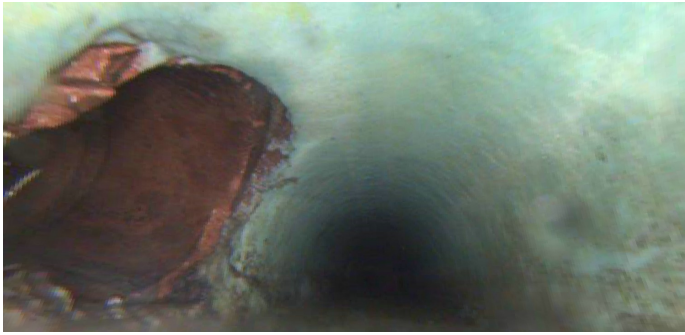
Code: **TB**  
Description: **Tap Break-in**

Distance (ft): **210.0**  
Structural Grade: **0**  
O&M Grade: **0**  
Clock Start/From: **2**  
Clock To:  
1st Value: **6.000**  
2nd Value:  
Value Percent:  
Continuous Index:  
Within 8" of Joint:  
Remarks:

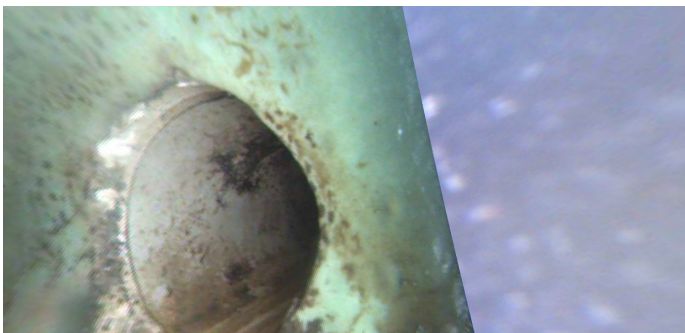
Code: **TB**  
Description: **Tap Break-in**

Distance (ft): **228.2**  
Structural Grade: **0**  
O&M Grade: **0**  
Clock Start/From: **10**  
Clock To:  
1st Value: **4.000**  
2nd Value:  
Value Percent:  
Continuous Index:  
Within 8" of Joint:  
Remarks:

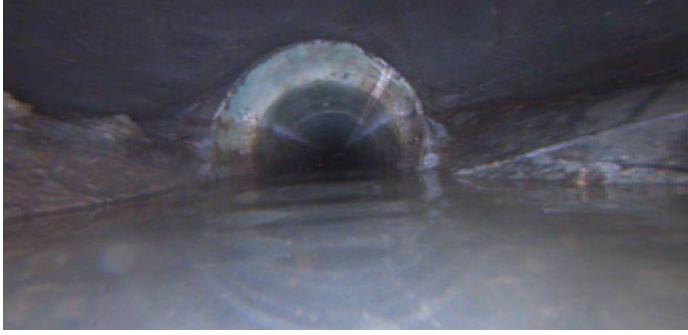
Code:	<b>AMH</b>
Description:	<b>Manhole</b>
Distance (ft):	<b>262.0</b>
Structural Grade:	<b>0</b>
O&M Grade:	<b>0</b>
Clock Start/From:	
Clock To:	
1st Value:	
2nd Value:	
Value Percent:	
Continuous Index:	
Within 8" of Joint:	<b>NO</b>
Remarks:	<b>M-305-002</b>
