Profile/Photo Observation Report

Date:	04/19/2018	Weather:		Coding:	PACP 6.0
Pipe Length (ft):	285.9	Owner:	NA	Pre Clean:	No Pre-Cleaning
P.O.#:		Surveyor:	Justin Gonzales	PSR:	P-305-003-002
Customer:		Clean Date:	01/01/1900	Shape:	C

Street:	OFF W 49TH AVE	Flow Control:	Not Controlled
City:	Hobart, IN	Year Renewed:	
Location:	Yard	Tape/Media #:	
Purpose:	Routine Assessment	Dia/Height:	10"
Use:	Sanitary	Material:	PVC
Drain Area:	NA	Lining:	
Category:	NA		
Comment:

Location Details:		Direction of Survey:	Upstream
US MH:	M-305-003	DS MH:	M-305-002
		Total Length Surveyed (ft):	273.8

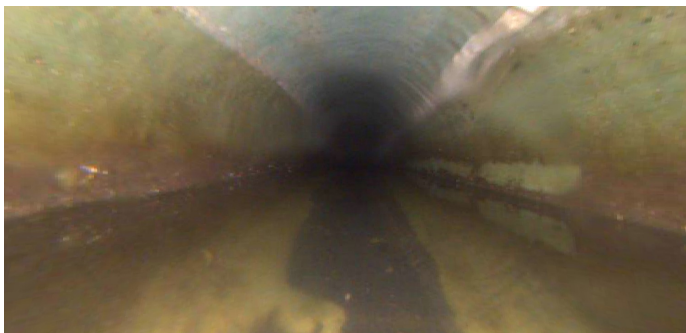
Code: **AMH**
Description: **Manhole**

Distance (ft): **.0**
Structural Grade: **0**
O&M Grade: **0**
Clock Start/From:
Clock To:
1st Value:
2nd Value:
Value Percent:
Continuous Index:
Within 8" of Joint: **NO**
Remarks: **M-305-002**

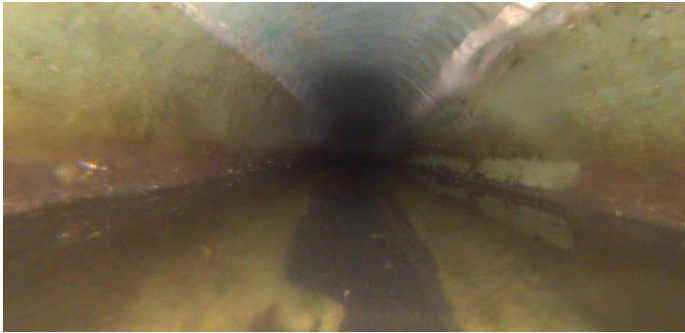
Code:	MWL
Description:	Water Level

Distance (ft):	.0
Structural Grade:	0
O&M Grade:	0
Clock Start/From:	
Clock To:	
1st Value:	
2nd Value:	
Value Percent:	15.000
Continuous Index:	
Within 8" of Joint:	NO
Remarks:

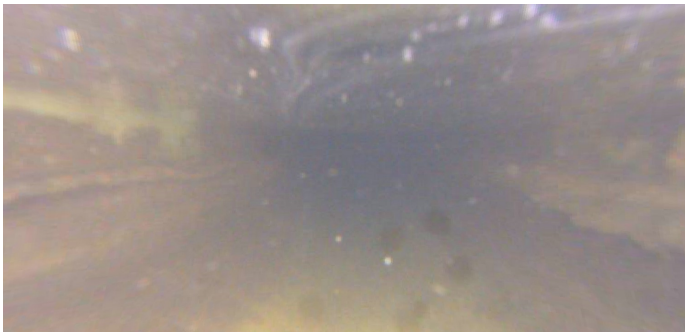
Code:	MGO
Description:	General Observation

Distance (ft):	5.6
Structural Grade:	0
O&M Grade:	0
Clock Start/From:	
Clock To:	
1st Value:	
2nd Value:	
Value Percent:	
Continuous Index:	
Within 8" of Joint:	NO
Remarks:	FLOW TO HIGH

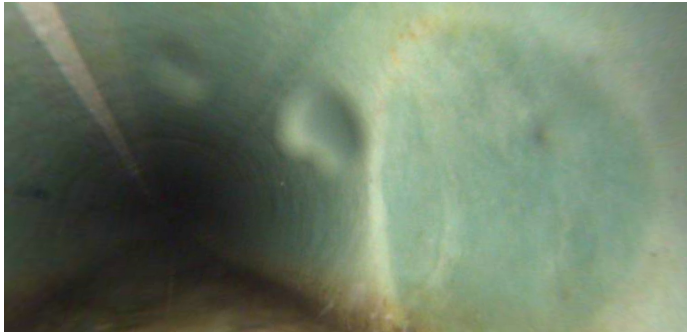
Code:	LFAC
Description:	Lining Failure Abandoned Connection
Distance (ft):	20.9
Structural Grade:	0
O&M Grade:	0
Clock Start/From:	3
Clock To:	
1st Value:	
2nd Value:	
Value Percent:	
Continuous Index:	
Within 8" of Joint:	NO
Remarks:

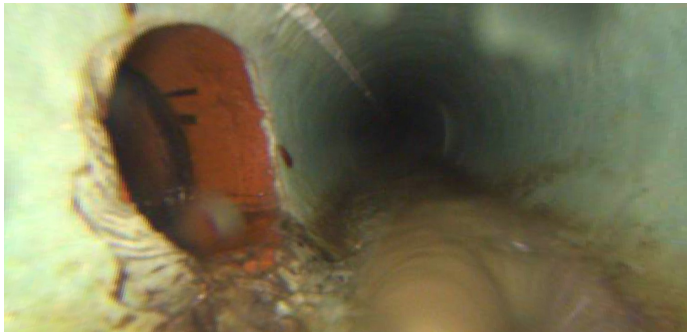
Code:	TF
Description:	Tap Factory
Distance (ft):	23.1
Structural Grade:	0
O&M Grade:	0
Clock Start/From:	9
Clock To:	
1st Value:	4.000
2nd Value:	
Value Percent:	
Continuous Index:	
Within 8" of Joint:	
Remarks:

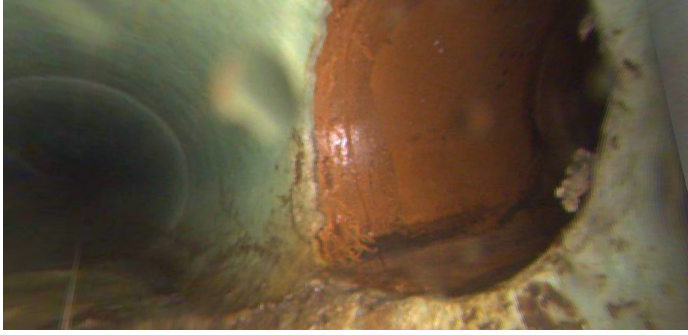
Code: **TF**
Description: **Tap Factory**

Distance (ft): **39.6**
Structural Grade: **0**
O&M Grade: **0**
Clock Start/From: **9**
Clock To:
1st Value: **4.000**
2nd Value:
Value Percent:
Continuous Index:
Within 8" of Joint:
Remarks:

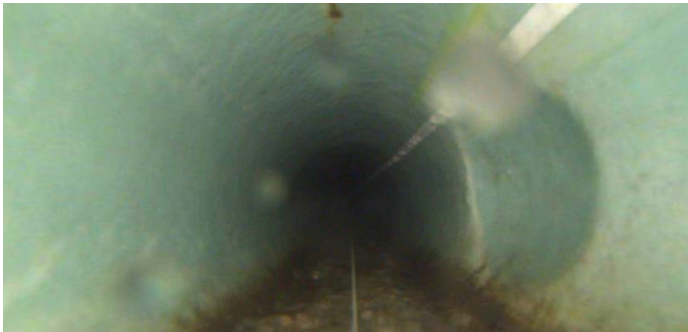
Code: **LFAC**
Description: **Lining Failure Abandoned Connection**

Distance (ft): **104.3**
Structural Grade: **0**
O&M Grade: **0**
Clock Start/From: **9**
Clock To:
1st Value:
2nd Value:
Value Percent:
Continuous Index:
Within 8" of Joint: **NO**
Remarks:

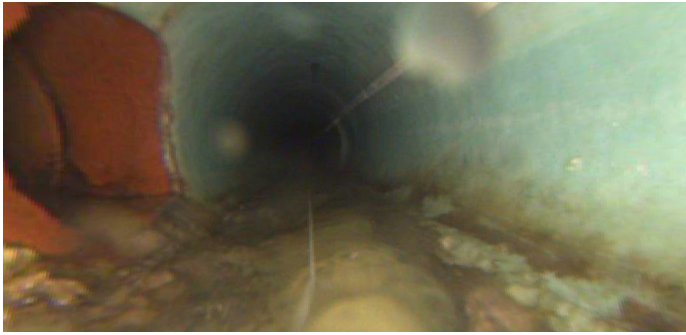
Code: **TBA**
Description: **Tap Break-in Active**

Distance (ft): **106.4**
Structural Grade: **0**
O&M Grade: **0**
Clock Start/From: **9**
Clock To:
1st Value: **4.000**
2nd Value:
Value Percent:
Continuous Index:
Within 8" of Joint:
Remarks:

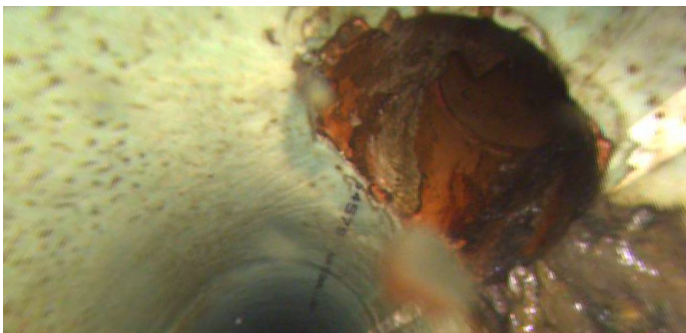
Code: **TF**
Description: **Tap Factory**

Distance (ft): **112.5**
Structural Grade: **0**
O&M Grade: **0**
Clock Start/From: **2**
Clock To:
1st Value: **4.000**
2nd Value:
Value Percent:
Continuous Index:
Within 8" of Joint:
Remarks:

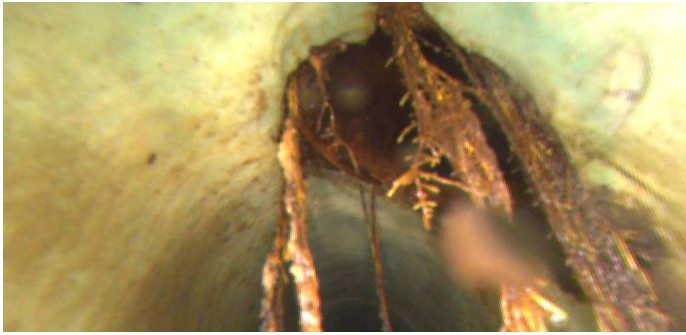
Code: **TFD**
Description: **Tap Factory Defective**

Distance (ft): **177.4**
Structural Grade: **0**
O&M Grade: **2**
Clock Start/From: **11**
Clock To:
1st Value: **4.000**
2nd Value:
Value Percent:
Continuous Index:
Within 8" of Joint:
Remarks: **rmc**

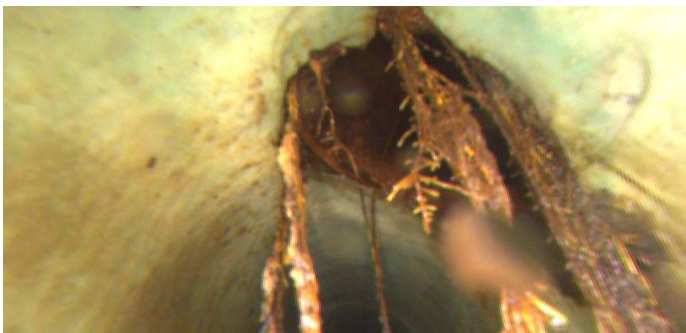
Code: **RMC**
Description: **Roots Medium Connection**

Distance (ft): **177.4**
Structural Grade: **0**
O&M Grade: **3**
Clock Start/From: **7**
Clock To: **12**
1st Value:
2nd Value:
Value Percent: **10.000**
Continuous Index:
Within 8" of Joint: **NO**
Remarks:

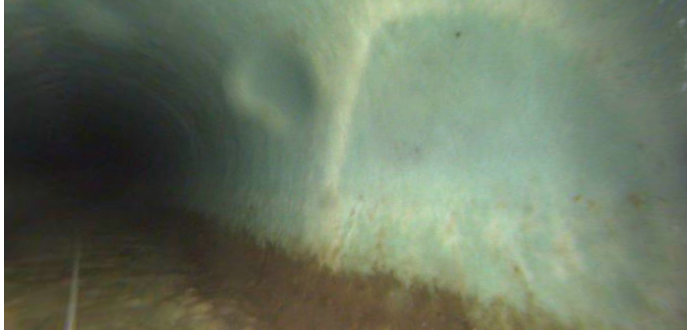
Code:	LFAC
Description:	Lining Failure Abandoned Connection
Distance (ft):	187.2
Structural Grade:	0
O&M Grade:	0
Clock Start/From:	9
Clock To:	
1st Value:	
2nd Value:	
Value Percent:	
Continuous Index:	
Within 8" of Joint:	NO
Remarks:

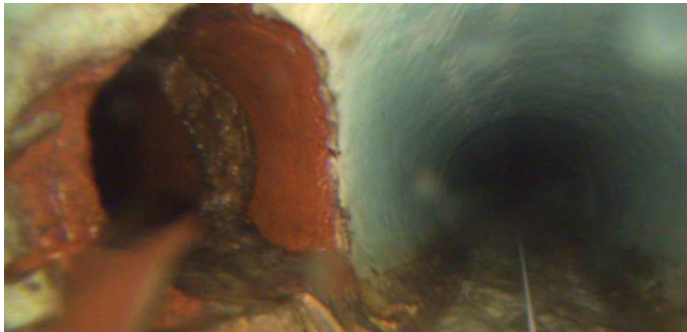
Code:	TBA
Description:	Tap Break-in Active
Distance (ft):	189.3
Structural Grade:	0
O&M Grade:	0
Clock Start/From:	9
Clock To:	
1st Value:	4.000
2nd Value:	
Value Percent:	
Continuous Index:	
Within 8" of Joint:	
Remarks:

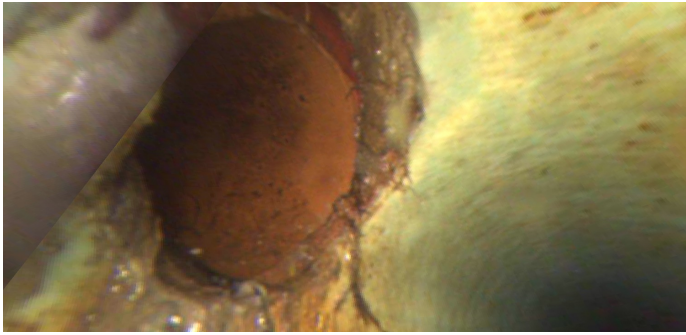
Code: **TFD**
Description: **Tap Factory Defective**

Distance (ft): **243.4**
Structural Grade: **0**
O&M Grade: **2**
Clock Start/From: **2**
Clock To:
1st Value: **4.000**
2nd Value:
Value Percent:
Continuous Index:
Within 8" of Joint:
Remarks: **roots**

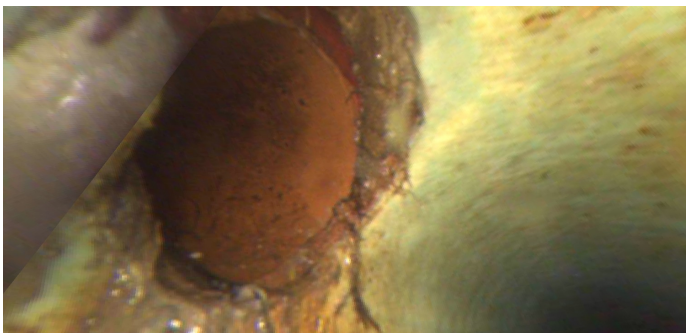
Code: **RFJ**
Description: **Roots Fine Joint**

Distance (ft): **243.4**
Structural Grade: **0**
O&M Grade: **1**
Clock Start/From: **2**
Clock To:
1st Value:
2nd Value:
Value Percent:
Continuous Index:
Within 8" of Joint: **YES**
Remarks:

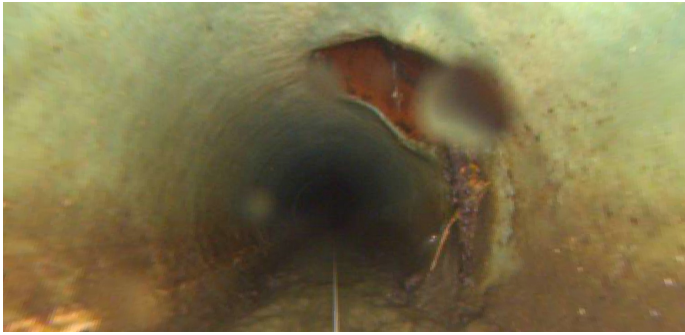
Code: **TFD**
Description: **Tap Factory Defective**

Distance (ft): **252.2**
Structural Grade: **0**
O&M Grade: **2**
Clock Start/From: **11**
Clock To:
1st Value: **4.000**
2nd Value:
Value Percent:
Continuous Index:
Within 8" of Joint:
Remarks: **roots**

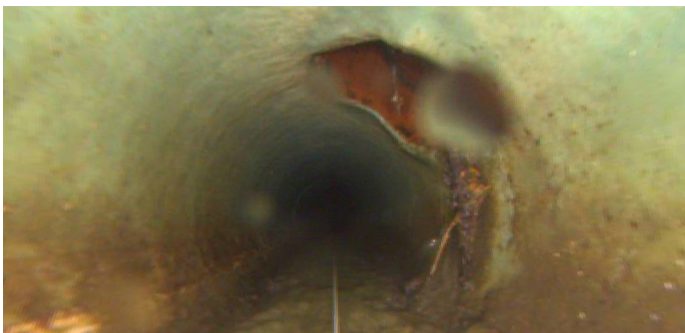
Code: **RFB**
Description: **Roots Fine Barrel**

Distance (ft): **252.2**
Structural Grade: **0**
O&M Grade: **2**
Clock Start/From: **7**
Clock To: **9**
1st Value:
2nd Value:
Value Percent:
Continuous Index:
Within 8" of Joint: **NO**
Remarks:

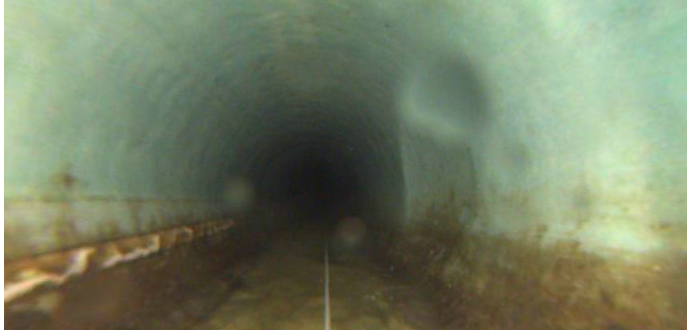
Code: **LFAC**
Description: **Lining Failure Abandoned Connection**

Distance (ft): **266.1**
Structural Grade: **0**
O&M Grade: **0**
Clock Start/From: **9**
Clock To:
1st Value:
2nd Value:
Value Percent:
Continuous Index:
Within 8" of Joint: **NO**
Remarks:

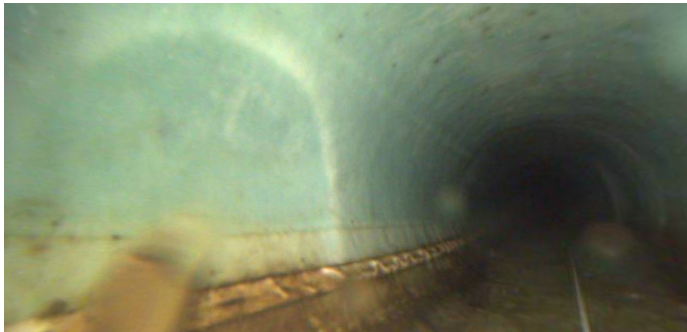
Code: **LFAC**
Description: **Lining Failure Abandoned Connection**

Distance (ft): **267.5**
Structural Grade: **0**
O&M Grade: **0**
Clock Start/From: **3**
Clock To:
1st Value:
2nd Value:
Value Percent:
Continuous Index:
Within 8" of Joint: **NO**
Remarks:

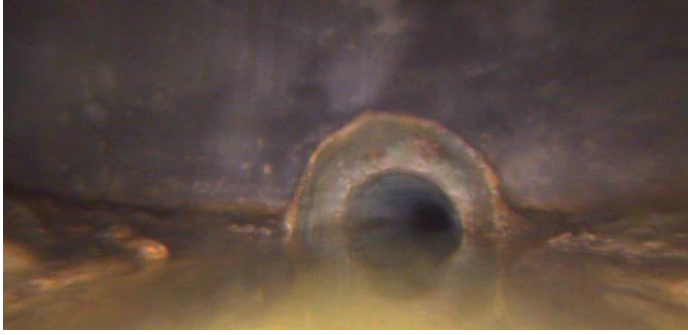
Code:	AMH
Description:	Manhole
Distance (ft):	273.8
Structural Grade:	0
O&M Grade:	0
Clock Start/From:	
Clock To:	
1st Value:	
2nd Value:	
Value Percent:	
Continuous Index:	
Within 8" of Joint:	NO
Remarks:	M-305-003
