## Profile/Photo Observation Report

Date:	<b>04/19/2018</b>	Weather:		Coding:	<b>PACP 6.0</b>
Pipe Length (ft):	<b>285.9</b>	Owner:	<b>NA</b>	Pre Clean:	<b>No Pre-Cleaning</b>
P.O.#:		Surveyor:	<b>Justin Gonzales</b>	PSR:	<b>P-305-003-002</b>
Customer:		Clean Date:	<b>01/01/1900</b>	Shape:	<b>C</b>

Street:	<b>FOXCROFT STREET</b>	Flow Control:	<b>Not Controlled</b>
City:	<b>Hobart, IN</b>	Year Renewed:	
Location:	<b>Yard</b>	Tape/Media #:	
Purpose:	<b>Routine Assessment</b>	Dia/Height:	<b>10"</b>
Use:	<b>Sanitary</b>	Material:	<b>PVC</b>
Drain Area:	<b>NA</b>	Lining:	
Category:	<b>NA</b>		
Comment:

Location Details:		Direction of Survey:	<b>Upstream</b>
US MH:	<b>M-305-003</b>	DS MH:	<b>M-305-002</b>
		Total Length Surveyed (ft):	<b>273.8</b>

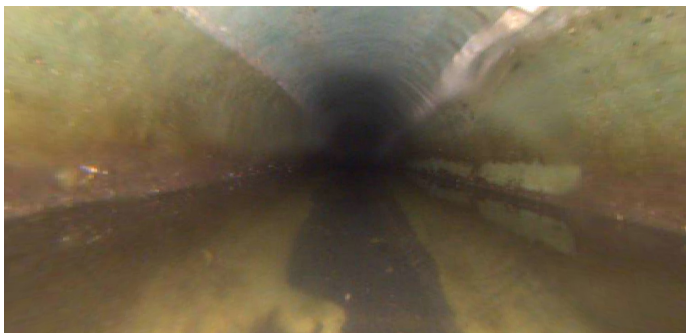
Code: **AMH**  
Description: **Manhole**

Distance (ft): **.0**  
Structural Grade: **0**  
O&M Grade: **0**  
Clock Start/From:  
Clock To:  
1st Value:  
2nd Value:  
Value Percent:  
Continuous Index:  
Within 8" of Joint: **NO**  
Remarks: **M-305-002**

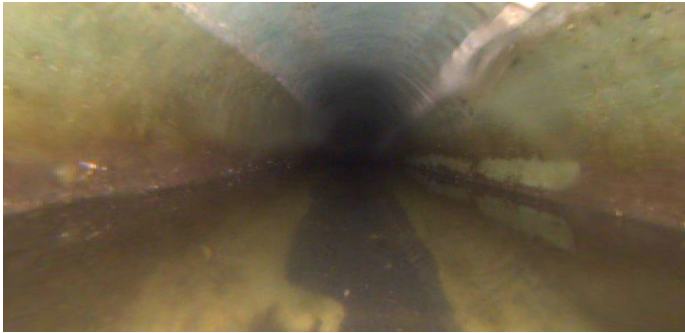
Code:	<b>MWL</b>
Description:	<b>Water Level</b>

Distance (ft):	<b>.0</b>
Structural Grade:	<b>0</b>
O&M Grade:	<b>0</b>
Clock Start/From:	
Clock To:	
1st Value:	
2nd Value:	
Value Percent:	<b>15.000</b>
Continuous Index:	
Within 8" of Joint:	<b>NO</b>
Remarks:

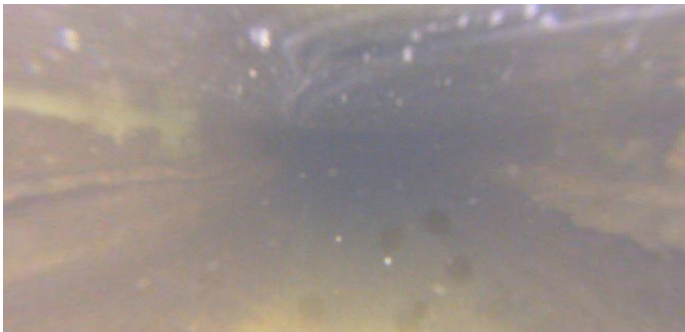
Code:	<b>MGO</b>
Description:	<b>General Observation</b>

Distance (ft):	<b>5.6</b>
Structural Grade:	<b>0</b>
O&M Grade:	<b>0</b>
Clock Start/From:	
Clock To:	
1st Value:	
2nd Value:	
Value Percent:	
Continuous Index:	
Within 8" of Joint:	<b>NO</b>
Remarks:	<b>FLOW TO HIGH</b>

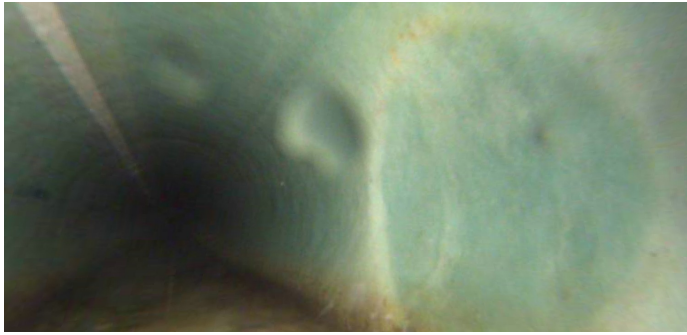
Code:	<b>LFAC</b>
Description:	<b>Lining Failure Abandoned Connection</b>
Distance (ft):	<b>20.9</b>
Structural Grade:	<b>0</b>
O&M Grade:	<b>0</b>
Clock Start/From:	<b>3</b>
Clock To:	
1st Value:	
2nd Value:	
Value Percent:	
Continuous Index:	
Within 8" of Joint:	<b>NO</b>
Remarks:

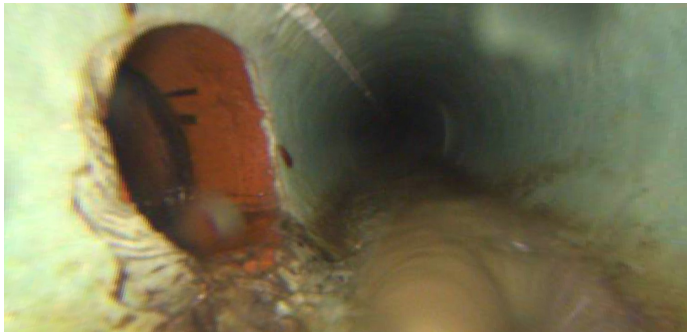
Code:	<b>TF</b>
Description:	<b>Tap Factory</b>
Distance (ft):	<b>23.1</b>
Structural Grade:	<b>0</b>
O&M Grade:	<b>0</b>
Clock Start/From:	<b>9</b>
Clock To:	
1st Value:	<b>4.000</b>
2nd Value:	
Value Percent:	
Continuous Index:	
Within 8" of Joint:	
Remarks:

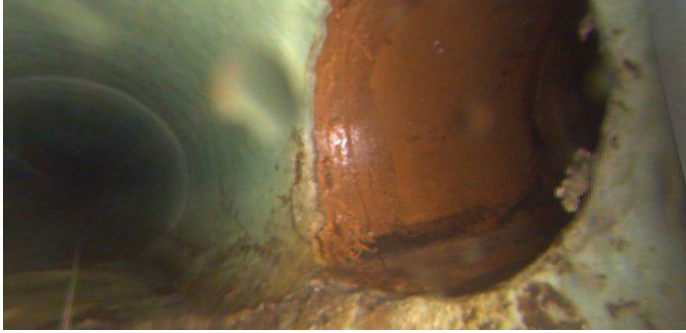
Code: **TF**  
Description: **Tap Factory**

Distance (ft): **39.6**  
Structural Grade: **0**  
O&M Grade: **0**  
Clock Start/From: **9**  
Clock To:  
1st Value: **4.000**  
2nd Value:  
Value Percent:  
Continuous Index:  
Within 8" of Joint:  
Remarks:

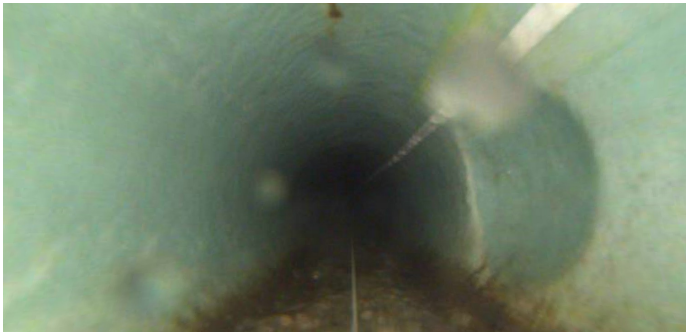
Code: **LFAC**  
Description: **Lining Failure Abandoned Connection**

Distance (ft): **104.3**  
Structural Grade: **0**  
O&M Grade: **0**  
Clock Start/From: **9**  
Clock To:  
1st Value:  
2nd Value:  
Value Percent:  
Continuous Index:  
Within 8" of Joint: **NO**  
Remarks:

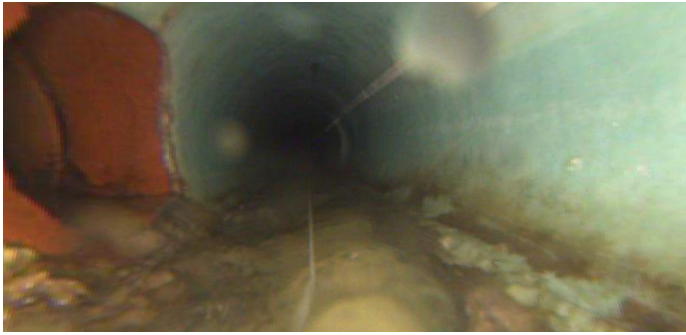
Code: **TBA**  
Description: **Tap Break-in Active**

Distance (ft): **106.4**  
Structural Grade: **0**  
O&M Grade: **0**  
Clock Start/From: **9**  
Clock To:  
1st Value: **4.000**  
2nd Value:  
Value Percent:  
Continuous Index:  
Within 8" of Joint:  
Remarks:

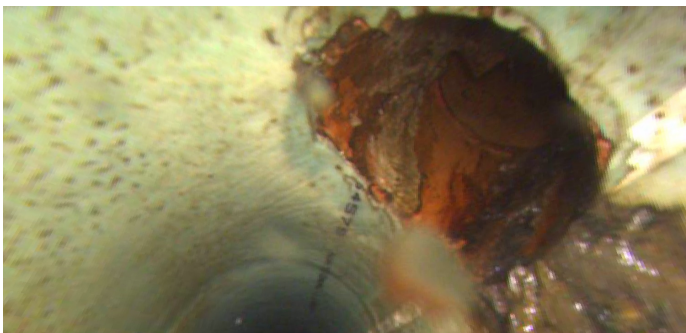
Code: **TF**  
Description: **Tap Factory**

Distance (ft): **112.5**  
Structural Grade: **0**  
O&M Grade: **0**  
Clock Start/From: **2**  
Clock To:  
1st Value: **4.000**  
2nd Value:  
Value Percent:  
Continuous Index:  
Within 8" of Joint:  
Remarks:

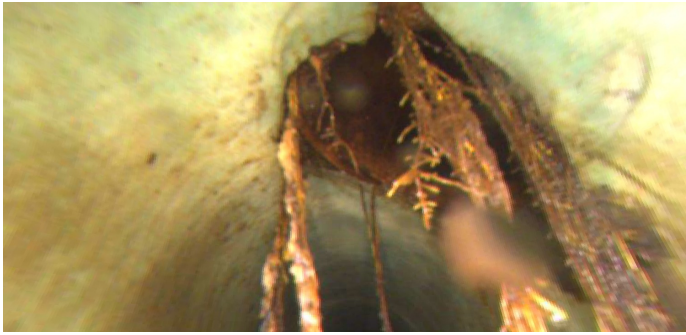
Code: **TFD**  
Description: **Tap Factory Defective**

Distance (ft): **177.4**  
Structural Grade: **0**  
O&M Grade: **2**  
Clock Start/From: **11**  
Clock To:  
1st Value: **4.000**  
2nd Value:  
Value Percent:  
Continuous Index:  
Within 8" of Joint:  
Remarks: **rmc**

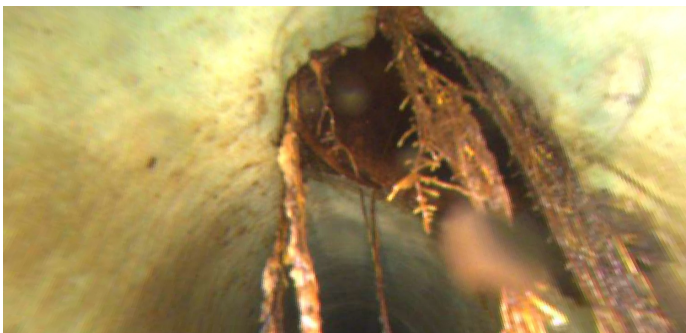
Code: **RMC**  
Description: **Roots Medium Connection**

Distance (ft): **177.4**  
Structural Grade: **0**  
O&M Grade: **3**  
Clock Start/From: **7**  
Clock To: **12**  
1st Value:  
2nd Value:  
Value Percent: **10.000**  
Continuous Index:  
Within 8" of Joint: **NO**  
Remarks:

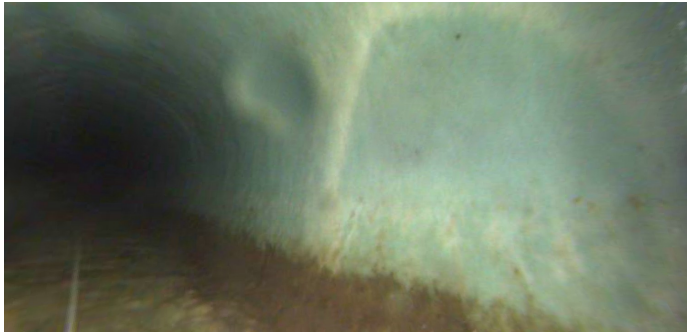
Code:	<b>LFAC</b>
Description:	<b>Lining Failure Abandoned Connection</b>
Distance (ft):	<b>187.2</b>
Structural Grade:	<b>0</b>
O&M Grade:	<b>0</b>
Clock Start/From:	<b>9</b>
Clock To:	
1st Value:	
2nd Value:	
Value Percent:	
Continuous Index:	
Within 8" of Joint:	<b>NO</b>
Remarks:

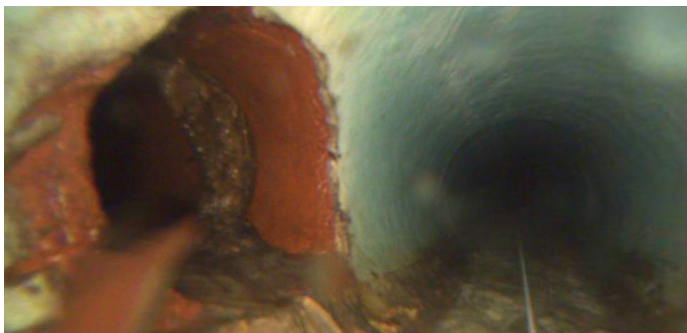
Code:	<b>TBA</b>
Description:	<b>Tap Break-in Active</b>
Distance (ft):	<b>189.3</b>
Structural Grade:	<b>0</b>
O&M Grade:	<b>0</b>
Clock Start/From:	<b>9</b>
Clock To:	
1st Value:	<b>4.000</b>
2nd Value:	
Value Percent:	
Continuous Index:	
Within 8" of Joint:	
Remarks:

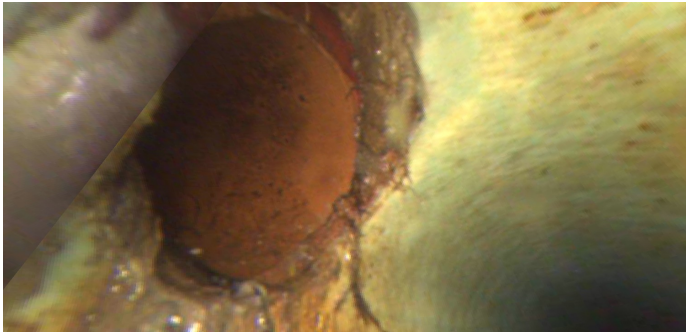
Code: **TFD**  
Description: **Tap Factory Defective**

Distance (ft): **243.4**  
Structural Grade: **0**  
O&M Grade: **2**  
Clock Start/From: **2**  
Clock To:  
1st Value: **4.000**  
2nd Value:  
Value Percent:  
Continuous Index:  
Within 8" of Joint:  
Remarks: **roots**

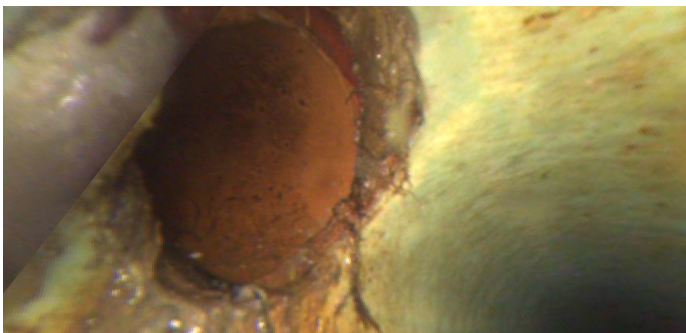
Code: **RFJ**  
Description: **Roots Fine Joint**

Distance (ft): **243.4**  
Structural Grade: **0**  
O&M Grade: **1**  
Clock Start/From: **2**  
Clock To:  
1st Value:  
2nd Value:  
Value Percent:  
Continuous Index:  
Within 8" of Joint: **YES**  
Remarks:

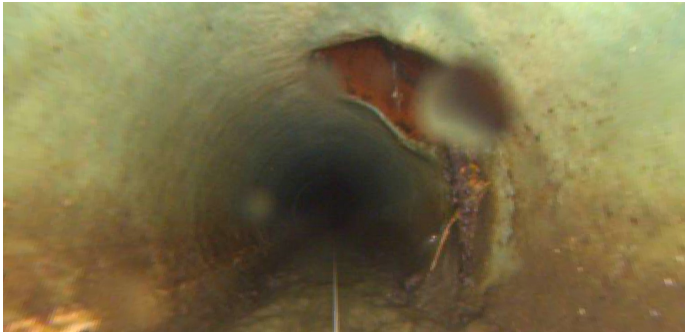
Code: **TFD**  
Description: **Tap Factory Defective**

Distance (ft): **252.2**  
Structural Grade: **0**  
O&M Grade: **2**  
Clock Start/From: **11**  
Clock To:  
1st Value: **4.000**  
2nd Value:  
Value Percent:  
Continuous Index:  
Within 8" of Joint:  
Remarks: **roots**

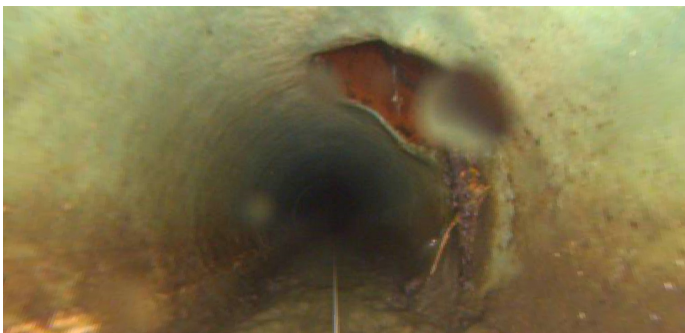
Code: **RFB**  
Description: **Roots Fine Barrel**

Distance (ft): **252.2**  
Structural Grade: **0**  
O&M Grade: **2**  
Clock Start/From: **7**  
Clock To: **9**  
1st Value:  
2nd Value:  
Value Percent:  
Continuous Index:  
Within 8" of Joint: **NO**  
Remarks:

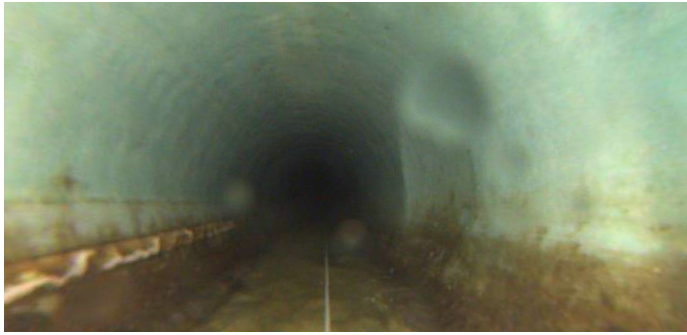
Code: **LFAC**  
 Description: **Lining Failure Abandoned Connection**

Distance (ft): **266.1**  
 Structural Grade: **0**  
 O&M Grade: **0**  
 Clock Start/From: **9**  
 Clock To:  
 1st Value:  
 2nd Value:  
 Value Percent:  
 Continuous Index:  
 Within 8" of Joint: **NO**  
 Remarks:

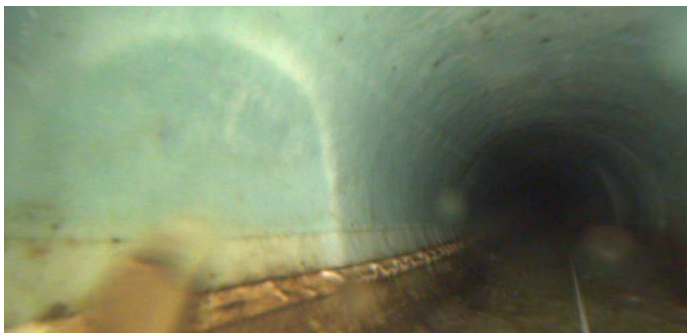
Code: **LFAC**  
 Description: **Lining Failure Abandoned Connection**

Distance (ft): **267.5**  
 Structural Grade: **0**  
 O&M Grade: **0**  
 Clock Start/From: **3**  
 Clock To:  
 1st Value:  
 2nd Value:  
 Value Percent:  
 Continuous Index:  
 Within 8" of Joint: **NO**  
 Remarks:

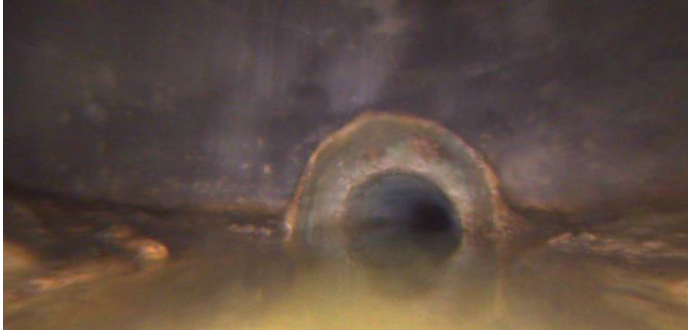
Code:	<b>AMH</b>
Description:	<b>Manhole</b>
Distance (ft):	<b>273.8</b>
Structural Grade:	<b>0</b>
O&M Grade:	<b>0</b>
Clock Start/From:	
Clock To:	
1st Value:	
2nd Value:	
Value Percent:	
Continuous Index:	
Within 8" of Joint:	<b>NO</b>
Remarks:	<b>M-305-003</b>
