Profile/Photo Observation Report

Date:	04/19/2018	Weather:		Coding:	PACP 6.0
Pipe Length (ft):	298.5	Owner:	NA	Pre Clean:	No Pre-Cleaning
P.O.#:		Surveyor:	Justin Gonzales	PSR:	P-305-004-003
Customer:		Clean Date:	01/01/1900	Shape:	C

Street:	OFF W 49TH AVE	Flow Control:	Not Controlled
City:	Hobart, IN	Year Renewed:	
Location:	Yard	Tape/Media #:	
Purpose:	Routine Assessment	Dia/Height:	10"
Use:	Sanitary	Material:	PVC
Drain Area:	NA	Lining:	Cured in Place
Category:	NA		
Comment:

Location Details:		Direction of Survey:	Upstream
US MH:	M-305-004	DS MH:	M-305-003
		Total Length Surveyed (ft):	295.6

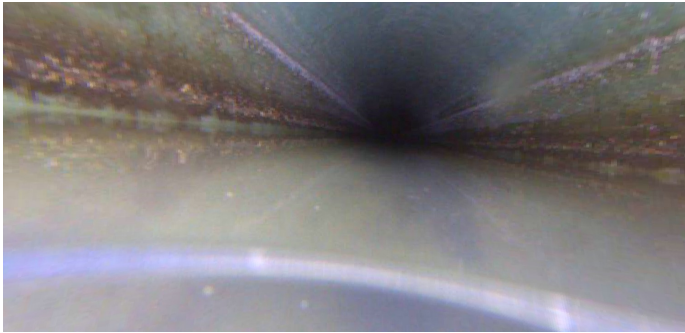
Code:	MWL
Description:	Water Level

Distance (ft):	.0
Structural Grade:	0
O&M Grade:	0
Clock Start/From:	
Clock To:	
1st Value:	
2nd Value:	
Value Percent:	30.000
Continuous Index:	
Within 8" of Joint:	NO
Remarks:

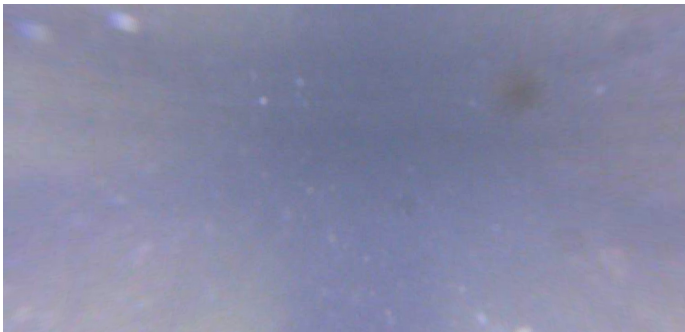
Code:	MGO
Description:	General Observation

Distance (ft):	1.7
Structural Grade:	0
O&M Grade:	0
Clock Start/From:	
Clock To:	
1st Value:	
2nd Value:	
Value Percent:	
Continuous Index:	
Within 8" of Joint:	NO
Remarks:	FLOW TO HIGH

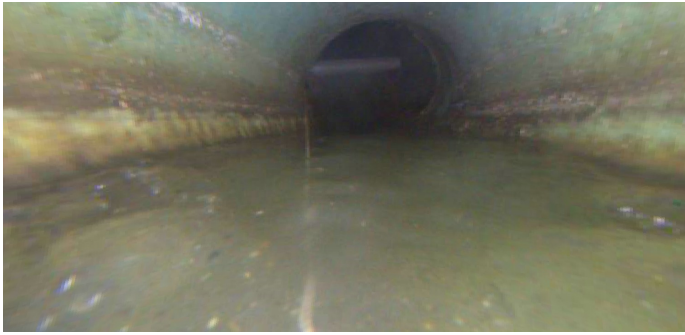
Code: **DAZ**
Description: **Deposits Attached Other**

Distance (ft): **1.7**
Structural Grade: **0**
O&M Grade: **2**
Clock Start/From: **7**
Clock To: **5**
1st Value:
2nd Value:
Value Percent: **5.000**
Continuous Index: **S01**
Within 8" of Joint: **YES**
Remarks: **WANDER**

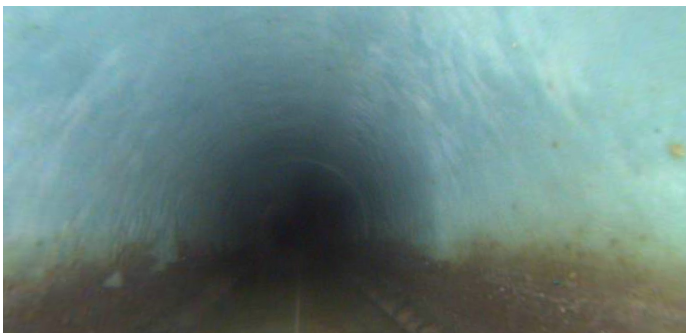
Code: **LFAC**
Description: **Lining Failure Abandoned Connection**

Distance (ft): **77.2**
Structural Grade: **0**
O&M Grade: **0**
Clock Start/From: **9**
Clock To:
1st Value:
2nd Value:
Value Percent:
Continuous Index:
Within 8" of Joint: **NO**
Remarks:

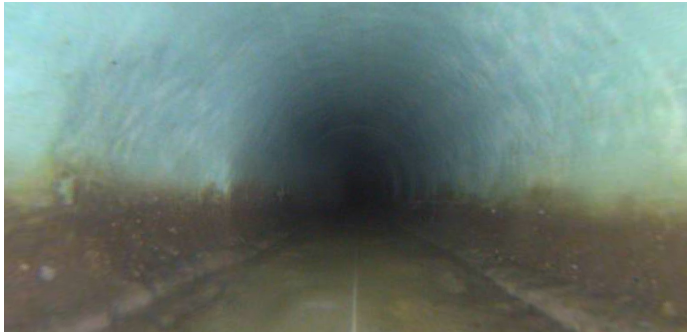
Code:	LFAC
Description:	Lining Failure Abandoned Connection
Distance (ft):	79.3
Structural Grade:	0
O&M Grade:	0
Clock Start/From:	3
Clock To:	
1st Value:	
2nd Value:	
Value Percent:	
Continuous Index:	
Within 8" of Joint:	NO
Remarks:

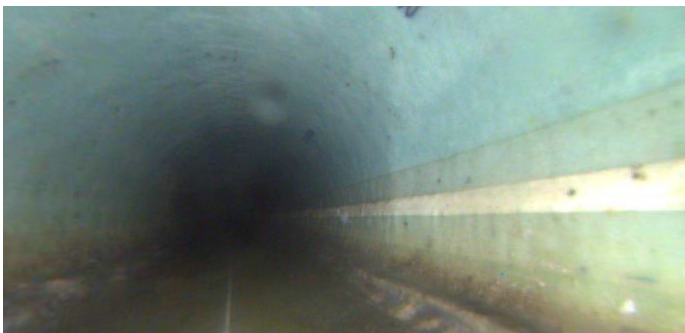
Code: **LFAC**
Description: **Lining Failure Abandoned Connection**

Distance (ft): **161.7**
Structural Grade: **0**
O&M Grade: **0**
Clock Start/From: **9**
Clock To:
1st Value:
2nd Value:
Value Percent:
Continuous Index:
Within 8" of Joint: **NO**
Remarks:

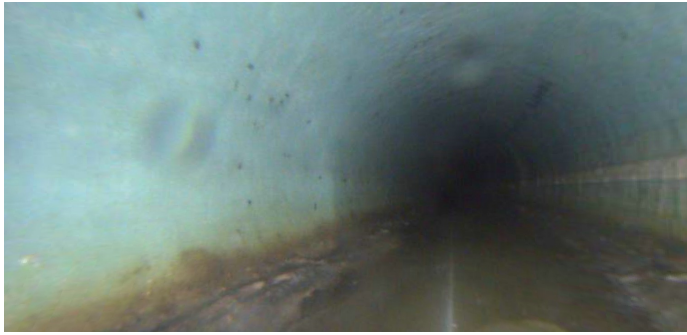
Code:	LFAC
Description:	Lining Failure Abandoned Connection
Distance (ft):	163.7
Structural Grade:	0
O&M Grade:	0
Clock Start/From:	3
Clock To:	
1st Value:	
2nd Value:	
Value Percent:	
Continuous Index:	
Within 8" of Joint:	NO
Remarks:

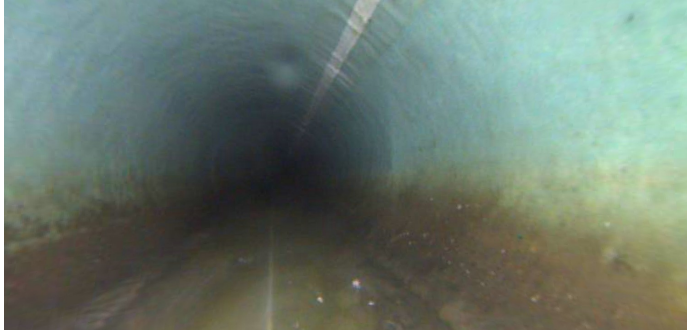
Code:	LFAC
Description:	Lining Failure Abandoned Connection
Distance (ft):	241.6
Structural Grade:	0
O&M Grade:	0
Clock Start/From:	9
Clock To:	
1st Value:	
2nd Value:	
Value Percent:	
Continuous Index:	
Within 8" of Joint:	NO
Remarks:

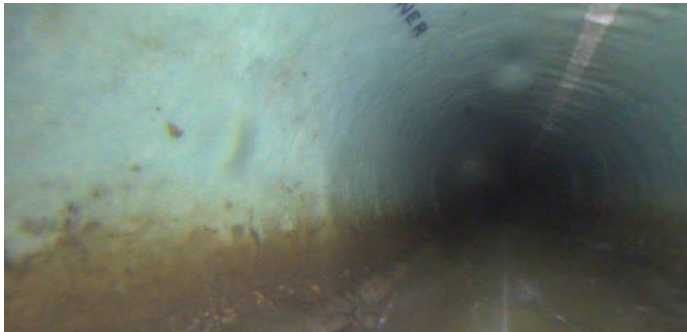
Code:	LFAC
Description:	Lining Failure Abandoned Connection
Distance (ft):	243.3
Structural Grade:	0
O&M Grade:	0
Clock Start/From:	3
Clock To:	
1st Value:	
2nd Value:	
Value Percent:	
Continuous Index:	
Within 8" of Joint:	NO
Remarks:

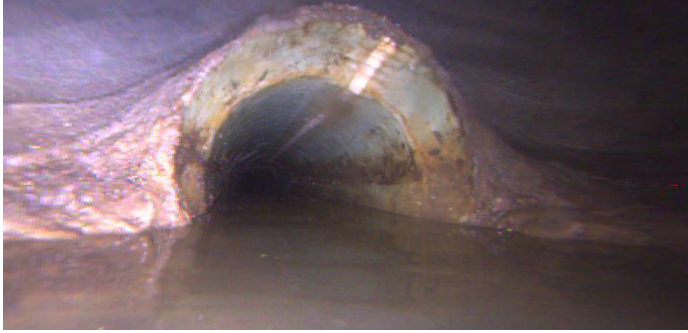
Code:	DAZ
Description:	Deposits Attached Other
Distance (ft):	295.6
Structural Grade:	0
O&M Grade:	2
Clock Start/From:	7
Clock To:	5
1st Value:	
2nd Value:	
Value Percent:	5.000
Continuous Index:	F01
Within 8" of Joint:	YES
Remarks:	WANDER
