## Profile/Photo Observation Report

Street:	<b>FOXCROFT STREET</b>	Flow Control:	<b>Not Controlled</b>
City:	<b>Hobart, IN</b>	Year Renewed:	
Location:	<b>Yard</b>	Tape/Media #:	
Purpose:	<b>Routine Assessment</b>	Dia/Height:	<b>10"</b>
Use:	<b>Sanitary</b>	Material:	<b>PVC</b>
Drain Area:	<b>NA</b>	Lining:	<b>Cured in Place</b>
Category:	<b>NA</b>		
Comment:

Location Details:		Direction of Survey:	<b>Upstream</b>
US MH:	<b>M-305-004</b>	DS MH:	<b>M-305-003</b>
		Total Length Surveyed (ft):	<b>295.6</b>

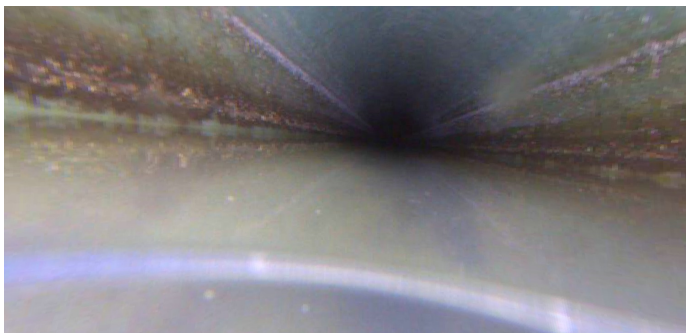
Code: **AMH**  
Description: **Manhole**

Distance (ft): **.0**  
Structural Grade: **0**  
O&M Grade: **0**  
Clock Start/From:  
Clock To:  
1st Value:  
2nd Value:  
Value Percent:  
Continuous Index:  
Within 8" of Joint: **NO**  
Remarks: **M-305-003**

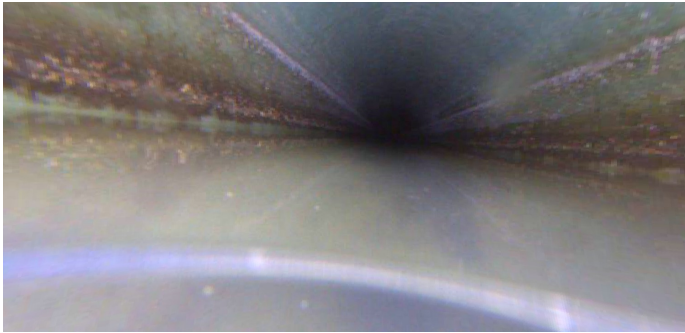
Code:	<b>MWL</b>
Description:	<b>Water Level</b>

Distance (ft):	<b>.0</b>
Structural Grade:	<b>0</b>
O&M Grade:	<b>0</b>
Clock Start/From:	
Clock To:	
1st Value:	
2nd Value:	
Value Percent:	<b>30.000</b>
Continuous Index:	
Within 8" of Joint:	<b>NO</b>
Remarks:

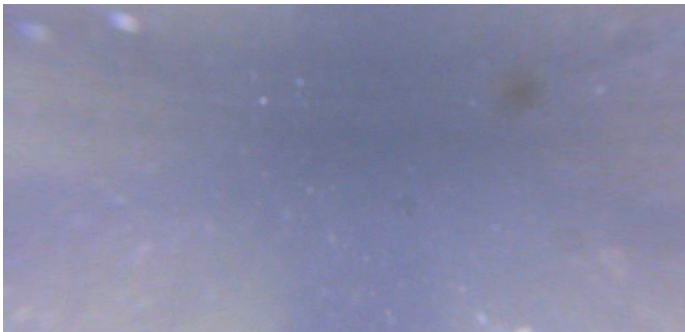
Code:	<b>MGO</b>
Description:	<b>General Observation</b>

Distance (ft):	<b>1.7</b>
Structural Grade:	<b>0</b>
O&M Grade:	<b>0</b>
Clock Start/From:	
Clock To:	
1st Value:	
2nd Value:	
Value Percent:	
Continuous Index:	
Within 8" of Joint:	<b>NO</b>
Remarks:	<b>FLOW TO HIGH</b>

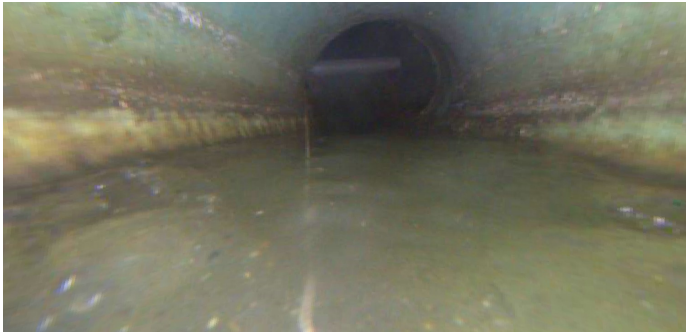
Code: **DAZ**  
Description: **Deposits Attached Other**

Distance (ft): **1.7**  
Structural Grade: **0**  
O&M Grade: **2**  
Clock Start/From: **7**  
Clock To: **5**  
1st Value:  
2nd Value:  
Value Percent: **5.000**  
Continuous Index: **S01**  
Within 8" of Joint: **YES**  
Remarks: **WANDER**

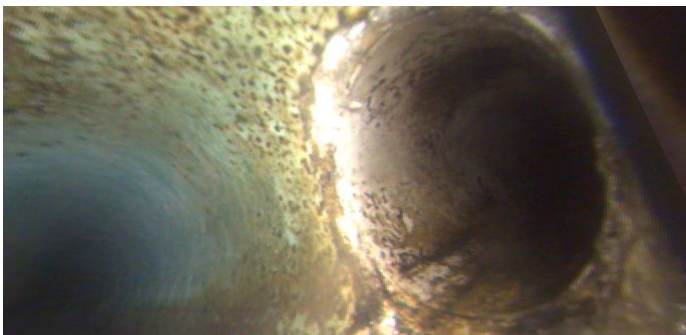
Code: **TF**  
Description: **Tap Factory**

Distance (ft): **72.1**  
Structural Grade: **0**  
O&M Grade: **0**  
Clock Start/From: **9**  
Clock To:  
1st Value: **4.000**  
2nd Value:  
Value Percent:  
Continuous Index:  
Within 8" of Joint:  
Remarks:

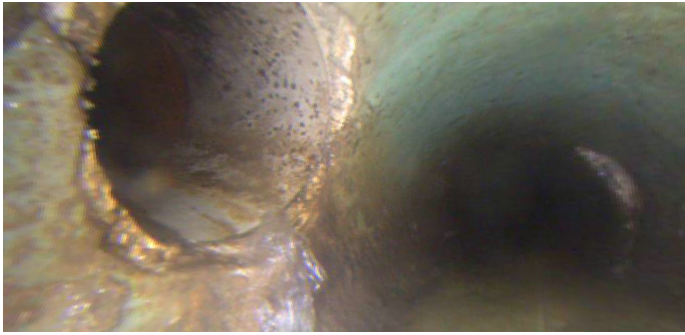
Code: **TFA**  
Description: **Tap Factory Active**

Distance (ft): **74.0**  
Structural Grade: **0**  
O&M Grade: **0**  
Clock Start/From: **3**  
Clock To:  
1st Value: **4.000**  
2nd Value:  
Value Percent:  
Continuous Index:  
Within 8" of Joint:  
Remarks:

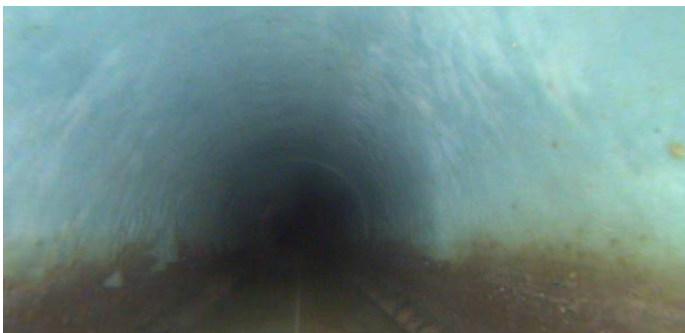
Code: **LFAC**  
Description: **Lining Failure Abandoned Connection**

Distance (ft): **77.2**  
Structural Grade: **0**  
O&M Grade: **0**  
Clock Start/From: **9**  
Clock To:  
1st Value:  
2nd Value:  
Value Percent:  
Continuous Index:  
Within 8" of Joint: **NO**  
Remarks:

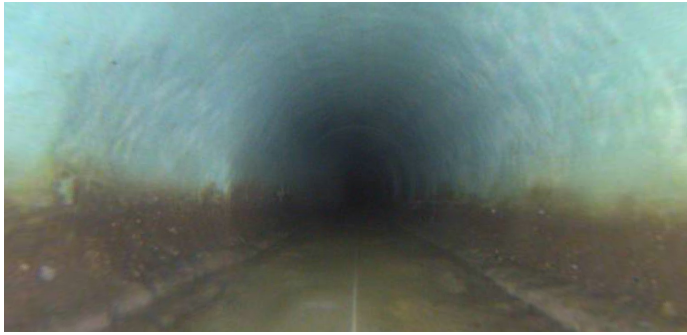
Code:	<b>LFAC</b>
Description:	<b>Lining Failure Abandoned Connection</b>
Distance (ft):	<b>79.3</b>
Structural Grade:	<b>0</b>
O&M Grade:	<b>0</b>
Clock Start/From:	<b>3</b>
Clock To:	
1st Value:	
2nd Value:	
Value Percent:	
Continuous Index:	
Within 8" of Joint:	<b>NO</b>
Remarks:

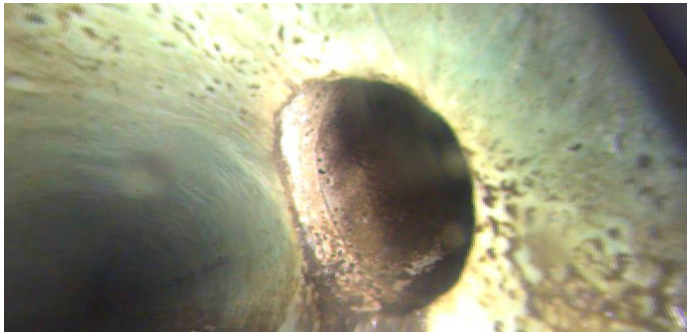
Code:	<b>TF</b>
Description:	<b>Tap Factory</b>
Distance (ft):	<b>127.8</b>
Structural Grade:	<b>0</b>
O&M Grade:	<b>0</b>
Clock Start/From:	<b>9</b>
Clock To:	
1st Value:	<b>4.000</b>
2nd Value:	
Value Percent:	
Continuous Index:	
Within 8" of Joint:	
Remarks:

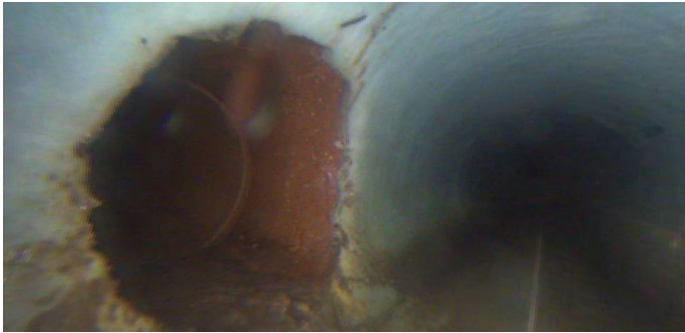
Code: **TF**  
Description: **Tap Factory**

Distance (ft): **146.4**  
Structural Grade: **0**  
O&M Grade: **0**  
Clock Start/From: **3**  
Clock To:  
1st Value: **4.000**  
2nd Value:  
Value Percent:  
Continuous Index:  
Within 8" of Joint:  
Remarks:

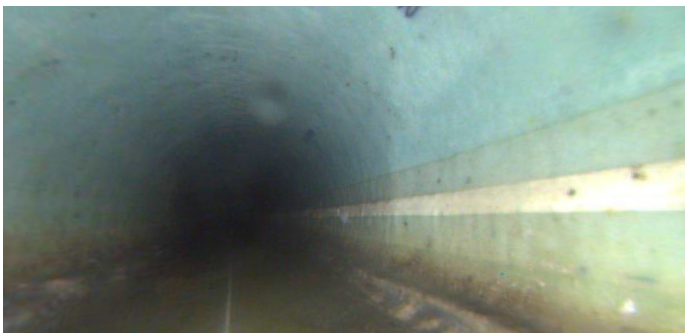
Code: **LFAC**  
Description: **Lining Failure Abandoned Connection**

Distance (ft): **161.7**  
Structural Grade: **0**  
O&M Grade: **0**  
Clock Start/From: **9**  
Clock To:  
1st Value:  
2nd Value:  
Value Percent:  
Continuous Index:  
Within 8" of Joint: **NO**  
Remarks:

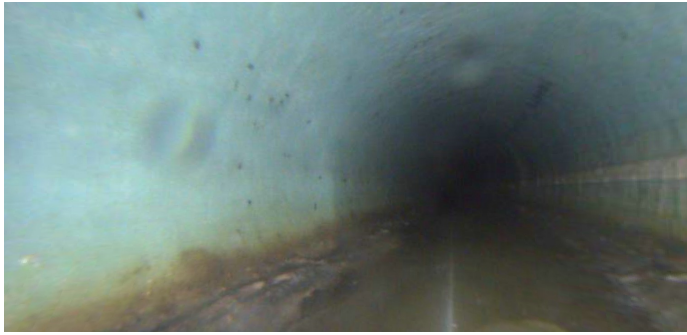
Code:	<b>LFAC</b>
Description:	<b>Lining Failure Abandoned Connection</b>
Distance (ft):	<b>163.7</b>
Structural Grade:	<b>0</b>
O&M Grade:	<b>0</b>
Clock Start/From:	<b>3</b>
Clock To:	
1st Value:	
2nd Value:	
Value Percent:	
Continuous Index:	
Within 8" of Joint:	<b>NO</b>
Remarks:

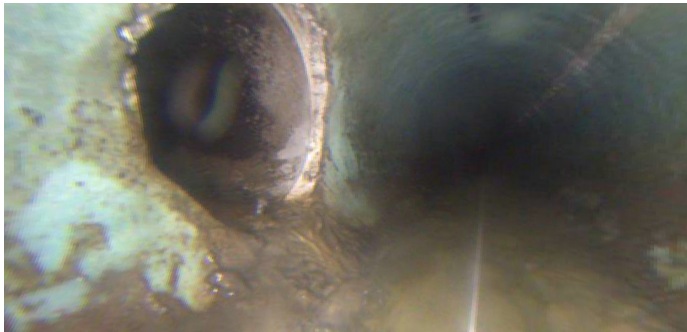
Code:	<b>TF</b>
Description:	<b>Tap Factory</b>
Distance (ft):	<b>233.6</b>
Structural Grade:	<b>0</b>
O&M Grade:	<b>0</b>
Clock Start/From:	<b>3</b>
Clock To:	
1st Value:	<b>4.000</b>
2nd Value:	
Value Percent:	
Continuous Index:	
Within 8" of Joint:	
Remarks:

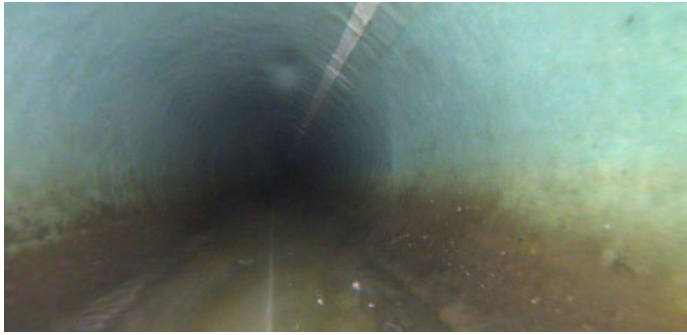
Code:	<b>LFAC</b>
Description:	<b>Lining Failure Abandoned Connection</b>
Distance (ft):	<b>241.6</b>
Structural Grade:	<b>0</b>
O&M Grade:	<b>0</b>
Clock Start/From:	<b>9</b>
Clock To:	
1st Value:	
2nd Value:	
Value Percent:	
Continuous Index:	
Within 8" of Joint:	<b>NO</b>
Remarks:

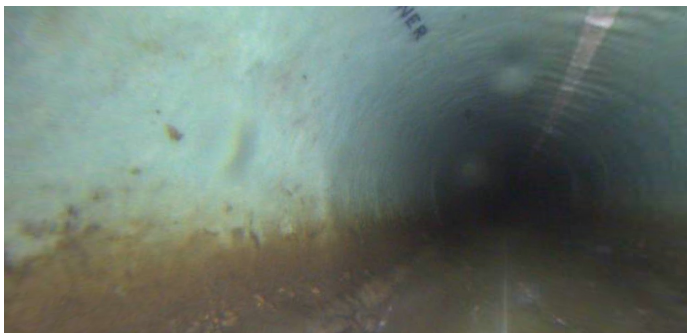
Code:	<b>LFAC</b>
Description:	<b>Lining Failure Abandoned Connection</b>
Distance (ft):	<b>243.3</b>
Structural Grade:	<b>0</b>
O&M Grade:	<b>0</b>
Clock Start/From:	<b>3</b>
Clock To:	
1st Value:	
2nd Value:	
Value Percent:	
Continuous Index:	
Within 8" of Joint:	<b>NO</b>
Remarks:

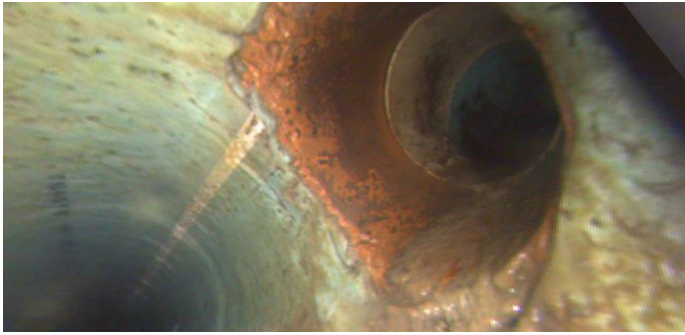
Code: **TF**  
Description: **Tap Factory**

Distance (ft): **244.9**  
Structural Grade: **0**  
O&M Grade: **0**  
Clock Start/From: **10**  
Clock To:  
1st Value: **4.000**  
2nd Value:  
Value Percent:  
Continuous Index:  
Within 8" of Joint:  
Remarks:

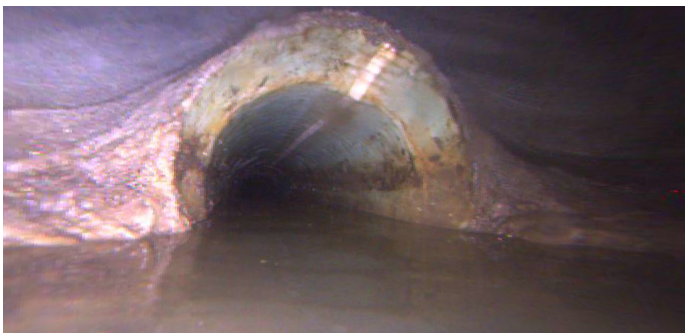
Code: **AMH**  
Description: **Manhole**

Distance (ft): **295.6**  
Structural Grade: **0**  
O&M Grade: **0**  
Clock Start/From:  
Clock To:  
1st Value:  
2nd Value:  
Value Percent:  
Continuous Index:  
Within 8" of Joint: **NO**  
Remarks: **M-305-004**

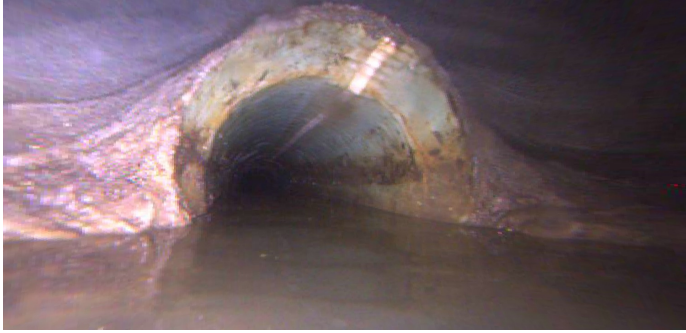
Code:	DAZ
Description:	Deposits Attached Other
Distance (ft):	295.6
Structural Grade:	0
O&M Grade:	2
Clock Start/From:	7
Clock To:	5
1st Value:	
2nd Value:	
Value Percent:	5.000
Continuous Index:	F01
Within 8" of Joint:	YES
Remarks:	WANDER
