## Profile/Photo Observation Report

Street:	<b>OFF W 49TH AVE</b>	Flow Control:	<b>Not Controlled</b>
City:	<b>Hobart, IN</b>	Year Renewed:	
Location:	<b>Yard</b>	Tape/Media #:	
Purpose:	<b>Routine Assessment</b>	Dia/Height:	<b>10"</b>
Use:	<b>Sanitary</b>	Material:	<b>PVC</b>
Drain Area:	<b>NA</b>	Lining:	<b>Cured in Place</b>
Category:	<b>NA</b>		
Comment:

Location Details:		Direction of Survey:	<b>Downstream</b>
US MH:	<b>M-305-005</b>	DS MH:	<b>M-305-004</b>
		Total Length Surveyed (ft):	<b>295.0</b>

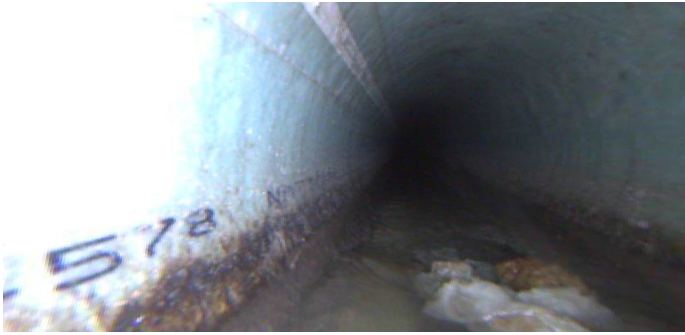
Code: **AMH**  
Description: **Manhole**

Distance (ft): **.0**  
Structural Grade: **0**  
O&M Grade: **0**  
Clock Start/From:  
Clock To:  
1st Value:  
2nd Value:  
Value Percent:  
Continuous Index:  
Within 8" of Joint: **NO**  
Remarks: **M-305-005**

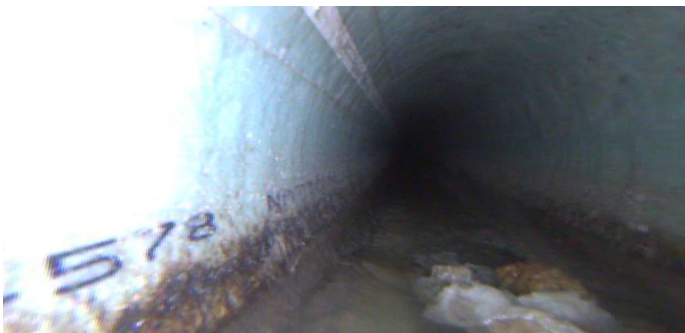
Code: **MWL**  
Description: **Water Level**

Distance (ft): **.0**  
Structural Grade: **0**  
O&M Grade: **0**  
Clock Start/From:  
Clock To:  
1st Value:  
2nd Value:  
Value Percent: **10.000**  
Continuous Index:  
Within 8" of Joint: **NO**  
Remarks:

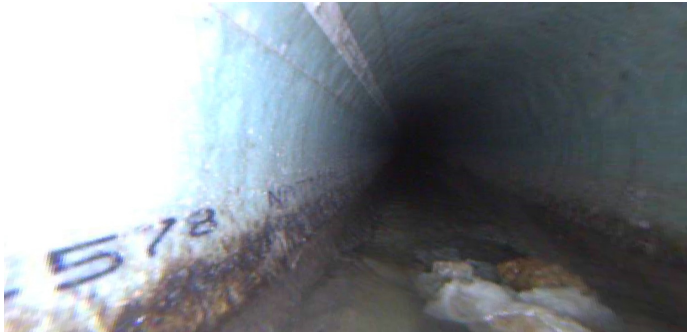
Code:	<b>MGO</b>
Description:	<b>General Observation</b>
Distance (ft):	<b>.0</b>
Structural Grade:	<b>0</b>
O&M Grade:	<b>0</b>
Clock Start/From:	
Clock To:	
1st Value:	
2nd Value:	
Value Percent:	
Continuous Index:	
Within 8" of Joint:	<b>NO</b>
Remarks:	<b>TOILET TISSUE</b>

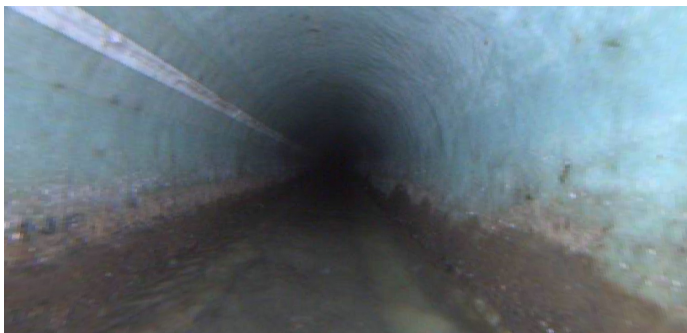
Code:	<b>DAZ</b>
Description:	<b>Deposits Attached Other</b>
Distance (ft):	<b>6.3</b>
Structural Grade:	<b>0</b>
O&M Grade:	<b>2</b>
Clock Start/From:	<b>7</b>
Clock To:	<b>5</b>
1st Value:	
2nd Value:	
Value Percent:	<b>5.000</b>
Continuous Index:	<b>S01</b>
Within 8" of Joint:	<b>YES</b>
Remarks:	<b>WANDER</b>

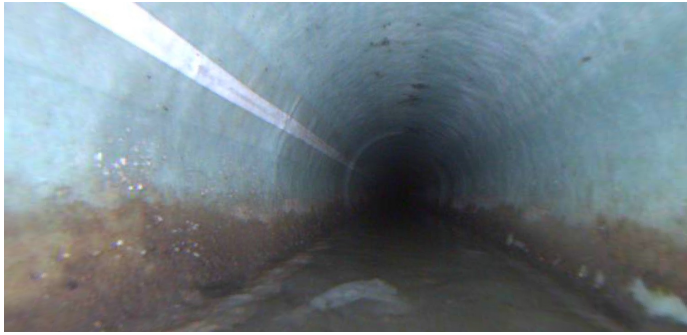
Code:	<b>LFAC</b>
Description:	<b>Lining Failure Abandoned Connection</b>
Distance (ft):	<b>14.5</b>
Structural Grade:	<b>0</b>
O&M Grade:	<b>0</b>
Clock Start/From:	<b>9</b>
Clock To:	
1st Value:	
2nd Value:	
Value Percent:	
Continuous Index:	
Within 8" of Joint:	<b>NO</b>
Remarks:

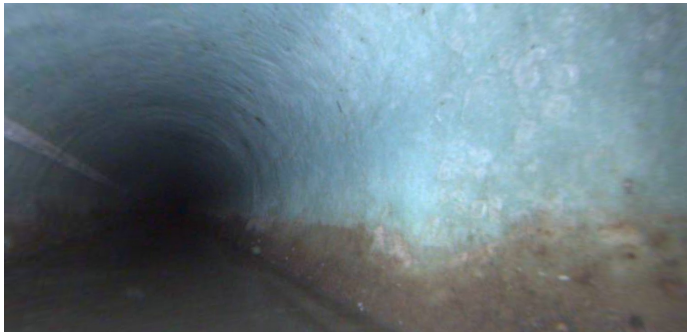
Code:	<b>LFAC</b>
Description:	<b>Lining Failure Abandoned Connection</b>
Distance (ft):	<b>16.9</b>
Structural Grade:	<b>0</b>
O&M Grade:	<b>0</b>
Clock Start/From:	<b>3</b>
Clock To:	
1st Value:	
2nd Value:	
Value Percent:	
Continuous Index:	
Within 8" of Joint:	<b>NO</b>
Remarks:

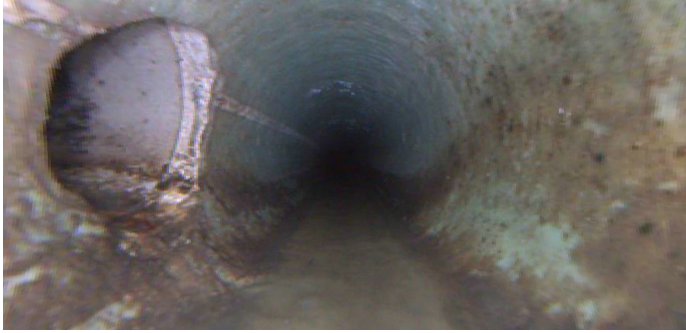
Code: **TF**  
Description: **Tap Factory**

Distance (ft): **30.1**  
Structural Grade: **0**  
O&M Grade: **0**  
Clock Start/From: **9**  
Clock To:  
1st Value: **4.000**  
2nd Value:  
Value Percent:  
Continuous Index:  
Within 8" of Joint:  
Remarks:

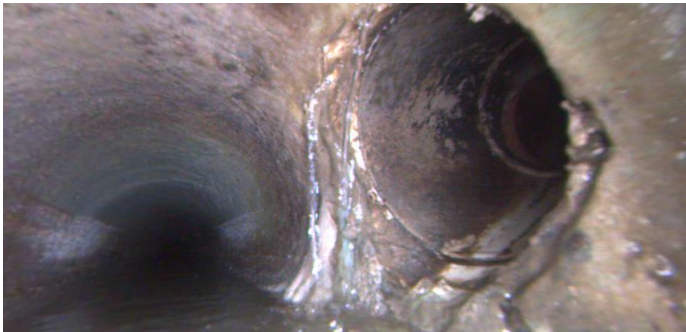
Code: **TFA**  
Description: **Tap Factory Active**

Distance (ft): **47.1**  
Structural Grade: **0**  
O&M Grade: **0**  
Clock Start/From: **3**  
Clock To:  
1st Value: **4.000**  
2nd Value:  
Value Percent:  
Continuous Index:  
Within 8" of Joint:  
Remarks:

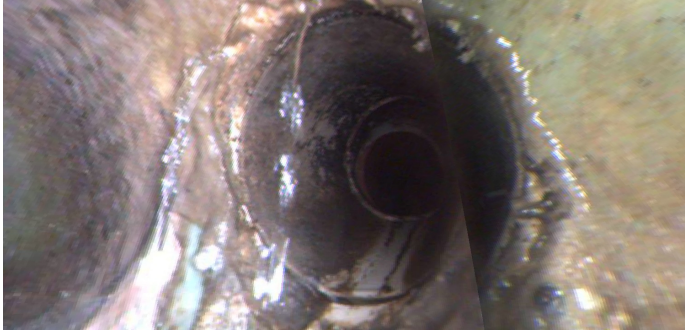
Code: ID  
Description: Infil Dripper

Distance (ft): 47.2  
Structural Grade: 0  
O&M Grade: 3  
Clock Start/From: 12  
Clock To:  
1st Value:  
2nd Value:  
Value Percent:  
Continuous Index:  
Within 8" of Joint:  
Remarks: COMING FROM TAP

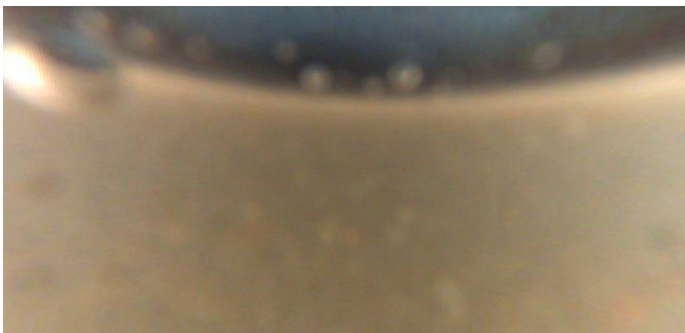
Code: MWLS  
Description: Water Level Sag

Distance (ft): 57.3  
Structural Grade: 3  
O&M Grade: 3  
Clock Start/From:  
Clock To:  
1st Value:  
2nd Value:  
Value Percent: 40.000  
Continuous Index:  
Within 8" of Joint: NO  
Remarks:

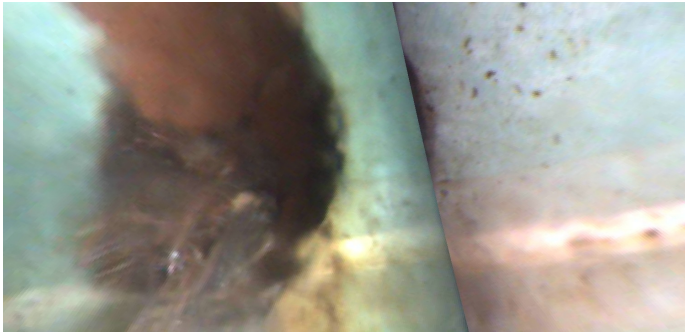
Code: **TFD**  
Description: **Tap Factory Defective**

Distance (ft): **84.3**  
Structural Grade: **0**  
O&M Grade: **2**  
Clock Start/From: **10**  
Clock To:  
1st Value: **4.000**  
2nd Value:  
Value Percent:  
Continuous Index:  
Within 8" of Joint:  
Remarks: **rfl**

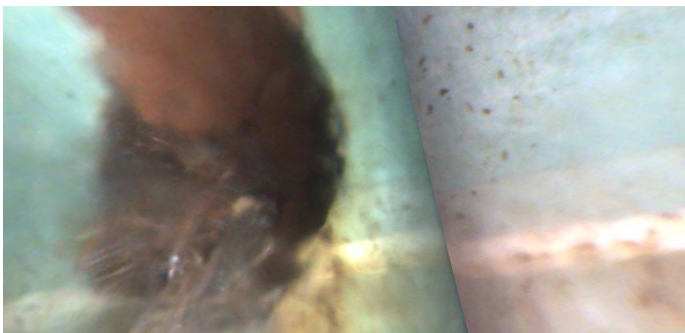
Code: **RFL**  
Description: **Roots Fine Lateral**

Distance (ft): **84.3**  
Structural Grade: **0**  
O&M Grade: **1**  
Clock Start/From: **10**  
Clock To:  
1st Value:  
2nd Value:  
Value Percent:  
Continuous Index:  
Within 8" of Joint: **NO**  
Remarks:

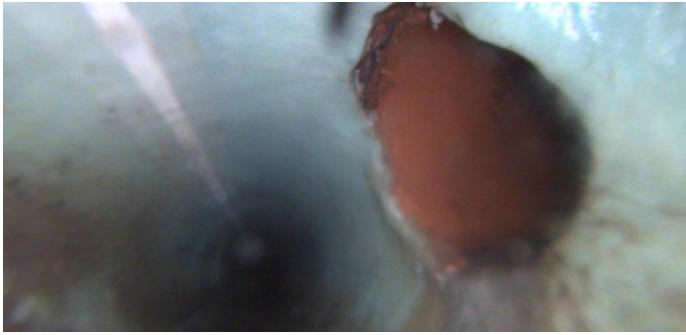
Code: **TF**  
Description: **Tap Factory**

Distance (ft): **95.9**  
Structural Grade: **0**  
O&M Grade: **0**  
Clock Start/From: **3**  
Clock To:  
1st Value: **4.000**  
2nd Value:  
Value Percent:  
Continuous Index:  
Within 8" of Joint:  
Remarks:

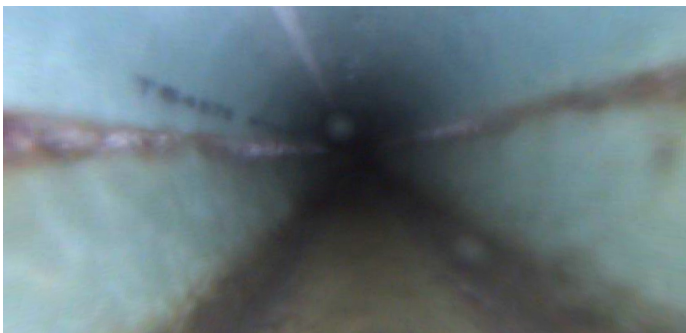
Code: **DAGS**  
Description: **Deposits Attached Grease**

Distance (ft): **127.4**  
Structural Grade: **0**  
O&M Grade: **2**  
Clock Start/From: **9**  
Clock To: **3**  
1st Value:  
2nd Value:  
Value Percent: **5.000**  
Continuous Index:  
Within 8" of Joint: **YES**  
Remarks:

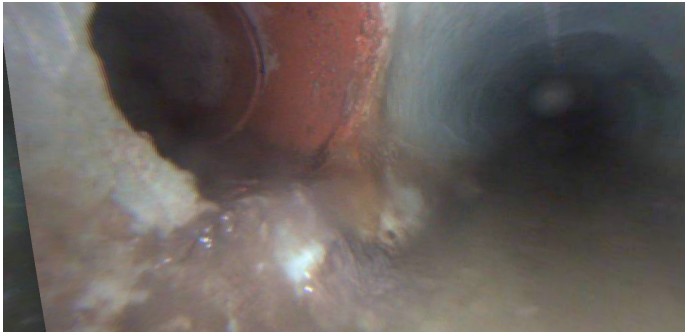
Code: **TF**  
Description: **Tap Factory**

Distance (ft): **181.6**  
Structural Grade: **0**  
O&M Grade: **0**  
Clock Start/From: **9**  
Clock To:  
1st Value: **4.000**  
2nd Value:  
Value Percent:  
Continuous Index:  
Within 8" of Joint:  
Remarks:

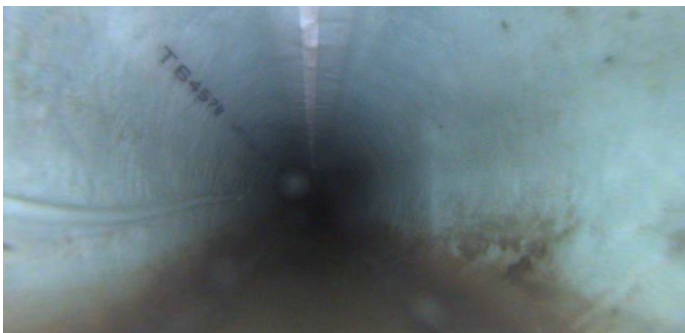
Code: **LFAC**  
Description: **Lining Failure Abandoned Connection**

Distance (ft): **183.1**  
Structural Grade: **0**  
O&M Grade: **0**  
Clock Start/From: **3**  
Clock To:  
1st Value:  
2nd Value:  
Value Percent:  
Continuous Index:  
Within 8" of Joint: **NO**  
Remarks:

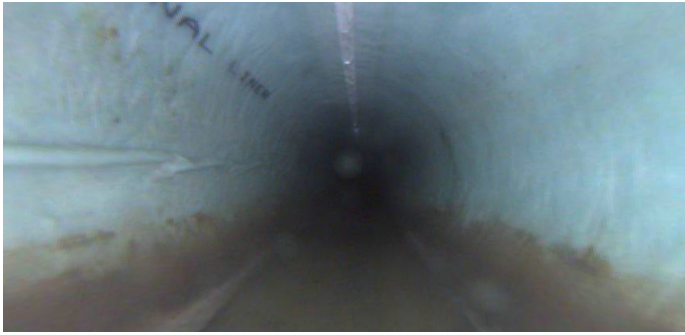
Code: **LFW**  
Description: **Lining Failure Wrinkled**

Distance (ft): **184.1**  
Structural Grade: **3**  
O&M Grade: **0**  
Clock Start/From: **9**  
Clock To:  
1st Value:  
2nd Value:  
Value Percent:  
Continuous Index:  
Within 8" of Joint: **NO**  
Remarks:

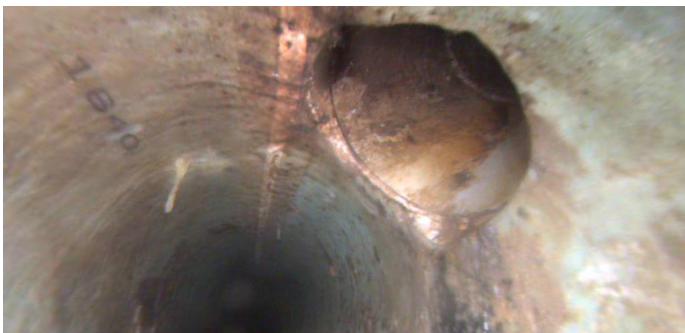
Code: **TF**  
Description: **Tap Factory**

Distance (ft): **205.7**  
Structural Grade: **0**  
O&M Grade: **0**  
Clock Start/From: **2**  
Clock To:  
1st Value: **4.000**  
2nd Value:  
Value Percent:  
Continuous Index:  
Within 8" of Joint:  
Remarks:

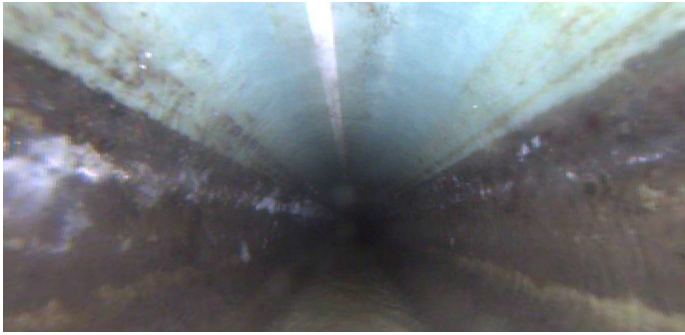
Code: **DAGS**  
Description: **Deposits Attached Grease**

Distance (ft): **269.6**  
Structural Grade: **0**  
O&M Grade: **2**  
Clock Start/From: **9**  
Clock To: **3**  
1st Value:  
2nd Value:  
Value Percent: **5.000**  
Continuous Index:  
Within 8" of Joint: **NO**  
Remarks:

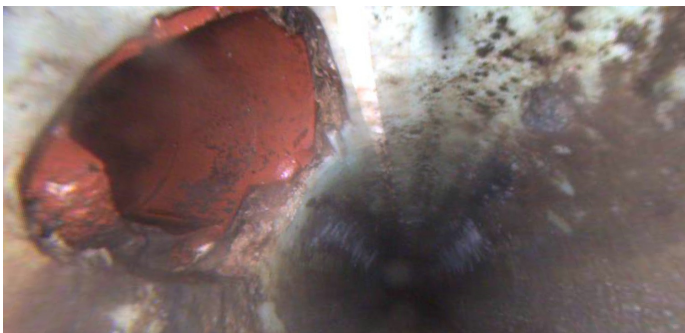
Code: **TB**  
Description: **Tap Break-in**

Distance (ft): **279.1**  
Structural Grade: **0**  
O&M Grade: **0**  
Clock Start/From: **10**  
Clock To:  
1st Value: **4.000**  
2nd Value:  
Value Percent:  
Continuous Index:  
Within 8" of Joint:  
Remarks:

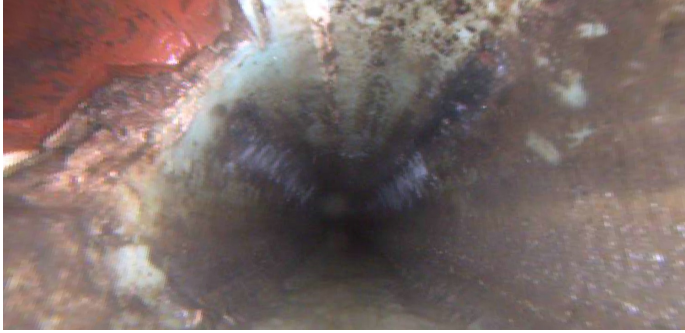
Code: **DAGS**  
Description: **Deposits Attached Grease**

Distance (ft): **279.4**  
Structural Grade: **0**  
O&M Grade: **2**  
Clock Start/From: **9**  
Clock To: **3**  
1st Value:  
2nd Value:  
Value Percent: **5.000**  
Continuous Index:  
Within 8" of Joint: **NO**  
Remarks:

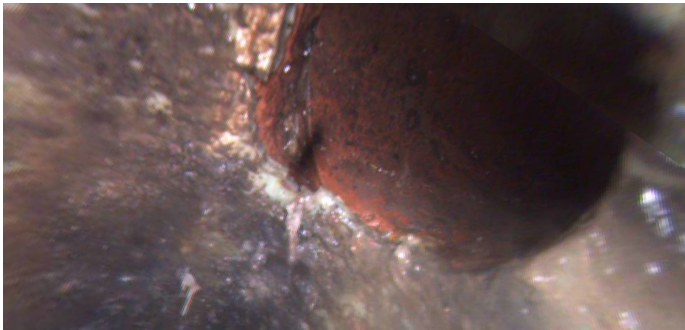
Code: **TF**  
Description: **Tap Factory**

Distance (ft): **286.8**  
Structural Grade: **0**  
O&M Grade: **0**  
Clock Start/From: **1**  
Clock To:  
1st Value: **4.000**  
2nd Value:  
Value Percent:  
Continuous Index:  
Within 8" of Joint:  
Remarks:

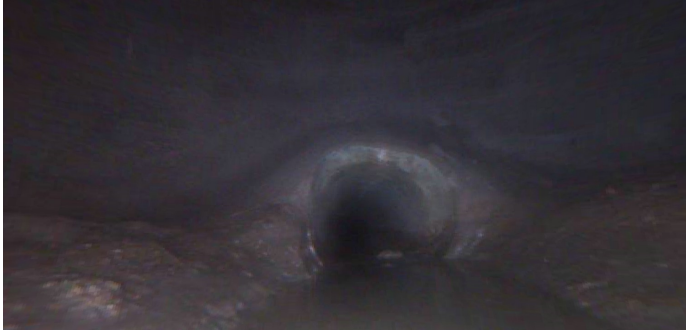
Code: **AMH**  
Description: **Manhole**

Distance (ft): **295.0**  
Structural Grade: **0**  
O&M Grade: **0**  
Clock Start/From:  
Clock To:  
1st Value:  
2nd Value:  
Value Percent:  
Continuous Index:  
Within 8" of Joint: **NO**  
Remarks: **M-305-004**

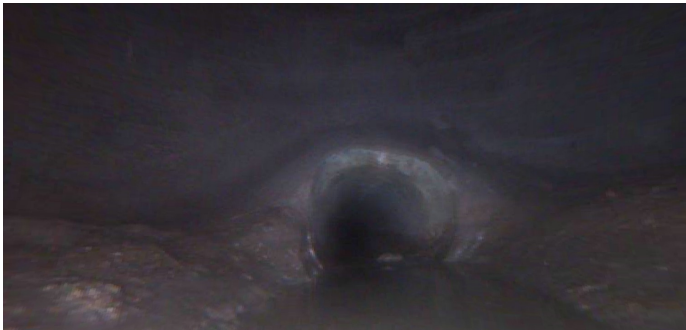
Code: **DAZ**  
Description: **Deposits Attached Other**

Distance (ft): **295.0**  
Structural Grade: **0**  
O&M Grade: **2**  
Clock Start/From: **7**  
Clock To: **5**  
1st Value:  
2nd Value:  
Value Percent: **5.000**  
Continuous Index: **F01**  
Within 8" of Joint: **YES**  
Remarks: **WANDER**
