Profile/Photo Observation Report

Date:	04/19/2018	Weather:		Coding:	PACP 6.0
Pipe Length (ft):	298.5	Owner:	NA	Pre Clean:	No Pre-Cleaning
P.O.#:		Surveyor:	Justin Gonzales	PSR:	P-305-005-004
Customer:		Clean Date:	01/01/1900	Shape:	C

Street:	FOXCROFT STREET	Flow Control:	Not Controlled
City:	Hobart, IN	Year Renewed:	
Location:	Yard	Tape/Media #:	
Purpose:	Routine Assessment	Dia/Height:	10"
Use:	Sanitary	Material:	PVC
Drain Area:	NA	Lining:	Cured in Place
Category:	NA		
Comment:

Location Details:		Direction of Survey:	Downstream
US MH:	M-305-005	DS MH:	M-305-004
		Total Length Surveyed (ft):	295.0

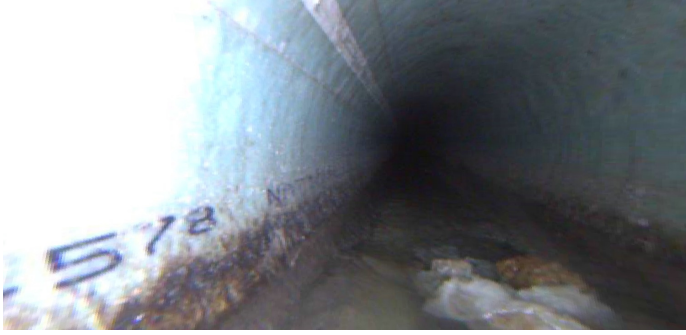
Code:	AMH
Description:	Manhole
Distance (ft):	.0
Structural Grade:	0
O&M Grade:	0
Clock Start/From:	
Clock To:	
1st Value:	
2nd Value:	
Value Percent:	
Continuous Index:	
Within 8" of Joint:	NO
Remarks:	M-305-005

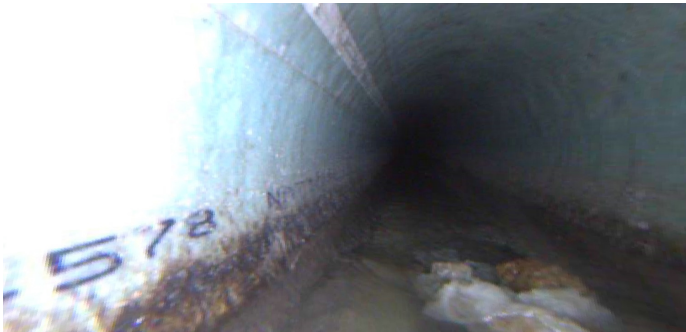
Code:	MWL
Description:	Water Level
Distance (ft):	.0
Structural Grade:	0
O&M Grade:	0
Clock Start/From:	
Clock To:	
1st Value:	
2nd Value:	
Value Percent:	10.000
Continuous Index:	
Within 8" of Joint:	NO
Remarks:

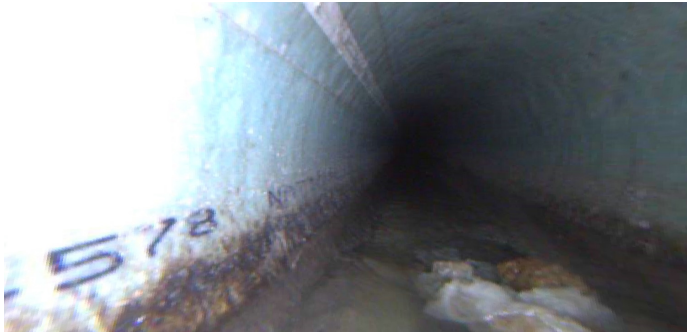
Code:	MGO
Description:	General Observation
Distance (ft):	.0
Structural Grade:	0
O&M Grade:	0
Clock Start/From:	
Clock To:	
1st Value:	
2nd Value:	
Value Percent:	
Continuous Index:	
Within 8" of Joint:	NO
Remarks:	TOILET TISSUE

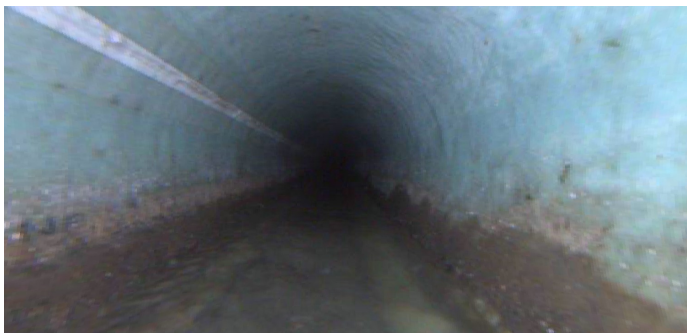
Code:	DAZ
Description:	Deposits Attached Other
Distance (ft):	6.3
Structural Grade:	0
O&M Grade:	2
Clock Start/From:	7
Clock To:	5
1st Value:	
2nd Value:	
Value Percent:	5.000
Continuous Index:	S01
Within 8" of Joint:	YES
Remarks:	WANDER

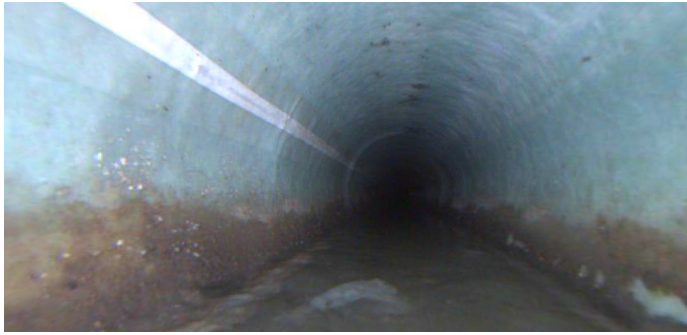
Code:	LFAC
Description:	Lining Failure Abandoned Connection
Distance (ft):	14.5
Structural Grade:	0
O&M Grade:	0
Clock Start/From:	9
Clock To:	
1st Value:	
2nd Value:	
Value Percent:	
Continuous Index:	
Within 8" of Joint:	NO
Remarks:

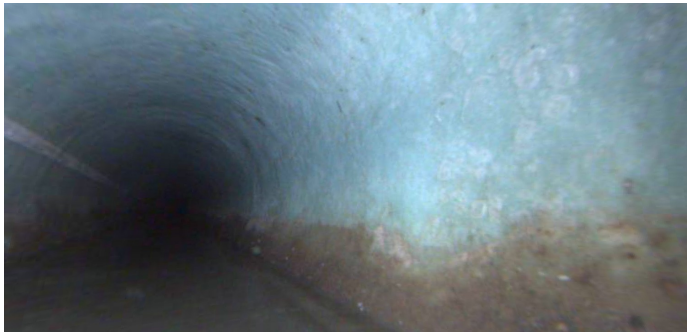
Code:	LFAC
Description:	Lining Failure Abandoned Connection
Distance (ft):	16.9
Structural Grade:	0
O&M Grade:	0
Clock Start/From:	3
Clock To:	
1st Value:	
2nd Value:	
Value Percent:	
Continuous Index:	
Within 8" of Joint:	NO
Remarks:

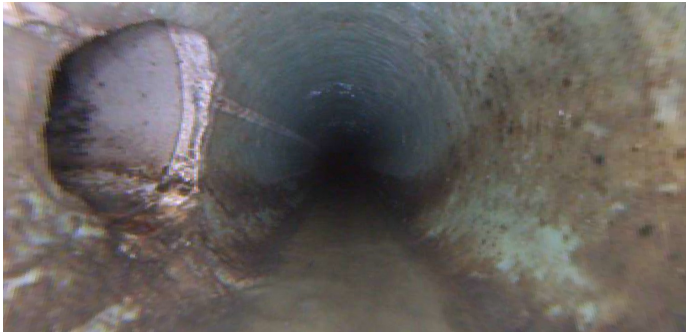
Code: **TF**
Description: **Tap Factory**

Distance (ft): **30.1**
Structural Grade: **0**
O&M Grade: **0**
Clock Start/From: **9**
Clock To:
1st Value: **4.000**
2nd Value:
Value Percent:
Continuous Index:
Within 8" of Joint:
Remarks:

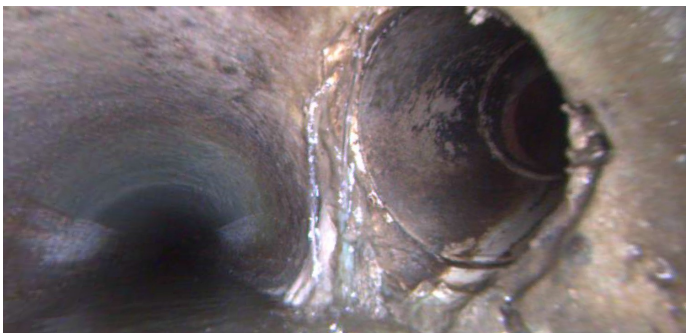
Code: **TFA**
Description: **Tap Factory Active**

Distance (ft): **47.1**
Structural Grade: **0**
O&M Grade: **0**
Clock Start/From: **3**
Clock To:
1st Value: **4.000**
2nd Value:
Value Percent:
Continuous Index:
Within 8" of Joint:
Remarks:

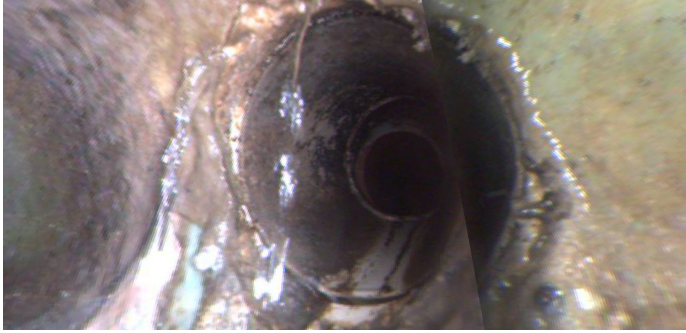
Code: ID
Description: Infil Dripper

Distance (ft): 47.2
Structural Grade: 0
O&M Grade: 3
Clock Start/From: 12
Clock To:
1st Value:
2nd Value:
Value Percent:
Continuous Index:
Within 8" of Joint:
Remarks: COMING FROM TAP

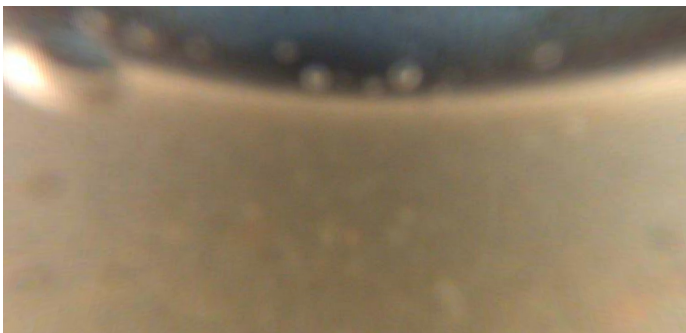
Code: MWLS
Description: Water Level Sag

Distance (ft): 57.3
Structural Grade: 3
O&M Grade: 3
Clock Start/From:
Clock To:
1st Value:
2nd Value:
Value Percent: 40.000
Continuous Index:
Within 8" of Joint: NO
Remarks:

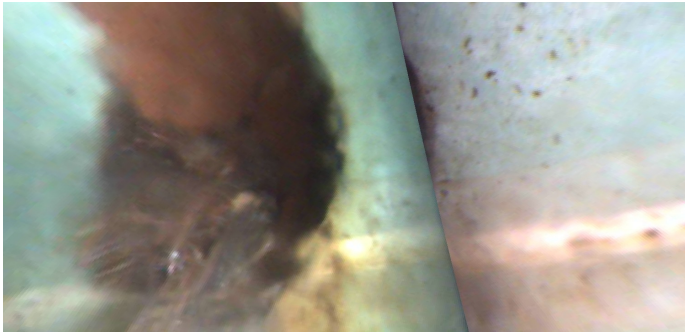
Code: **TFD**
Description: **Tap Factory Defective**

Distance (ft): **84.3**
Structural Grade: **0**
O&M Grade: **2**
Clock Start/From: **10**
Clock To:
1st Value: **4.000**
2nd Value:
Value Percent:
Continuous Index:
Within 8" of Joint:
Remarks: **rfl**

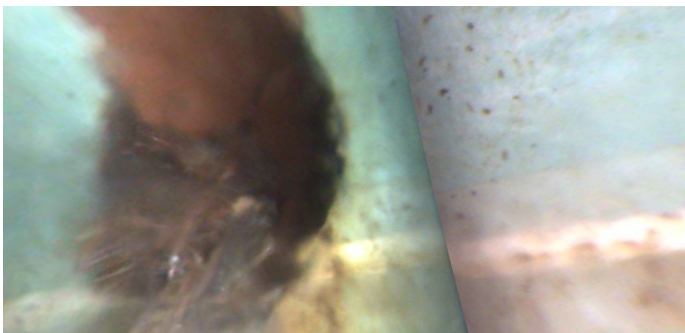
Code: **RFL**
Description: **Roots Fine Lateral**

Distance (ft): **84.3**
Structural Grade: **0**
O&M Grade: **1**
Clock Start/From: **10**
Clock To:
1st Value:
2nd Value:
Value Percent:
Continuous Index:
Within 8" of Joint: **NO**
Remarks:

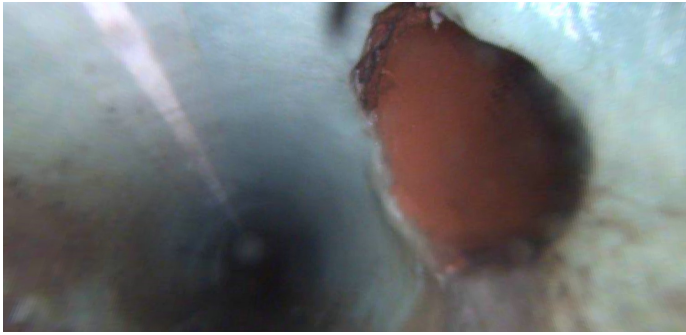
Code: **TF**
Description: **Tap Factory**

Distance (ft): **95.9**
Structural Grade: **0**
O&M Grade: **0**
Clock Start/From: **3**
Clock To:
1st Value: **4.000**
2nd Value:
Value Percent:
Continuous Index:
Within 8" of Joint:
Remarks:

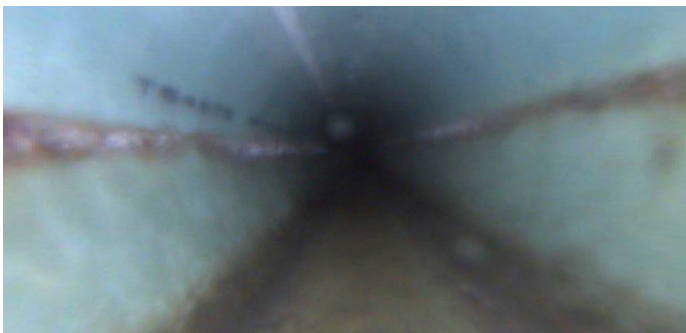
Code: **DAGS**
Description: **Deposits Attached Grease**

Distance (ft): **127.4**
Structural Grade: **0**
O&M Grade: **2**
Clock Start/From: **9**
Clock To: **3**
1st Value:
2nd Value:
Value Percent: **5.000**
Continuous Index:
Within 8" of Joint: **YES**
Remarks:

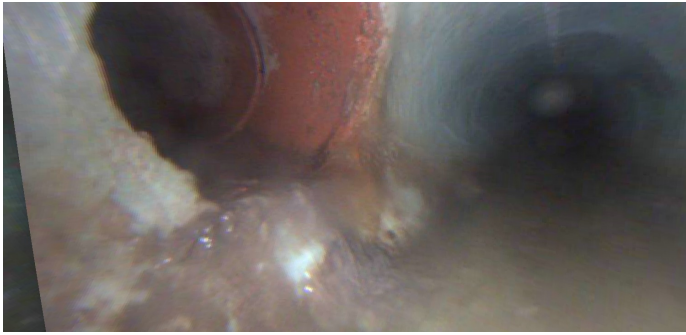
Code: **TF**
Description: **Tap Factory**

Distance (ft): **181.6**
Structural Grade: **0**
O&M Grade: **0**
Clock Start/From: **9**
Clock To:
1st Value: **4.000**
2nd Value:
Value Percent:
Continuous Index:
Within 8" of Joint:
Remarks:

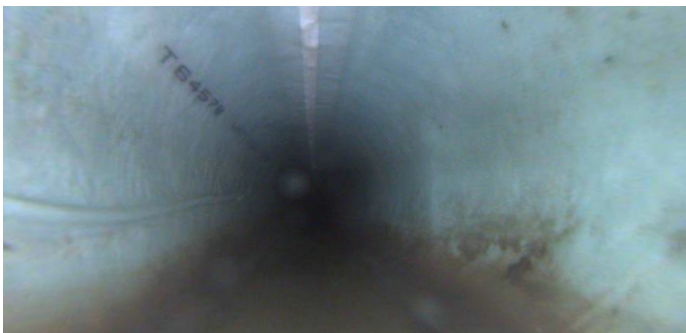
Code: **LFAC**
Description: **Lining Failure Abandoned Connection**

Distance (ft): **183.1**
Structural Grade: **0**
O&M Grade: **0**
Clock Start/From: **3**
Clock To:
1st Value:
2nd Value:
Value Percent:
Continuous Index:
Within 8" of Joint: **NO**
Remarks:

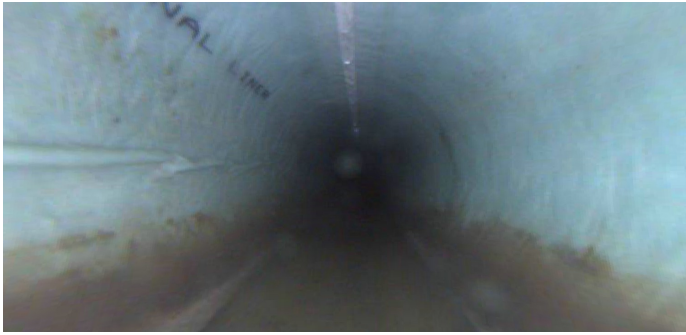
Code: **LFW**
Description: **Lining Failure Wrinkled**

Distance (ft): **184.1**
Structural Grade: **3**
O&M Grade: **0**
Clock Start/From: **9**
Clock To:
1st Value:
2nd Value:
Value Percent:
Continuous Index:
Within 8" of Joint: **NO**
Remarks:

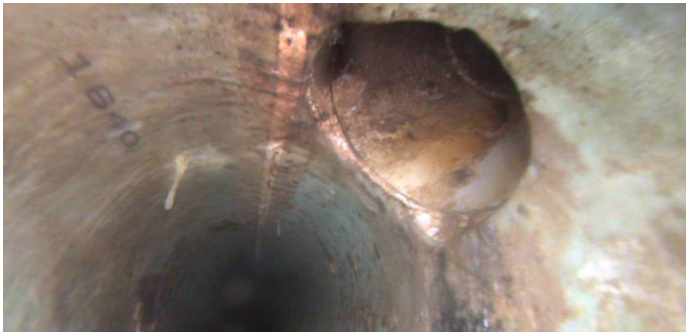
Code: **TF**
Description: **Tap Factory**

Distance (ft): **205.7**
Structural Grade: **0**
O&M Grade: **0**
Clock Start/From: **2**
Clock To:
1st Value: **4.000**
2nd Value:
Value Percent:
Continuous Index:
Within 8" of Joint:
Remarks:

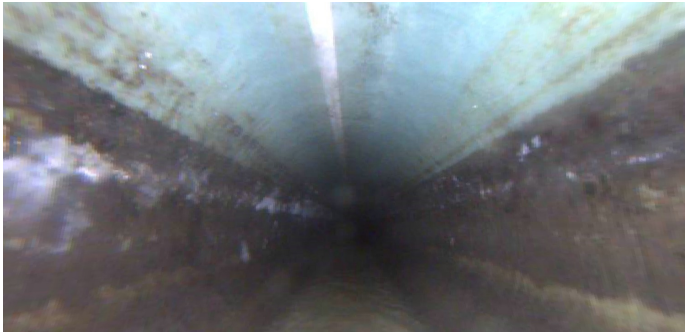
Code: **DAGS**
Description: **Deposits Attached Grease**

Distance (ft): **269.6**
Structural Grade: **0**
O&M Grade: **2**
Clock Start/From: **9**
Clock To: **3**
1st Value:
2nd Value:
Value Percent: **5.000**
Continuous Index:
Within 8" of Joint: **NO**
Remarks:

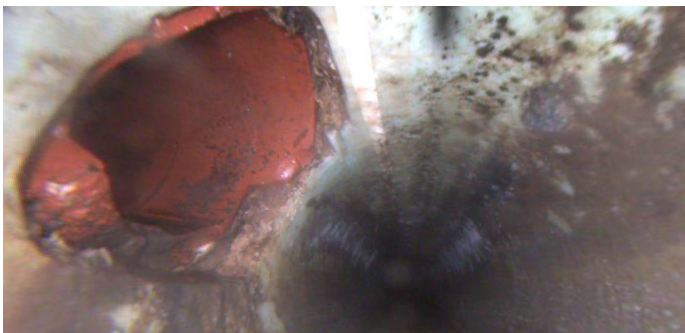
Code: **TB**
Description: **Tap Break-in**

Distance (ft): **279.1**
Structural Grade: **0**
O&M Grade: **0**
Clock Start/From: **10**
Clock To:
1st Value: **4.000**
2nd Value:
Value Percent:
Continuous Index:
Within 8" of Joint:
Remarks:

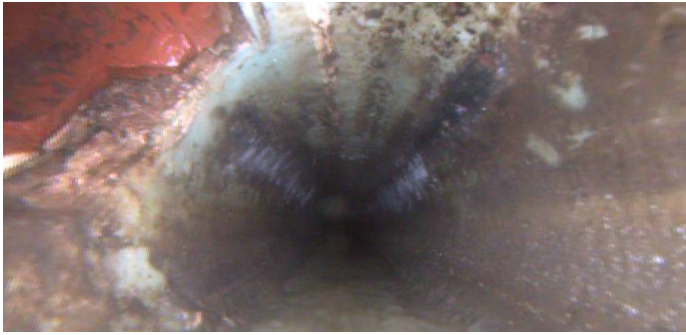
Code: **DAGS**
Description: **Deposits Attached Grease**

Distance (ft): **279.4**
Structural Grade: **0**
O&M Grade: **2**
Clock Start/From: **9**
Clock To: **3**
1st Value:
2nd Value:
Value Percent: **5.000**
Continuous Index:
Within 8" of Joint: **NO**
Remarks:

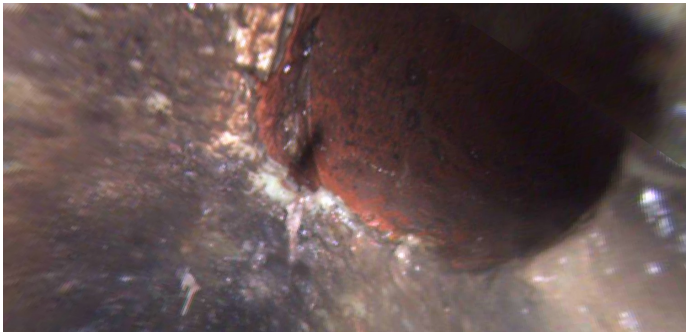
Code: **TF**
Description: **Tap Factory**

Distance (ft): **286.8**
Structural Grade: **0**
O&M Grade: **0**
Clock Start/From: **1**
Clock To:
1st Value: **4.000**
2nd Value:
Value Percent:
Continuous Index:
Within 8" of Joint:
Remarks:

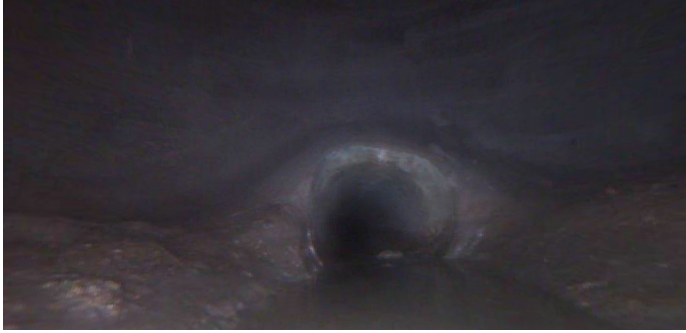
Code: **AMH**
Description: **Manhole**

Distance (ft): **295.0**
Structural Grade: **0**
O&M Grade: **0**
Clock Start/From:
Clock To:
1st Value:
2nd Value:
Value Percent:
Continuous Index:
Within 8" of Joint: **NO**
Remarks: **M-305-004**

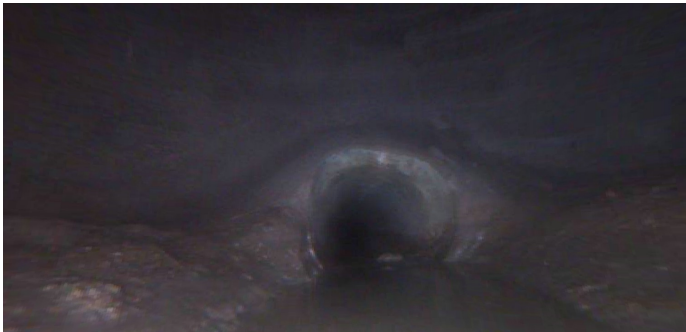
Code: **DAZ**
Description: **Deposits Attached Other**

Distance (ft): **295.0**
Structural Grade: **0**
O&M Grade: **2**
Clock Start/From: **7**
Clock To: **5**
1st Value:
2nd Value:
Value Percent: **5.000**
Continuous Index: **F01**
Within 8" of Joint: **YES**
Remarks: **WANDER**
