Profile/Photo Observation Report

Street:	WILDROSE DR	Flow Control:	Not Controlled
City:	Hobart, IN	Year Renewed:	
Location:	Yard	Tape/Media #:	
Purpose:	Routine Assessment	Dia/Height:	10"
Use:	Sanitary	Material:	PVC
Drain Area:	NA	Lining:	Cured in Place
Category:	NA		
Comment:

Location Details:		Direction of Survey:	Upstream
US MH:	M-305-006	DS MH:	M-305-005
		Total Length Surveyed (ft):	294.2

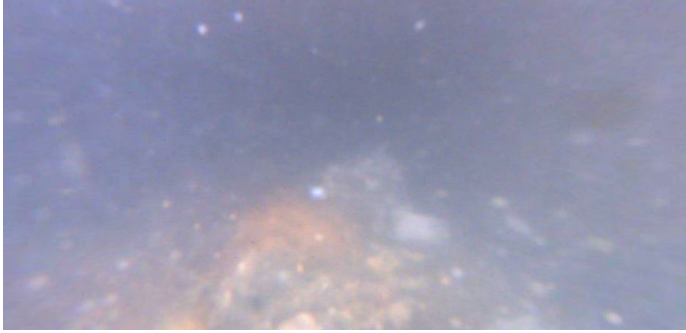
Code: **AMH**
Description: **Manhole**

Distance (ft): **.0**
Structural Grade: **0**
O&M Grade: **0**
Clock Start/From:
Clock To:
1st Value:
2nd Value:
Value Percent:
Continuous Index:
Within 8" of Joint: **NO**
Remarks: **M-305-005**

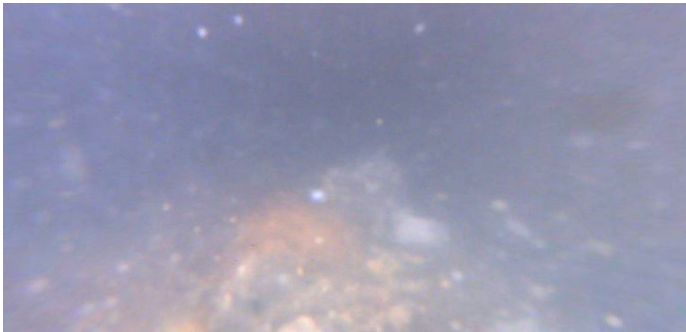
Code: **MWL**
Description: **Water Level**

Distance (ft): **.0**
Structural Grade: **0**
O&M Grade: **0**
Clock Start/From:
Clock To:
1st Value:
2nd Value:
Value Percent: **100.000**
Continuous Index:
Within 8" of Joint: **NO**
Remarks:

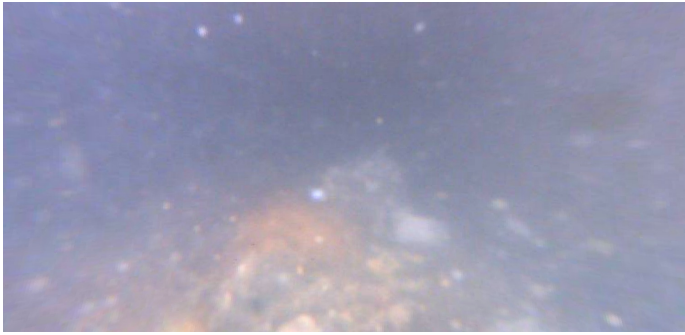
Code: **MGO**
Description: **General Observation**

Distance (ft): **.0**
Structural Grade: **0**
O&M Grade: **0**
Clock Start/From:
Clock To:
1st Value:
2nd Value:
Value Percent:
Continuous Index:
Within 8" of Joint: **NO**
Remarks: **FLOW TO HIGH**

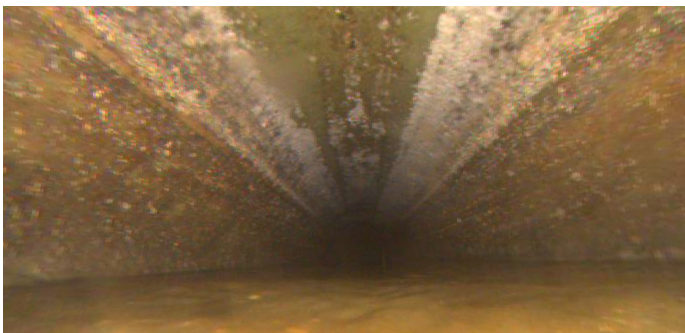
Code: **DAGS**
Description: **Deposits Attached Grease**

Distance (ft): **3.2**
Structural Grade: **0**
O&M Grade: **2**
Clock Start/From: **7**
Clock To: **5**
1st Value:
2nd Value:
Value Percent: **5.000**
Continuous Index: **S02**
Within 8" of Joint: **YES**
Remarks: **WANDER**

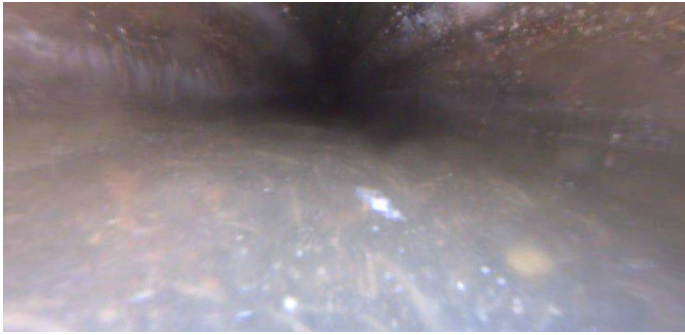
Code: **MGO**
Description: **General Observation**

Distance (ft): **4.4**
Structural Grade: **0**
O&M Grade: **0**
Clock Start/From:
Clock To:
1st Value:
2nd Value:
Value Percent:
Continuous Index:
Within 8" of Joint: **NO**
Remarks: **FRONT FLOW SUBSIDED;
RETURNING TO FRONT CAMERA**

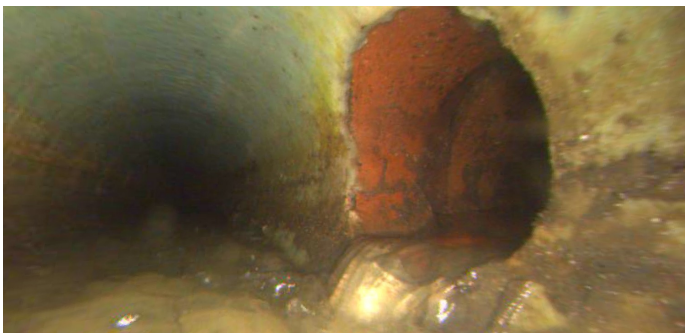
Code: **TFA**
Description: **Tap Factory Active**

Distance (ft): **61.6**
Structural Grade: **0**
O&M Grade: **0**
Clock Start/From: **9**
Clock To:
1st Value: **4.000**
2nd Value:
Value Percent:
Continuous Index:
Within 8" of Joint:
Remarks:

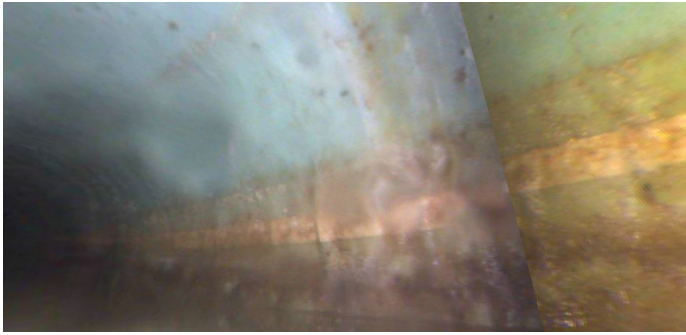
Code: **LFW**
Description: **Lining Failure Wrinkled**

Distance (ft): **61.6**
Structural Grade: **3**
O&M Grade: **0**
Clock Start/From: **3**
Clock To:
1st Value:
2nd Value:
Value Percent:
Continuous Index:
Within 8" of Joint: **NO**
Remarks:

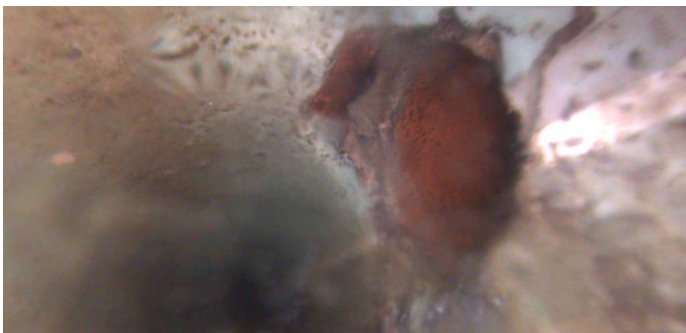
Code: **TB**
Description: **Tap Break-in**

Distance (ft): **74.4**
Structural Grade: **0**
O&M Grade: **0**
Clock Start/From: **10**
Clock To:
1st Value: **4.000**
2nd Value:
Value Percent:
Continuous Index:
Within 8" of Joint:
Remarks:

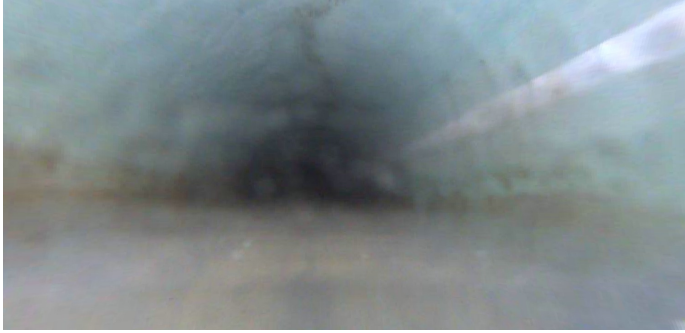
Code: **MWLS**
Description: **Water Level Sag**

Distance (ft): **106.8**
Structural Grade: **2**
O&M Grade: **3**
Clock Start/From:
Clock To:
1st Value:
2nd Value:
Value Percent: **15.000**
Continuous Index:
Within 8" of Joint: **NO**
Remarks:

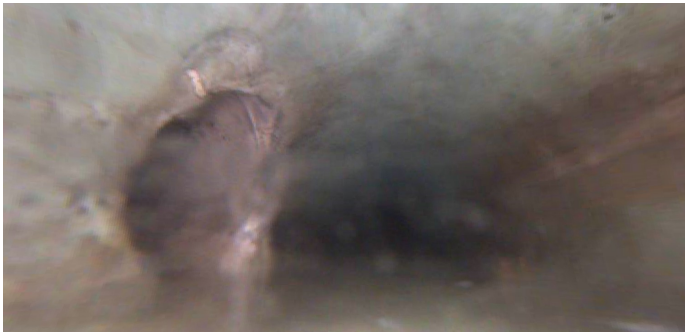
Code: **TF**
Description: **Tap Factory**

Distance (ft): **111.5**
Structural Grade: **0**
O&M Grade: **0**
Clock Start/From: **9**
Clock To:
1st Value: **4.000**
2nd Value:
Value Percent:
Continuous Index:
Within 8" of Joint:
Remarks:

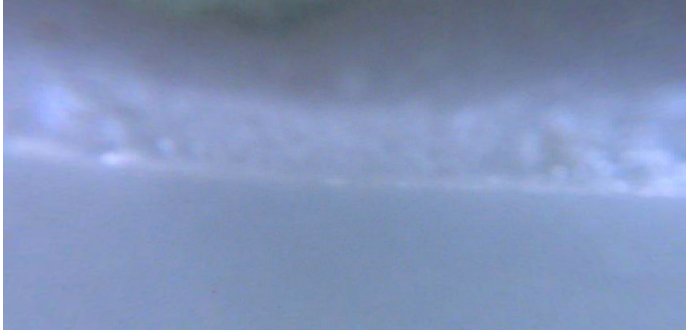
Code: **MWLS**
Description: **Water Level Sag**

Distance (ft): **119.6**
Structural Grade: **4**
O&M Grade: **3**
Clock Start/From:
Clock To:
1st Value:
2nd Value:
Value Percent: **70.000**
Continuous Index:
Within 8" of Joint: **NO**
Remarks:

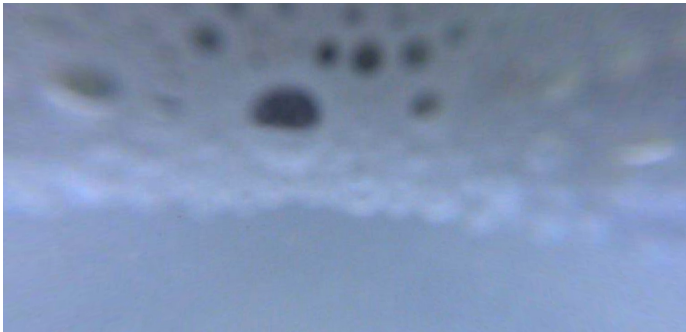
Code: **MGO**
Description: **General Observation**

Distance (ft): **121.8**
Structural Grade: **0**
O&M Grade: **0**
Clock Start/From:
Clock To:
1st Value:
2nd Value:
Value Percent:
Continuous Index:
Within 8" of Joint: **NO**
Remarks: **FLOW TO HIGH**

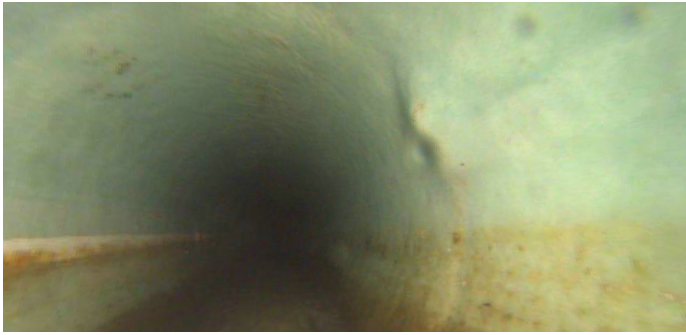
Code: **LFBU**
Description: **Lining Failure Bulges**

Distance (ft): **129.2**
Structural Grade: **0**
O&M Grade: **0**
Clock Start/From: **10**
Clock To:
1st Value:
2nd Value:
Value Percent:
Continuous Index:
Within 8" of Joint: **NO**
Remarks:

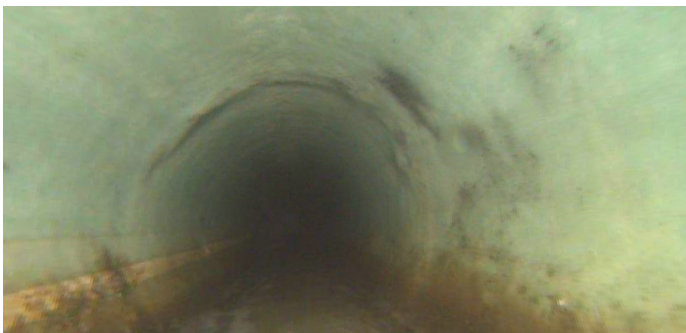
Code: **LFBU**
Description: **Lining Failure Bulges**

Distance (ft): **139.5**
Structural Grade: **0**
O&M Grade: **0**
Clock Start/From: **10**
Clock To: **2**
1st Value:
2nd Value:
Value Percent:
Continuous Index:
Within 8" of Joint: **NO**
Remarks:

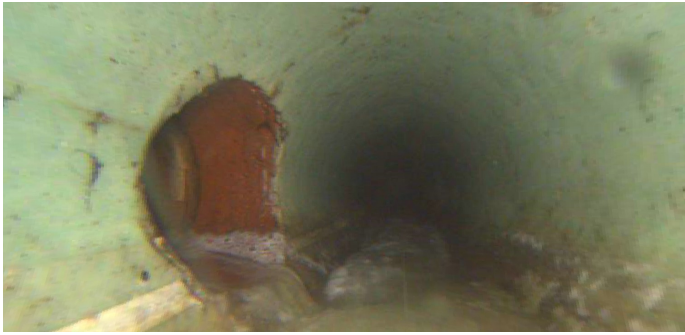
Code: **TFA**
Description: **Tap Factory Active**

Distance (ft): **147.9**
Structural Grade: **0**
O&M Grade: **0**
Clock Start/From: **3**
Clock To:
1st Value: **6.000**
2nd Value:
Value Percent:
Continuous Index:
Within 8" of Joint:
Remarks:

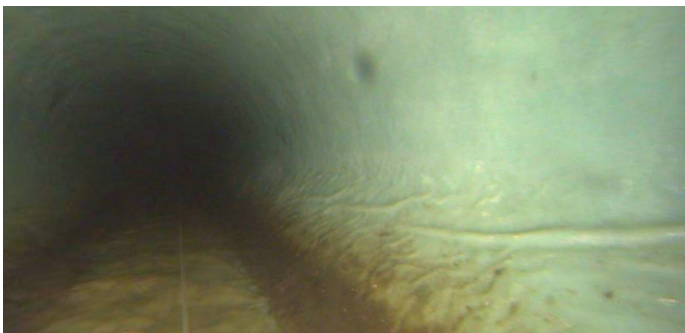
Code: **LFW**
Description: **Lining Failure Wrinkled**

Distance (ft): **167.3**
Structural Grade: **3**
O&M Grade: **0**
Clock Start/From: **7**
Clock To:
1st Value:
2nd Value:
Value Percent:
Continuous Index:
Within 8" of Joint: **NO**
Remarks:

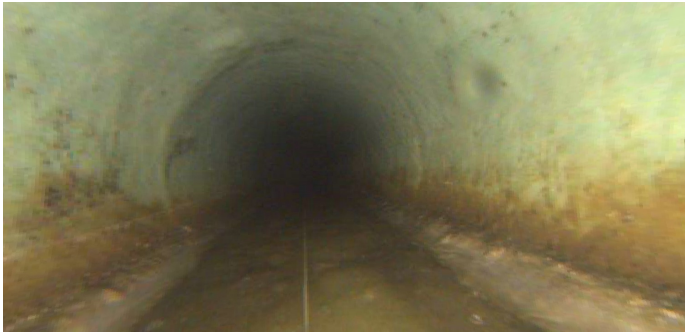
Code: **LFBU**
Description: **Lining Failure Bulges**

Distance (ft): **188.9**
Structural Grade: **0**
O&M Grade: **0**
Clock Start/From: **12**
Clock To: **4**
1st Value:
2nd Value:
Value Percent:
Continuous Index:
Within 8" of Joint: **NO**
Remarks:

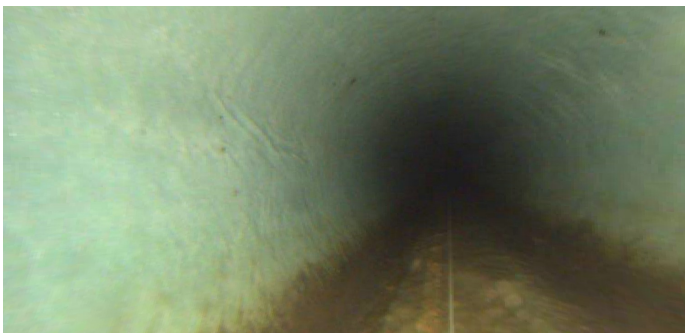
Code: **LFW**
Description: **Lining Failure Wrinkled**

Distance (ft): **202.3**
Structural Grade: **3**
O&M Grade: **0**
Clock Start/From: **3**
Clock To:
1st Value:
2nd Value:
Value Percent:
Continuous Index:
Within 8" of Joint: **NO**
Remarks:

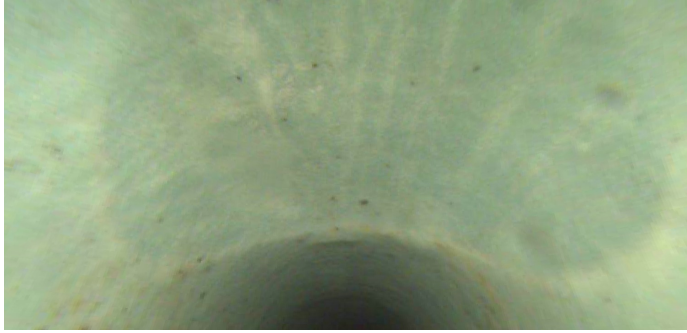
Code:	LFAC
Description:	Lining Failure Abandoned Connection
Distance (ft):	234.8
Structural Grade:	0
O&M Grade:	0
Clock Start/From:	12
Clock To:	
1st Value:	
2nd Value:	
Value Percent:	
Continuous Index:	
Within 8" of Joint:	NO
Remarks:

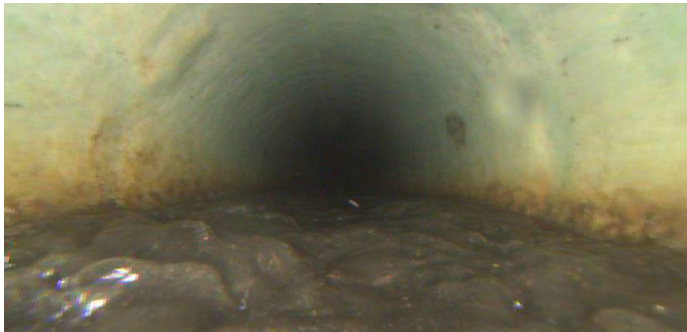
Code:	MWL
Description:	Water Level
Distance (ft):	256.0
Structural Grade:	0
O&M Grade:	0
Clock Start/From:	
Clock To:	
1st Value:	
2nd Value:	
Value Percent:	15.000
Continuous Index:	
Within 8" of Joint:	NO
Remarks:

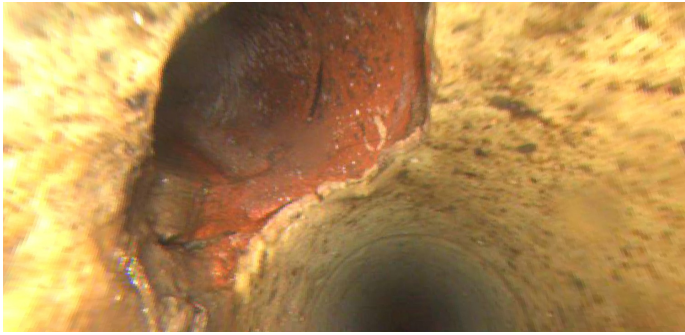
Code: **TF**
Description: **Tap Factory**

Distance (ft): **286.5**
Structural Grade: **0**
O&M Grade: **0**
Clock Start/From: **2**
Clock To:
1st Value: **6.000**
2nd Value:
Value Percent:
Continuous Index:
Within 8" of Joint:
Remarks:

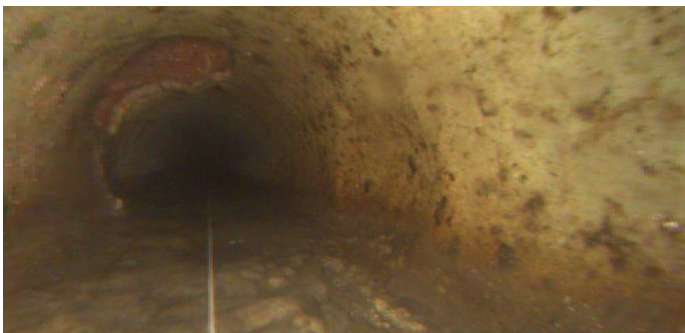
Code: **MGO**
Description: **General Observation**

Distance (ft): **287.4**
Structural Grade: **0**
O&M Grade: **0**
Clock Start/From:
Clock To:
1st Value:
2nd Value:
Value Percent:
Continuous Index:
Within 8" of Joint: **NO**
Remarks: **IMPRINT OF TAP**

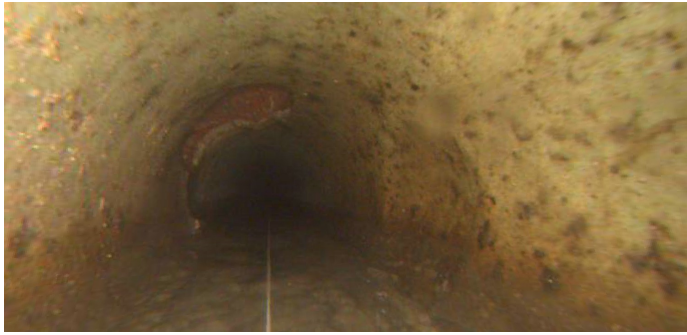
Code: **LFAC**
Description: **Lining Failure Abandoned Connection**

Distance (ft): **287.5**
Structural Grade: **0**
O&M Grade: **0**
Clock Start/From: **9**
Clock To:
1st Value:
2nd Value:
Value Percent:
Continuous Index:
Within 8" of Joint: **NO**
Remarks:

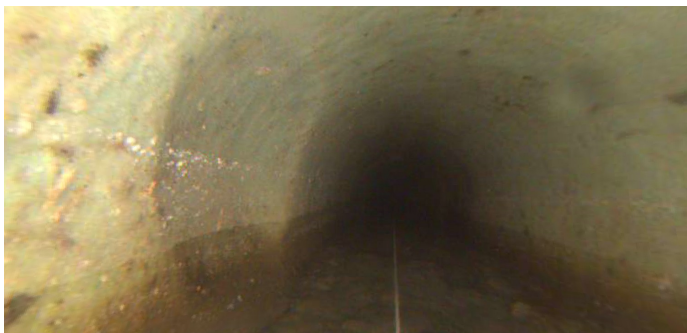
Code: **LFAC**
Description: **Lining Failure Abandoned Connection**

Distance (ft): **289.3**
Structural Grade: **0**
O&M Grade: **0**
Clock Start/From: **3**
Clock To:
1st Value:
2nd Value:
Value Percent:
Continuous Index:
Within 8" of Joint: **NO**
Remarks:

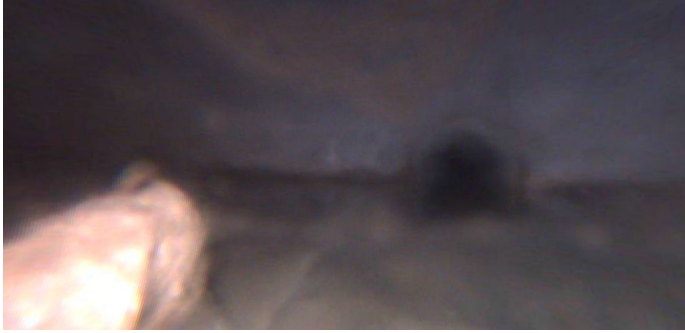
Code: **AMH**
Description: **Manhole**

Distance (ft): **294.2**
Structural Grade: **0**
O&M Grade: **0**
Clock Start/From:
Clock To:
1st Value:
2nd Value:
Value Percent:
Continuous Index:
Within 8" of Joint: **NO**
Remarks: **M-305-006**

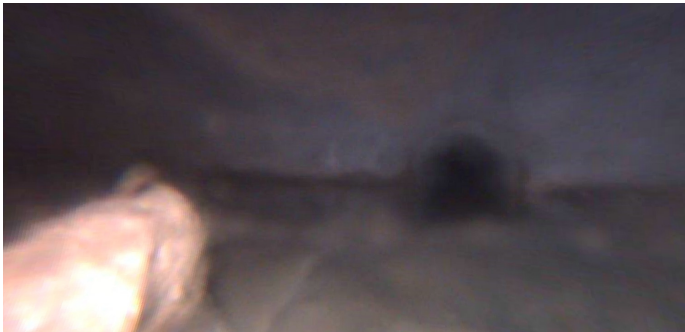
Code: **DAGS**
Description: **Deposits Attached Grease**

Distance (ft): **294.2**
Structural Grade: **0**
O&M Grade: **2**
Clock Start/From: **7**
Clock To: **5**
1st Value:
2nd Value:
Value Percent: **5.000**
Continuous Index: **F02**
Within 8" of Joint: **YES**
Remarks: **WANDER**
