## Profile/Photo Observation Report

Date:	<b>04/19/2018</b>	Weather:		Coding:	<b>PACP 6.0</b>
Pipe Length (ft):	<b>296.0</b>	Owner:	<b>NA</b>	Pre Clean:	<b>No Pre-Cleaning</b>
P.O.#:		Surveyor:	<b>Justin Gonzales</b>	PSR:	<b>P-305-006-005</b>
Customer:		Clean Date:	<b>01/01/1900</b>	Shape:	<b>C</b>

Street:	<b>FOXCROFT STREET</b>	Flow Control:	<b>Not Controlled</b>
City:	<b>Hobart, IN</b>	Year Renewed:	
Location:	<b>Yard</b>	Tape/Media #:	
Purpose:	<b>Routine Assessment</b>	Dia/Height:	<b>10"</b>
Use:	<b>Sanitary</b>	Material:	<b>PVC</b>
Drain Area:	<b>NA</b>	Lining:	<b>Cured in Place</b>
Category:	<b>NA</b>		
Comment:

Location Details:		Direction of Survey:	<b>Upstream</b>
US MH:	<b>M-305-006</b>	DS MH:	<b>M-305-005</b>
		Total Length Surveyed (ft):	<b>294.2</b>

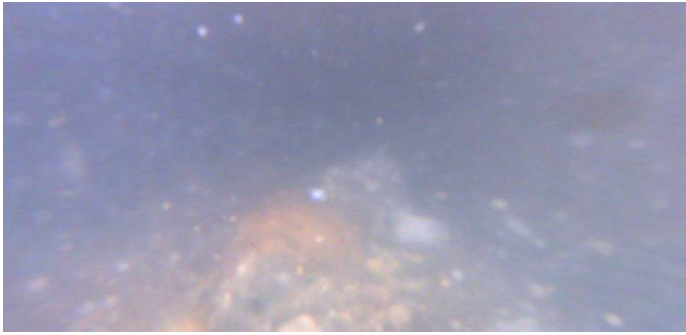
Code: **AMH**  
Description: **Manhole**

Distance (ft): **.0**  
Structural Grade: **0**  
O&M Grade: **0**  
Clock Start/From:  
Clock To:  
1st Value:  
2nd Value:  
Value Percent:  
Continuous Index:  
Within 8" of Joint: **NO**  
Remarks: **M-305-005**

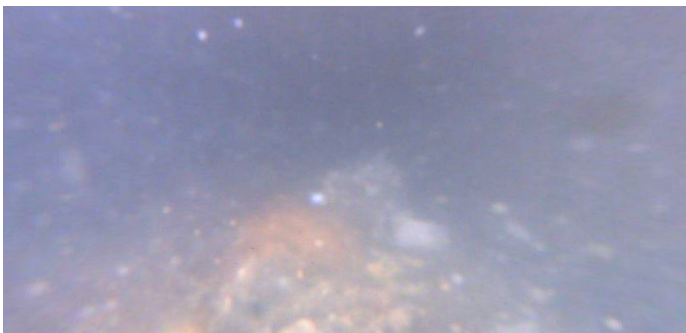
Code: **MWL**  
Description: **Water Level**

Distance (ft): **.0**  
Structural Grade: **0**  
O&M Grade: **0**  
Clock Start/From:  
Clock To:  
1st Value:  
2nd Value:  
Value Percent: **100.000**  
Continuous Index:  
Within 8" of Joint: **NO**  
Remarks:

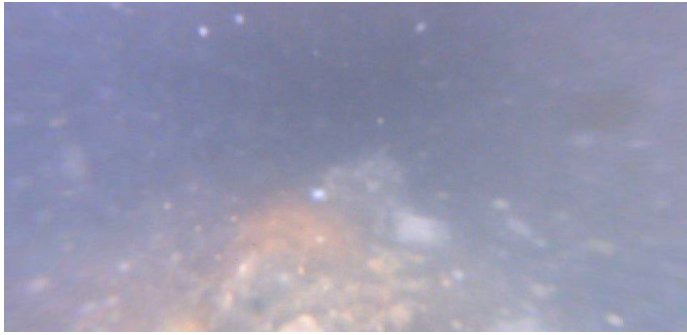
Code:	<b>MGO</b>
Description:	<b>General Observation</b>
Distance (ft):	<b>.0</b>
Structural Grade:	<b>0</b>
O&M Grade:	<b>0</b>
Clock Start/From:	
Clock To:	
1st Value:	
2nd Value:	
Value Percent:	
Continuous Index:	
Within 8" of Joint:	<b>NO</b>
Remarks:	<b>FLOW TO HIGH</b>

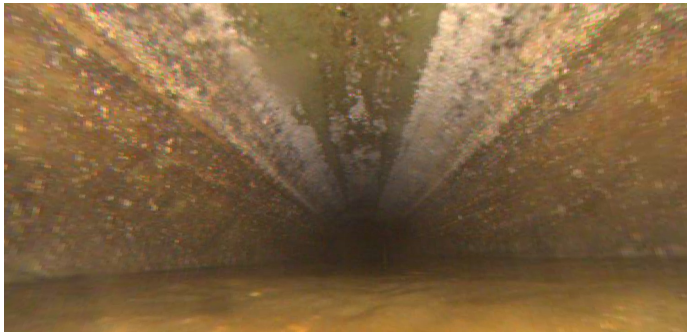
Code:	<b>DAGS</b>
Description:	<b>Deposits Attached Grease</b>
Distance (ft):	<b>3.2</b>
Structural Grade:	<b>0</b>
O&M Grade:	<b>2</b>
Clock Start/From:	<b>7</b>
Clock To:	<b>5</b>
1st Value:	
2nd Value:	
Value Percent:	<b>5.000</b>
Continuous Index:	<b>S02</b>
Within 8" of Joint:	<b>YES</b>
Remarks:	<b>WANDER</b>

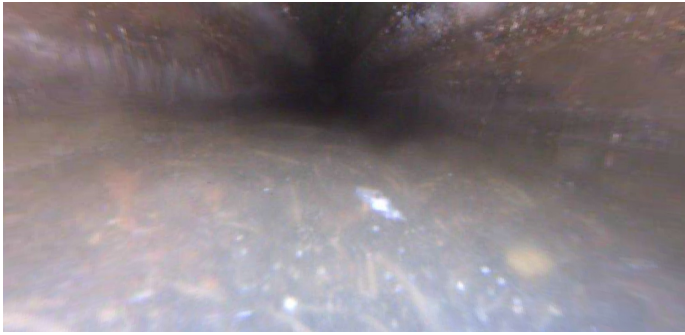
Code: **MGO**  
Description: **General Observation**

Distance (ft): **4.4**  
Structural Grade: **0**  
O&M Grade: **0**  
Clock Start/From:  
Clock To:  
1st Value:  
2nd Value:  
Value Percent:  
Continuous Index:  
Within 8" of Joint: **NO**  
Remarks: **FRONT FLOW SUBSIDED;  
RETURNING TO FRONT CAMERA**

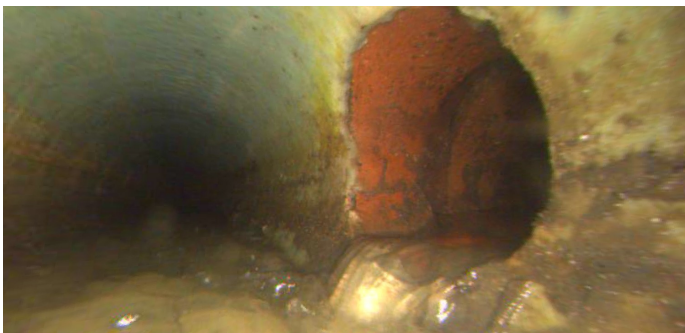
Code: **TFA**  
Description: **Tap Factory Active**

Distance (ft): **61.6**  
Structural Grade: **0**  
O&M Grade: **0**  
Clock Start/From: **9**  
Clock To:  
1st Value: **4.000**  
2nd Value:  
Value Percent:  
Continuous Index:  
Within 8" of Joint:  
Remarks:

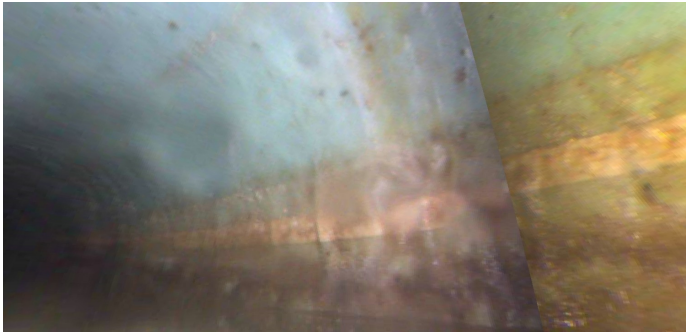
Code: **LFW**  
Description: **Lining Failure Wrinkled**

Distance (ft): **61.6**  
Structural Grade: **3**  
O&M Grade: **0**  
Clock Start/From: **3**  
Clock To:  
1st Value:  
2nd Value:  
Value Percent:  
Continuous Index:  
Within 8" of Joint: **NO**  
Remarks:

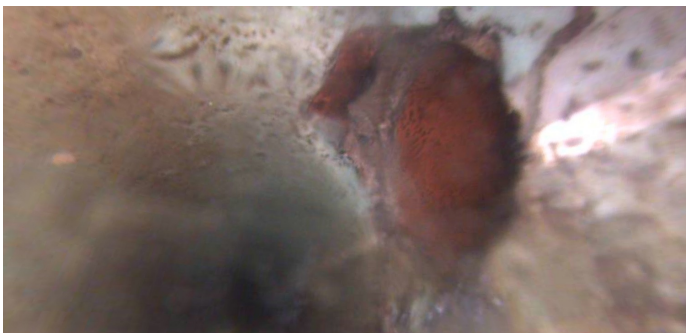
Code: **TB**  
Description: **Tap Break-in**

Distance (ft): **74.4**  
Structural Grade: **0**  
O&M Grade: **0**  
Clock Start/From: **10**  
Clock To:  
1st Value: **4.000**  
2nd Value:  
Value Percent:  
Continuous Index:  
Within 8" of Joint:  
Remarks:

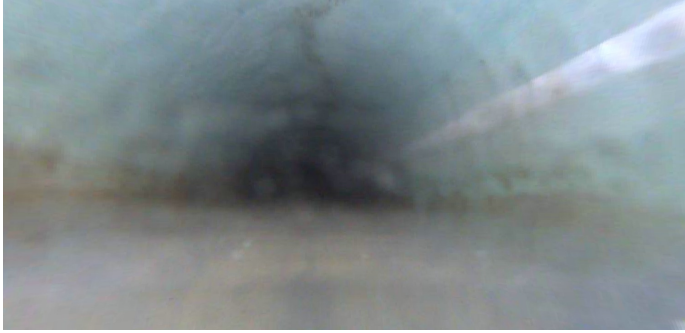
Code: **MWLS**  
Description: **Water Level Sag**

Distance (ft): **106.8**  
Structural Grade: **2**  
O&M Grade: **3**  
Clock Start/From:  
Clock To:  
1st Value:  
2nd Value:  
Value Percent: **15.000**  
Continuous Index:  
Within 8" of Joint: **NO**  
Remarks:

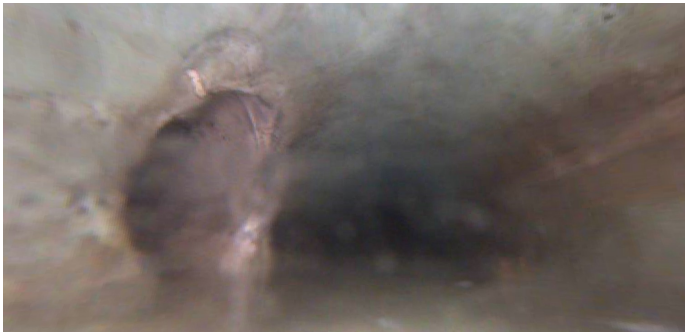
Code: **TF**  
Description: **Tap Factory**

Distance (ft): **111.5**  
Structural Grade: **0**  
O&M Grade: **0**  
Clock Start/From: **9**  
Clock To:  
1st Value: **4.000**  
2nd Value:  
Value Percent:  
Continuous Index:  
Within 8" of Joint:  
Remarks:

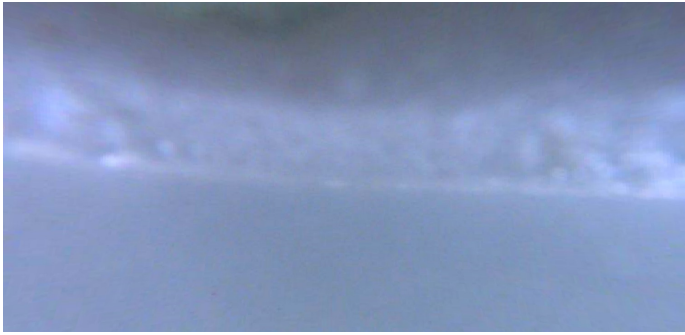
Code: **MWLS**  
Description: **Water Level Sag**

Distance (ft): **119.6**  
Structural Grade: **4**  
O&M Grade: **3**  
Clock Start/From:  
Clock To:  
1st Value:  
2nd Value:  
Value Percent: **70.000**  
Continuous Index:  
Within 8" of Joint: **NO**  
Remarks:

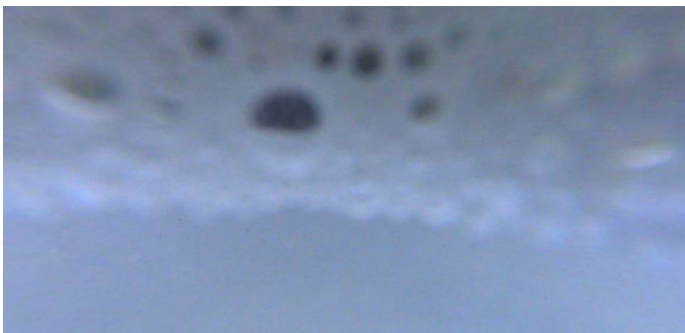
Code: **MGO**  
Description: **General Observation**

Distance (ft): **121.8**  
Structural Grade: **0**  
O&M Grade: **0**  
Clock Start/From:  
Clock To:  
1st Value:  
2nd Value:  
Value Percent:  
Continuous Index:  
Within 8" of Joint: **NO**  
Remarks: **FLOW TO HIGH**

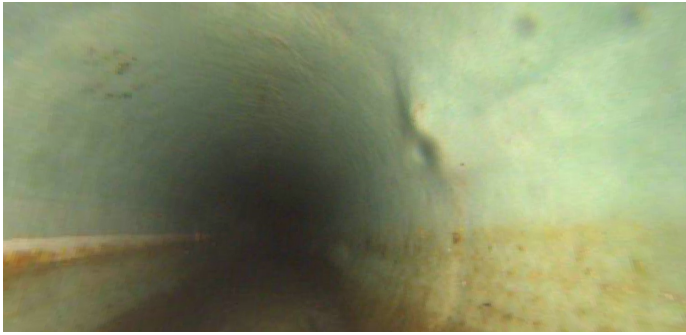
Code: **LFBU**  
Description: **Lining Failure Bulges**

Distance (ft): **129.2**  
Structural Grade: **0**  
O&M Grade: **0**  
Clock Start/From: **10**  
Clock To:  
1st Value:  
2nd Value:  
Value Percent:  
Continuous Index:  
Within 8" of Joint: **NO**  
Remarks:

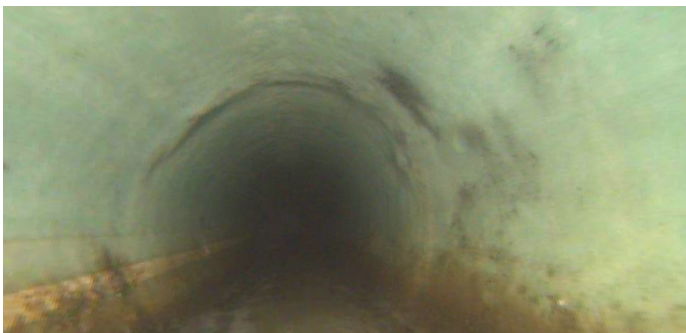
Code: **LFBU**  
Description: **Lining Failure Bulges**

Distance (ft): **139.5**  
Structural Grade: **0**  
O&M Grade: **0**  
Clock Start/From: **10**  
Clock To: **2**  
1st Value:  
2nd Value:  
Value Percent:  
Continuous Index:  
Within 8" of Joint: **NO**  
Remarks:

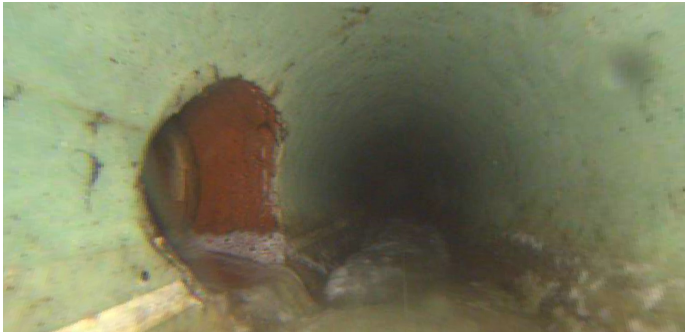
Code: **TFA**  
Description: **Tap Factory Active**

Distance (ft): **147.9**  
Structural Grade: **0**  
O&M Grade: **0**  
Clock Start/From: **3**  
Clock To:  
1st Value: **6.000**  
2nd Value:  
Value Percent:  
Continuous Index:  
Within 8" of Joint:  
Remarks:

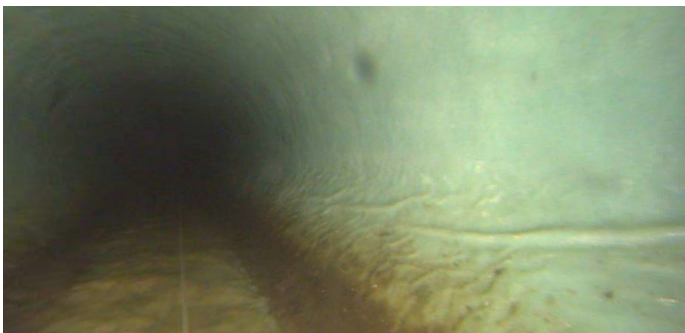
Code: **LFW**  
Description: **Lining Failure Wrinkled**

Distance (ft): **167.3**  
Structural Grade: **3**  
O&M Grade: **0**  
Clock Start/From: **7**  
Clock To:  
1st Value:  
2nd Value:  
Value Percent:  
Continuous Index:  
Within 8" of Joint: **NO**  
Remarks:

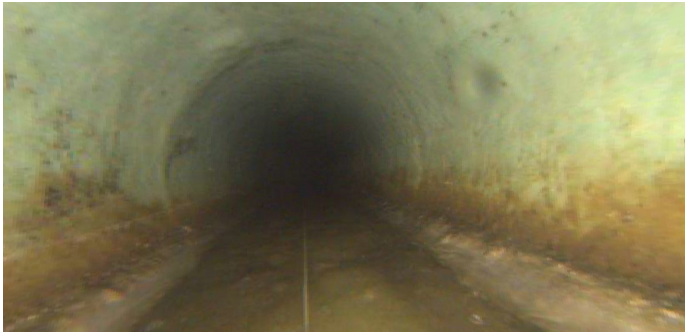
Code: **LFBU**  
Description: **Lining Failure Bulges**

Distance (ft): **188.9**  
Structural Grade: **0**  
O&M Grade: **0**  
Clock Start/From: **12**  
Clock To: **4**  
1st Value:  
2nd Value:  
Value Percent:  
Continuous Index:  
Within 8" of Joint: **NO**  
Remarks:

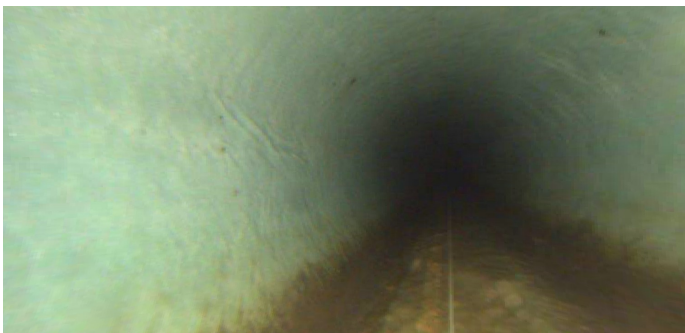
Code: **LFW**  
Description: **Lining Failure Wrinkled**

Distance (ft): **202.3**  
Structural Grade: **3**  
O&M Grade: **0**  
Clock Start/From: **3**  
Clock To:  
1st Value:  
2nd Value:  
Value Percent:  
Continuous Index:  
Within 8" of Joint: **NO**  
Remarks:

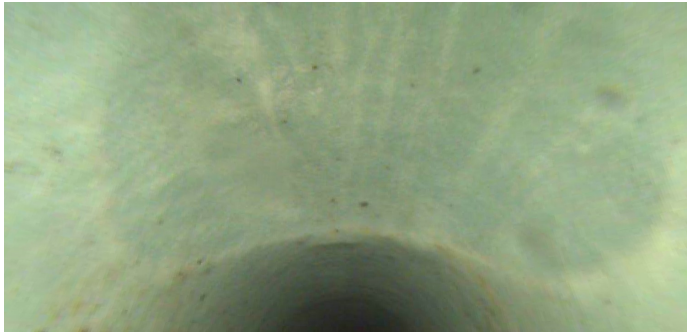
Code:	<b>LFAC</b>
Description:	<b>Lining Failure Abandoned Connection</b>
Distance (ft):	<b>234.8</b>
Structural Grade:	<b>0</b>
O&M Grade:	<b>0</b>
Clock Start/From:	<b>12</b>
Clock To:	
1st Value:	
2nd Value:	
Value Percent:	
Continuous Index:	
Within 8" of Joint:	<b>NO</b>
Remarks:

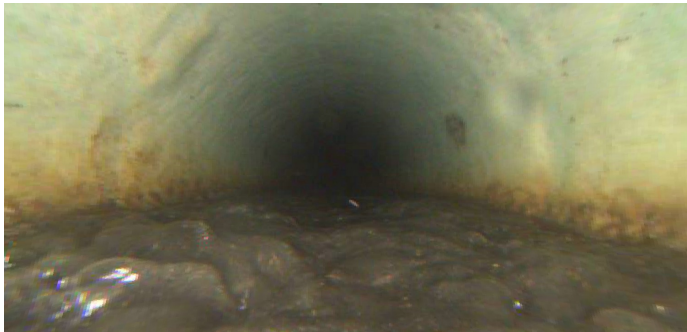
Code:	<b>MWL</b>
Description:	<b>Water Level</b>
Distance (ft):	<b>256.0</b>
Structural Grade:	<b>0</b>
O&M Grade:	<b>0</b>
Clock Start/From:	
Clock To:	
1st Value:	
2nd Value:	
Value Percent:	<b>15.000</b>
Continuous Index:	
Within 8" of Joint:	<b>NO</b>
Remarks:

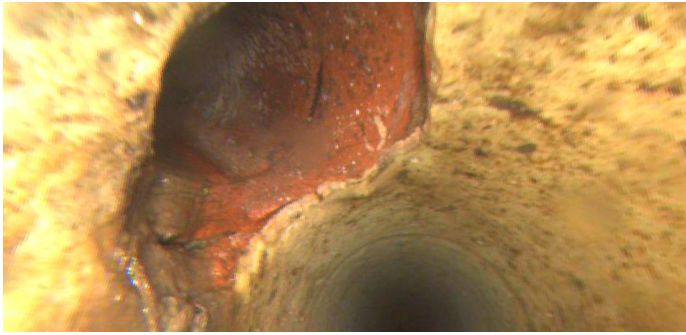
Code: **TF**  
Description: **Tap Factory**

Distance (ft): **286.5**  
Structural Grade: **0**  
O&M Grade: **0**  
Clock Start/From: **2**  
Clock To:  
1st Value: **6.000**  
2nd Value:  
Value Percent:  
Continuous Index:  
Within 8" of Joint:  
Remarks:

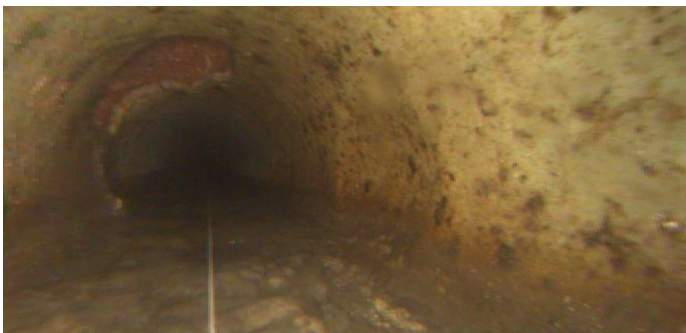
Code: **MGO**  
Description: **General Observation**

Distance (ft): **287.4**  
Structural Grade: **0**  
O&M Grade: **0**  
Clock Start/From:  
Clock To:  
1st Value:  
2nd Value:  
Value Percent:  
Continuous Index:  
Within 8" of Joint: **NO**  
Remarks: **IMPRINT OF TAP**

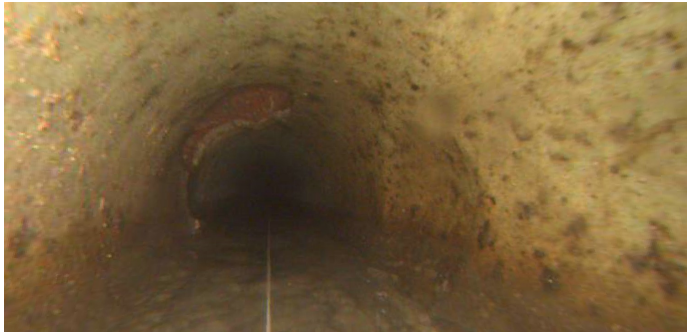
Code:	<b>LFAC</b>
Description:	<b>Lining Failure Abandoned Connection</b>
Distance (ft):	<b>287.5</b>
Structural Grade:	<b>0</b>
O&M Grade:	<b>0</b>
Clock Start/From:	<b>9</b>
Clock To:	
1st Value:	
2nd Value:	
Value Percent:	
Continuous Index:	
Within 8" of Joint:	<b>NO</b>
Remarks:

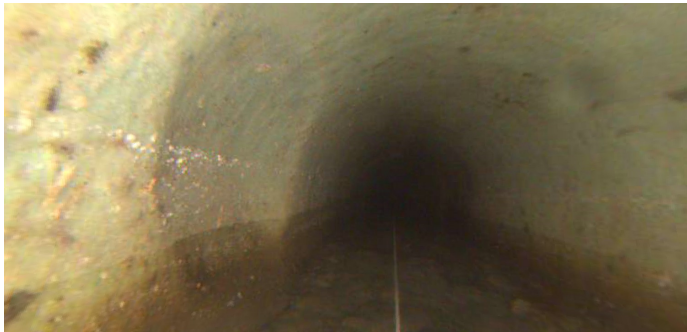
Code:	<b>LFAC</b>
Description:	<b>Lining Failure Abandoned Connection</b>
Distance (ft):	<b>289.3</b>
Structural Grade:	<b>0</b>
O&M Grade:	<b>0</b>
Clock Start/From:	<b>3</b>
Clock To:	
1st Value:	
2nd Value:	
Value Percent:	
Continuous Index:	
Within 8" of Joint:	<b>NO</b>
Remarks:

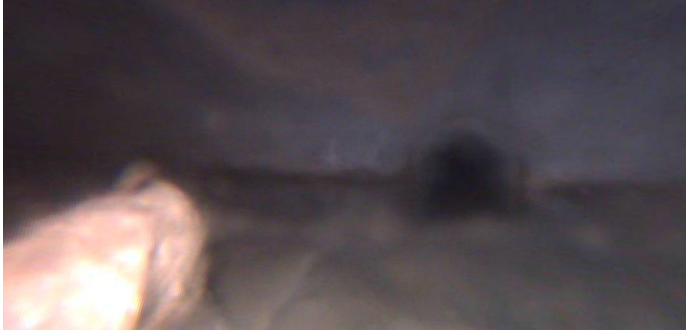
Code: **AMH**  
Description: **Manhole**

Distance (ft): **294.2**  
Structural Grade: **0**  
O&M Grade: **0**  
Clock Start/From:  
Clock To:  
1st Value:  
2nd Value:  
Value Percent:  
Continuous Index:  
Within 8" of Joint: **NO**  
Remarks: **M-305-006**

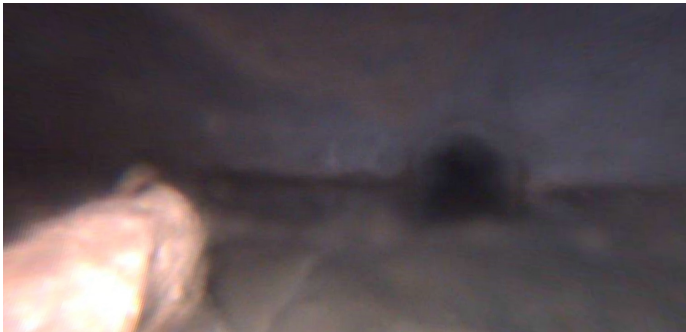
Code: **DAGS**  
Description: **Deposits Attached Grease**

Distance (ft): **294.2**  
Structural Grade: **0**  
O&M Grade: **2**  
Clock Start/From: **7**  
Clock To: **5**  
1st Value:  
2nd Value:  
Value Percent: **5.000**  
Continuous Index: **F02**  
Within 8" of Joint: **YES**  
Remarks: **WANDER**
