Profile/Photo Observation Report

Street:	ALLEY WALNUT LN & W 49TH AVE	Flow Control:	Not Controlled
City:	Hobart, IN	Year Renewed:	
Location:	Yard	Tape/Media #:	
Purpose:	Routine Assessment	Dia/Height:	10"
Use:	Sanitary	Material:	VCP
Drain Area:	NA	Lining:	Cured in Place
Category:	NA		
Comment:

Location Details:		Direction of Survey:	Downstream
US MH:	M-305-007	DS MH:	M-305-006
		Total Length Surveyed (ft):	277.8

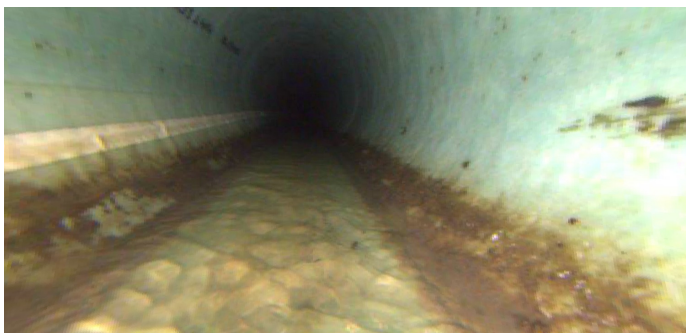
Code: **AMH**
Description: **Manhole**

Distance (ft): **.0**
Structural Grade: **0**
O&M Grade: **0**
Clock Start/From:
Clock To:
1st Value:
2nd Value:
Value Percent:
Continuous Index:
Within 8" of Joint: **NO**
Remarks: **M-305-007**

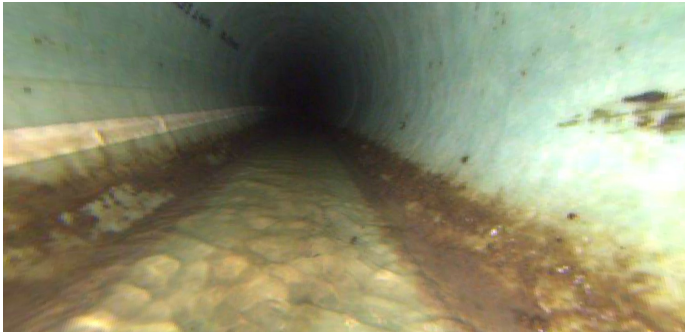
Code:	MWL
Description:	Water Level

Distance (ft):	.0
Structural Grade:	0
O&M Grade:	0
Clock Start/From:	
Clock To:	
1st Value:	
2nd Value:	
Value Percent:	10.000
Continuous Index:	
Within 8" of Joint:	NO
Remarks:

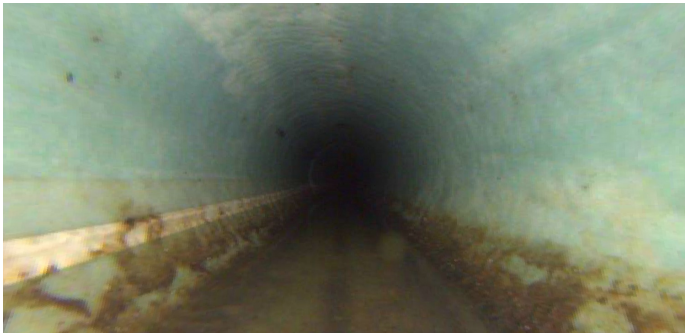
Code:	DAZ
Description:	Deposits Attached Other

Distance (ft):	8.0
Structural Grade:	0
O&M Grade:	2
Clock Start/From:	7
Clock To:	5
1st Value:	
2nd Value:	
Value Percent:	5.000
Continuous Index:	S01
Within 8" of Joint:	YES
Remarks:	WANDER

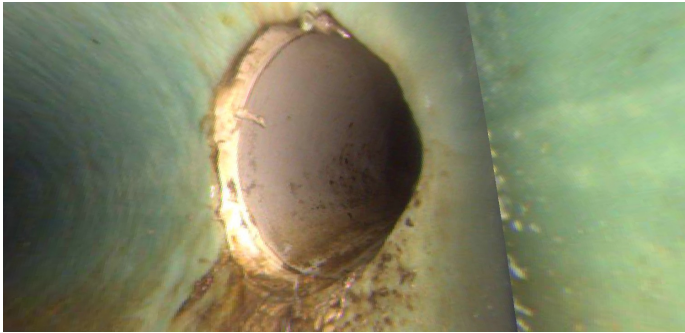
Code: **TF**
Description: **Tap Factory**

Distance (ft): **43.1**
Structural Grade: **0**
O&M Grade: **0**
Clock Start/From: **3**
Clock To:
1st Value: **4.000**
2nd Value:
Value Percent:
Continuous Index:
Within 8" of Joint:
Remarks:

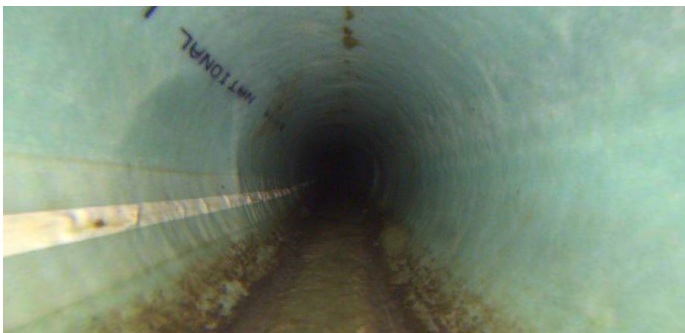
Code: **LFAC**
Description: **Lining Failure Abandoned Connection**

Distance (ft): **46.1**
Structural Grade: **0**
O&M Grade: **0**
Clock Start/From: **9**
Clock To:
1st Value:
2nd Value:
Value Percent:
Continuous Index:
Within 8" of Joint: **NO**
Remarks:

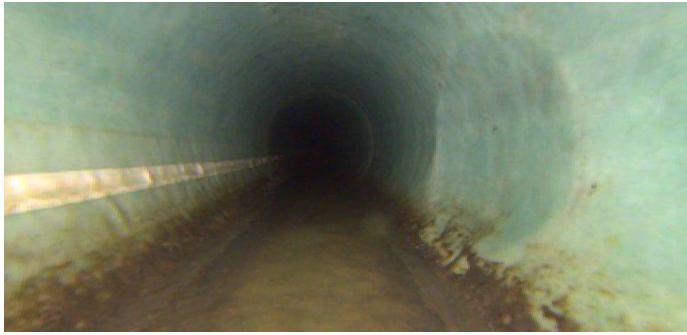
Code:	LFAC
Description:	Lining Failure Abandoned Connection
Distance (ft):	48.3
Structural Grade:	0
O&M Grade:	0
Clock Start/From:	3
Clock To:	
1st Value:	
2nd Value:	
Value Percent:	
Continuous Index:	
Within 8" of Joint:	NO
Remarks:

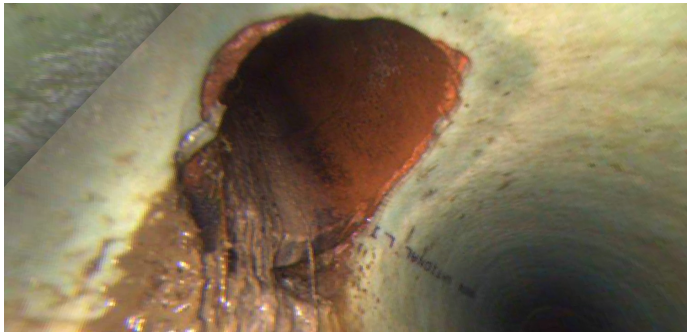
Code:	TFD
Description:	Tap Factory Defective
Distance (ft):	56.0
Structural Grade:	0
O&M Grade:	2
Clock Start/From:	10
Clock To:	
1st Value:	4.000
2nd Value:	
Value Percent:	
Continuous Index:	
Within 8" of Joint:	
Remarks:	roots

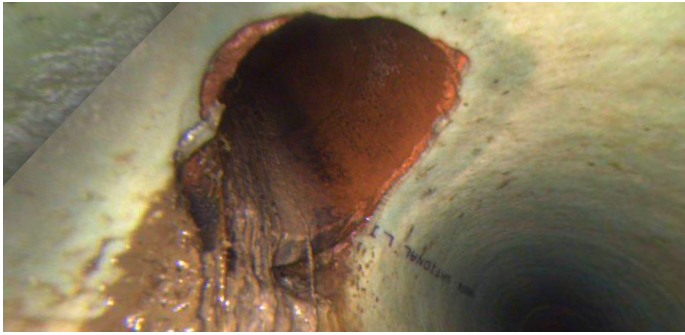
Code: **RFL**
Description: **Roots Fine Lateral**

Distance (ft): **56.0**
Structural Grade: **0**
O&M Grade: **1**
Clock Start/From: **10**
Clock To:
1st Value:
2nd Value:
Value Percent:
Continuous Index:
Within 8" of Joint: **NO**
Remarks:

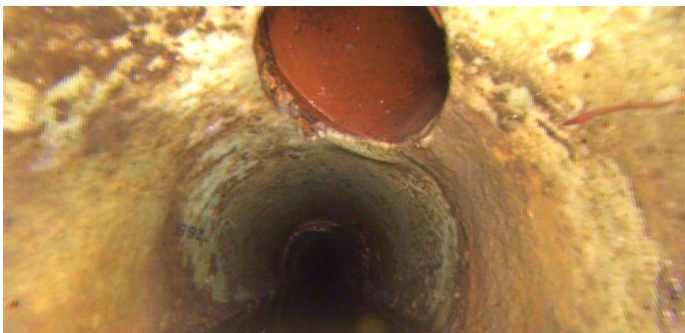
Code: **TF**
Description: **Tap Factory**

Distance (ft): **105.9**
Structural Grade: **0**
O&M Grade: **0**
Clock Start/From: **1**
Clock To:
1st Value: **4.000**
2nd Value:
Value Percent:
Continuous Index:
Within 8" of Joint:
Remarks:

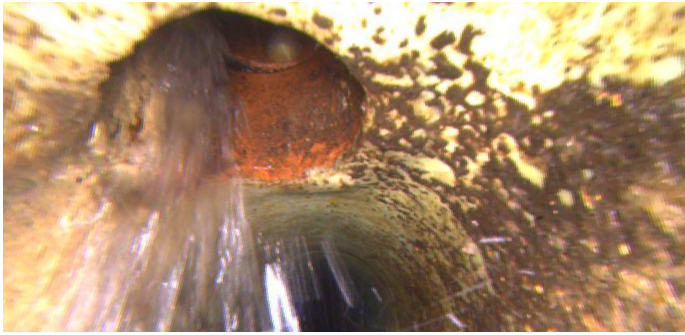
Code: **TFA**
Description: **Tap Factory Active**

Distance (ft): **108.3**
Structural Grade: **0**
O&M Grade: **0**
Clock Start/From: **11**
Clock To:
1st Value: **4.000**
2nd Value:
Value Percent:
Continuous Index:
Within 8" of Joint:
Remarks:

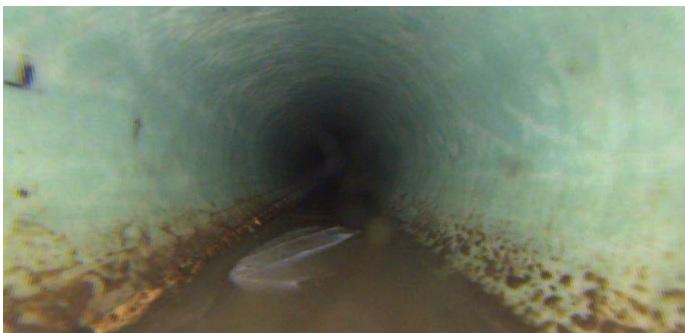
Code: **MGO**
Description: **General Observation**

Distance (ft): **113.5**
Structural Grade: **0**
O&M Grade: **0**
Clock Start/From:
Clock To:
1st Value:
2nd Value:
Value Percent:
Continuous Index:
Within 8" of Joint: **NO**
Remarks: **TOILET TISSUE**

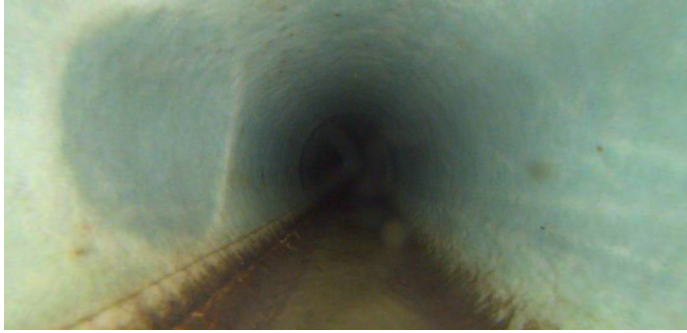
Code:	LFAC
Description:	Lining Failure Abandoned Connection
Distance (ft):	125.0
Structural Grade:	0
O&M Grade:	0
Clock Start/From:	9
Clock To:	
1st Value:	
2nd Value:	
Value Percent:	
Continuous Index:	
Within 8" of Joint:	NO
Remarks:

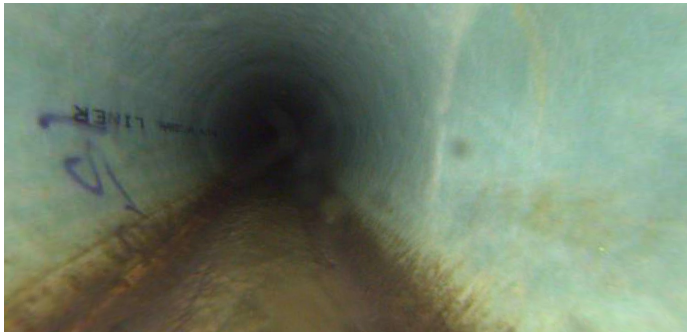
Code:	LFAC
Description:	Lining Failure Abandoned Connection
Distance (ft):	127.2
Structural Grade:	0
O&M Grade:	0
Clock Start/From:	3
Clock To:	
1st Value:	
2nd Value:	
Value Percent:	
Continuous Index:	
Within 8" of Joint:	NO
Remarks:

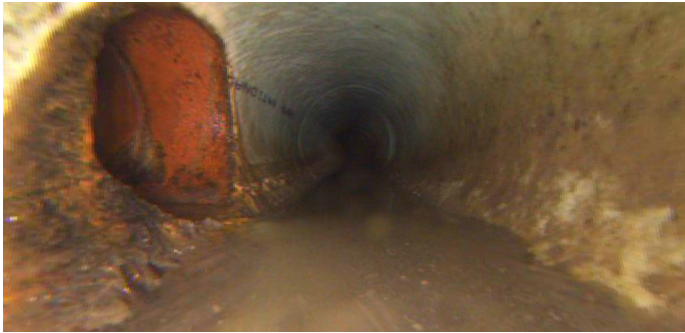
Code: **TF**
Description: **Tap Factory**

Distance (ft): **203.6**
Structural Grade: **0**
O&M Grade: **0**
Clock Start/From: **9**
Clock To:
1st Value: **4.000**
2nd Value:
Value Percent:
Continuous Index:
Within 8" of Joint:
Remarks:

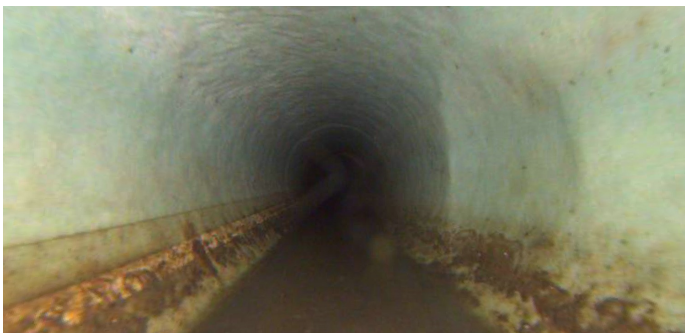
Code: **LFAC**
Description: **Lining Failure Abandoned Connection**

Distance (ft): **205.5**
Structural Grade: **0**
O&M Grade: **0**
Clock Start/From: **3**
Clock To:
1st Value:
2nd Value:
Value Percent:
Continuous Index:
Within 8" of Joint: **NO**
Remarks:

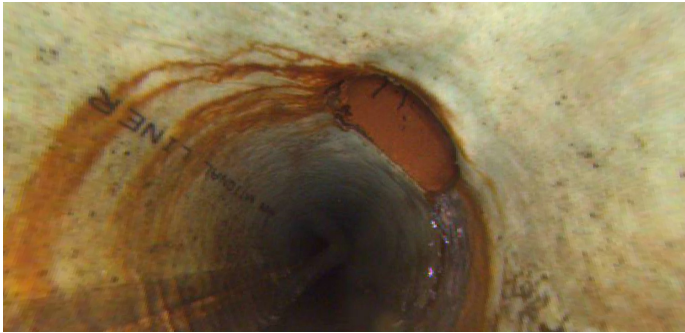
Code: **TF**
Description: **Tap Factory**

Distance (ft): **208.8**
Structural Grade: **0**
O&M Grade: **0**
Clock Start/From: **2**
Clock To:
1st Value: **4.000**
2nd Value:
Value Percent:
Continuous Index:
Within 8" of Joint:
Remarks:

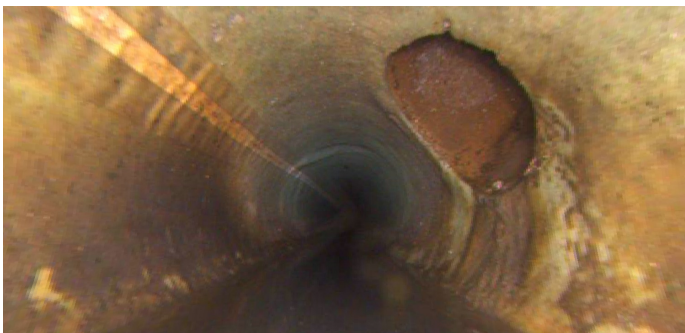
Code: **TF**
Description: **Tap Factory**

Distance (ft): **250.7**
Structural Grade: **0**
O&M Grade: **0**
Clock Start/From: **2**
Clock To:
1st Value: **4.000**
2nd Value:
Value Percent:
Continuous Index:
Within 8" of Joint:
Remarks:

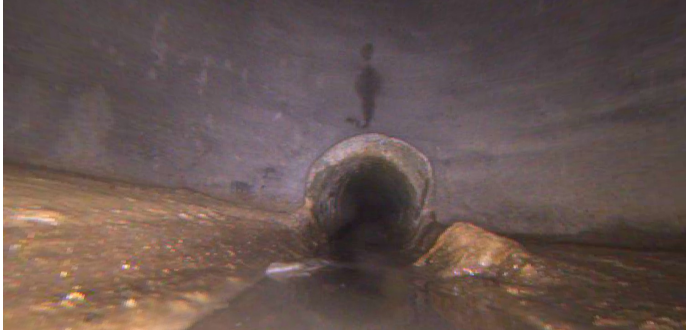
Code: **AMH**
Description: **Manhole**

Distance (ft): **277.8**
Structural Grade: **0**
O&M Grade: **0**
Clock Start/From:
Clock To:
1st Value:
2nd Value:
Value Percent:
Continuous Index:
Within 8" of Joint: **NO**
Remarks: **M-305-006**

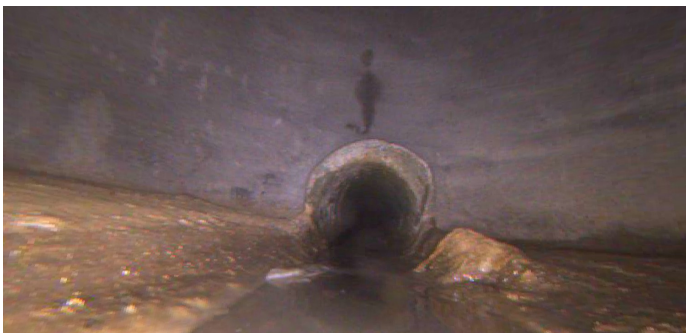
Code: **DAZ**
Description: **Deposits Attached Other**

Distance (ft): **277.8**
Structural Grade: **0**
O&M Grade: **2**
Clock Start/From: **7**
Clock To: **5**
1st Value:
2nd Value:
Value Percent: **5.000**
Continuous Index: **F01**
Within 8" of Joint: **YES**
Remarks: **WANDER**
