Profile/Photo Observation Report

Date:	04/19/2018	Weather:		Coding:	PACP 6.0
Pipe Length (ft):	306.8	Owner:	NA	Pre Clean:	No Pre-Cleaning
P.O.#:		Surveyor:	Justin Gonzales	PSR:	P-305-009-008
Customer:		Clean Date:	01/01/1900	Shape:	C

Street:	FOXCROFT STREET	Flow Control:	Not Controlled
City:	Hobart, IN	Year Renewed:	
Location:	Yard	Tape/Media #:	
Purpose:	Routine Assessment	Dia/Height:	10"
Use:	Sanitary	Material:	PVC
Drain Area:	NA	Lining:	
Category:	NA		
Comment:

Location Details:		Direction of Survey:	Downstream
US MH:	M-305-009	DS MH:	M-305-008
		Total Length Surveyed (ft):	274.7

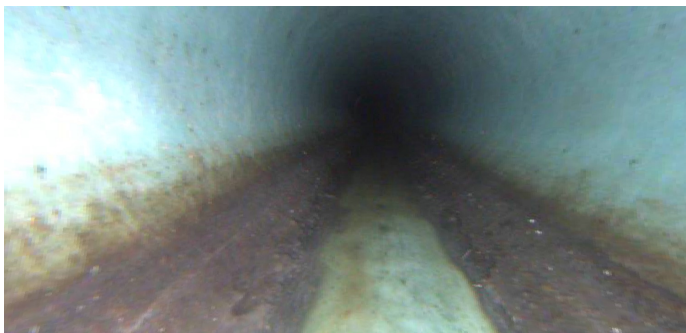
Code: **AMH**
Description: **Manhole**

Distance (ft): **.0**
Structural Grade: **0**
O&M Grade: **0**
Clock Start/From:
Clock To:
1st Value:
2nd Value:
Value Percent:
Continuous Index:
Within 8" of Joint: **NO**
Remarks: **M-305-009**

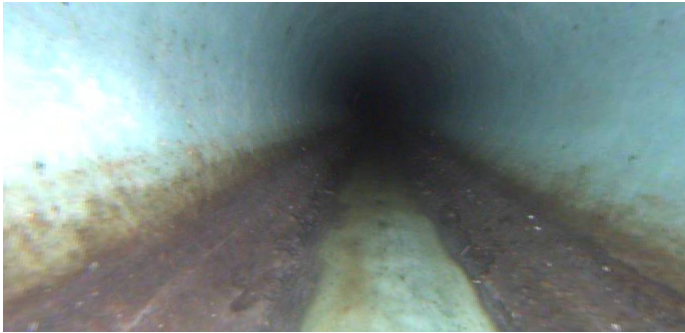
Code:	MWL
Description:	Water Level

Distance (ft):	.0
Structural Grade:	0
O&M Grade:	0
Clock Start/From:	
Clock To:	
1st Value:	
2nd Value:	
Value Percent:	5.000
Continuous Index:	
Within 8" of Joint:	NO
Remarks:

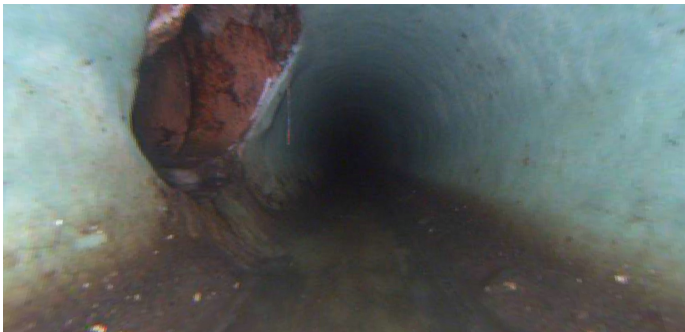
Code:	TB
Description:	Tap Break-in

Distance (ft):	6.9
Structural Grade:	0
O&M Grade:	0
Clock Start/From:	9
Clock To:	
1st Value:	4.000
2nd Value:	
Value Percent:	
Continuous Index:	
Within 8" of Joint:	
Remarks:

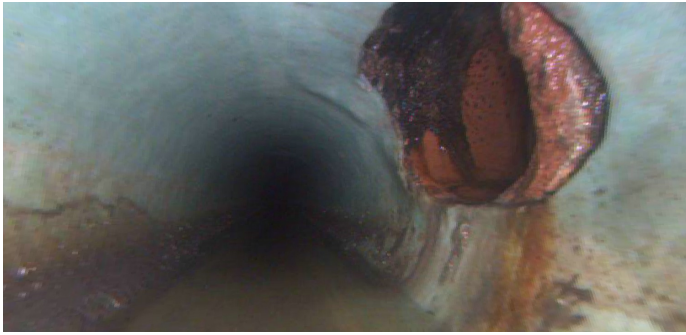
Code: **TBI**
Description: **Tap Break-in Intruding**

Distance (ft): **21.9**
Structural Grade: **0**
O&M Grade: **2**
Clock Start/From: **3**
Clock To:
1st Value: **4.000**
2nd Value: **1.000**
Value Percent:
Continuous Index:
Within 8" of Joint:
Remarks:

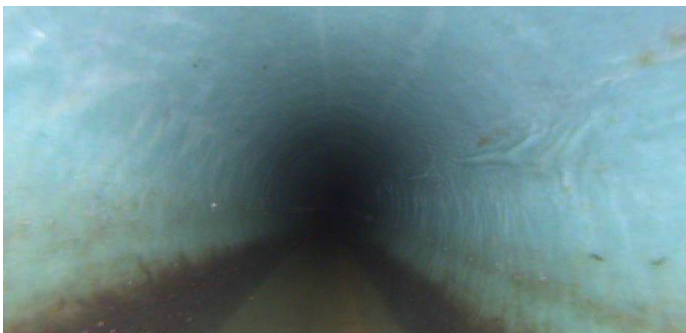
Code: **LFW**
Description: **Lining Failure Wrinkled**

Distance (ft): **42.6**
Structural Grade: **3**
O&M Grade: **0**
Clock Start/From: **3**
Clock To:
1st Value:
2nd Value:
Value Percent:
Continuous Index:
Within 8" of Joint: **NO**
Remarks:

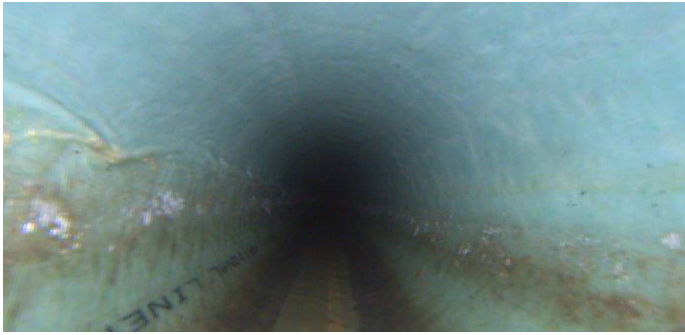
Code: **LFW**
Description: **Lining Failure Wrinkled**

Distance (ft): **52.6**
Structural Grade: **3**
O&M Grade: **0**
Clock Start/From: **9**
Clock To:
1st Value:
2nd Value:
Value Percent:
Continuous Index:
Within 8" of Joint: **NO**
Remarks:

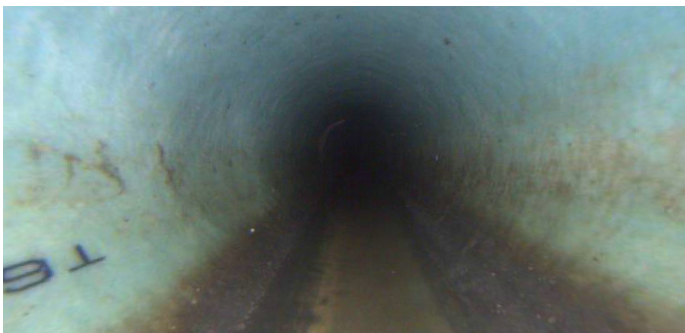
Code: **LFAC**
Description: **Lining Failure Abandoned Connection**

Distance (ft): **74.7**
Structural Grade: **0**
O&M Grade: **0**
Clock Start/From: **9**
Clock To:
1st Value:
2nd Value:
Value Percent:
Continuous Index:
Within 8" of Joint: **NO**
Remarks:

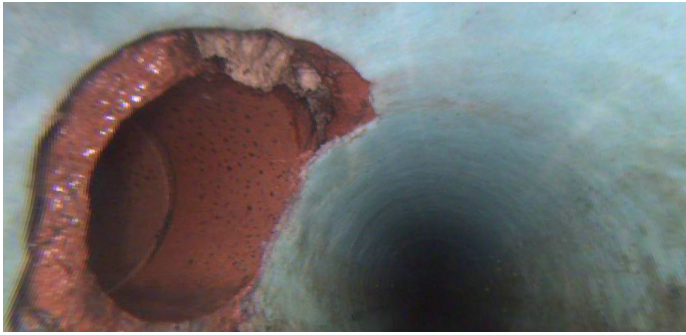
Code: **TB**
Description: **Tap Break-in**

Distance (ft): **77.5**
Structural Grade: **0**
O&M Grade: **0**
Clock Start/From: **9**
Clock To:
1st Value: **4.000**
2nd Value:
Value Percent:
Continuous Index:
Within 8" of Joint:
Remarks:

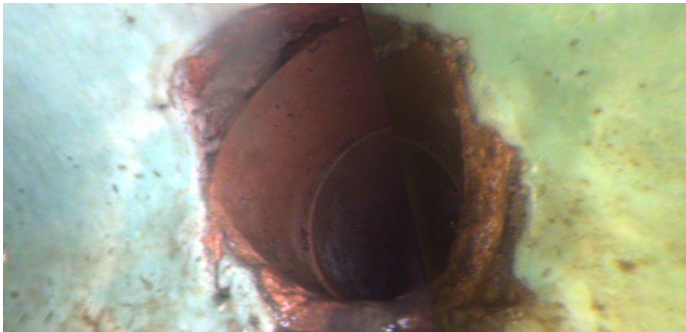
Code: **TB**
Description: **Tap Break-in**

Distance (ft): **91.0**
Structural Grade: **0**
O&M Grade: **0**
Clock Start/From: **3**
Clock To:
1st Value: **4.000**
2nd Value:
Value Percent:
Continuous Index:
Within 8" of Joint:
Remarks:

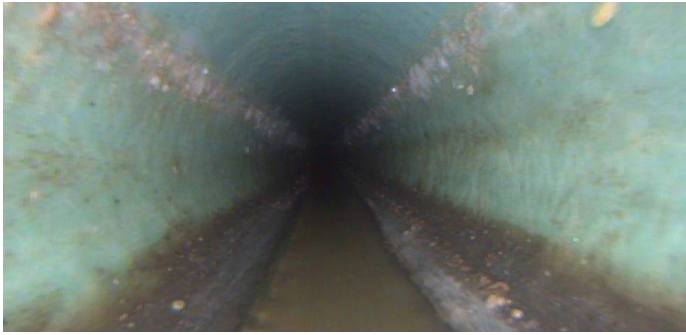
Code: **DAGS**
Description: **Deposits Attached Grease**

Distance (ft): **111.3**
Structural Grade: **0**
O&M Grade: **2**
Clock Start/From: **7**
Clock To: **5**
1st Value:
2nd Value:
Value Percent: **5.000**
Continuous Index: **S02**
Within 8" of Joint: **YES**
Remarks: **WANDER**

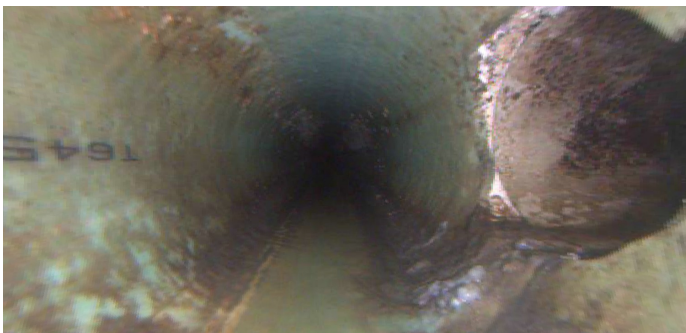
Code: **TF**
Description: **Tap Factory**

Distance (ft): **141.4**
Structural Grade: **0**
O&M Grade: **0**
Clock Start/From: **3**
Clock To:
1st Value: **4.000**
2nd Value:
Value Percent:
Continuous Index:
Within 8" of Joint:
Remarks:

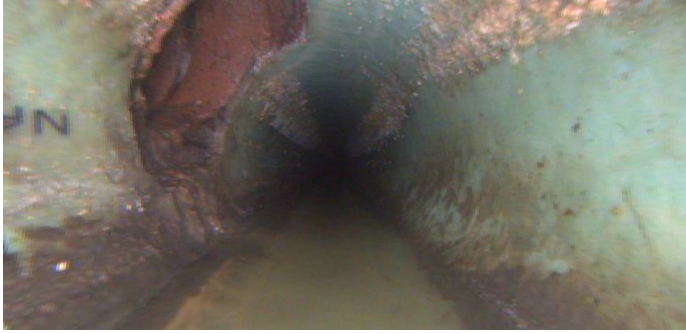
Code: **TB**
Description: **Tap Break-in**

Distance (ft): **146.2**
Structural Grade: **0**
O&M Grade: **0**
Clock Start/From: **10**
Clock To:
1st Value: **4.000**
2nd Value:
Value Percent:
Continuous Index:
Within 8" of Joint:
Remarks:

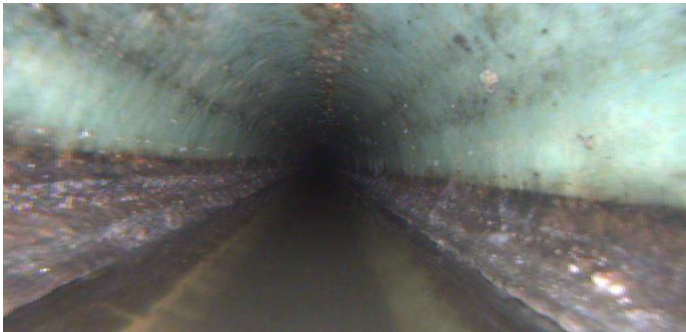
Code: **DSF**
Description: **Deposits Settled Fine**

Distance (ft): **189.5**
Structural Grade: **0**
O&M Grade: **2**
Clock Start/From: **6**
Clock To:
1st Value:
2nd Value:
Value Percent: **5.000**
Continuous Index: **S03**
Within 8" of Joint: **NO**
Remarks:

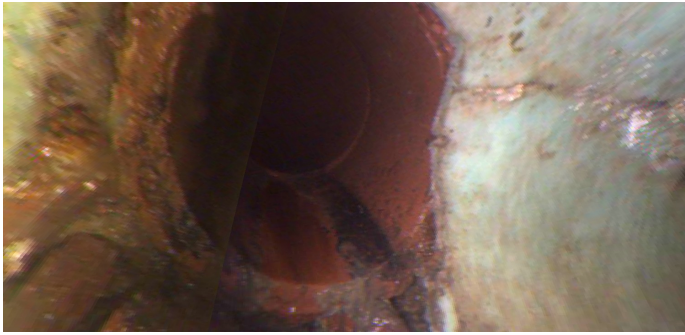
Code: **TB**
Description: **Tap Break-in**

Distance (ft): **234.6**
Structural Grade: **0**
O&M Grade: **0**
Clock Start/From: **10**
Clock To:
1st Value: **4.000**
2nd Value:
Value Percent:
Continuous Index:
Within 8" of Joint:
Remarks:

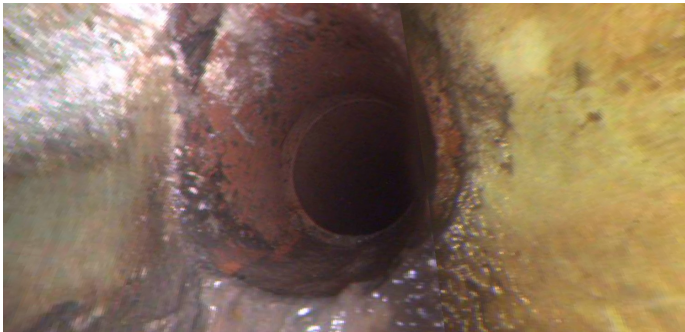
Code: **TB**
Description: **Tap Break-in**

Distance (ft): **236.3**
Structural Grade: **0**
O&M Grade: **0**
Clock Start/From: **3**
Clock To:
1st Value: **4.000**
2nd Value:
Value Percent:
Continuous Index:
Within 8" of Joint:
Remarks:

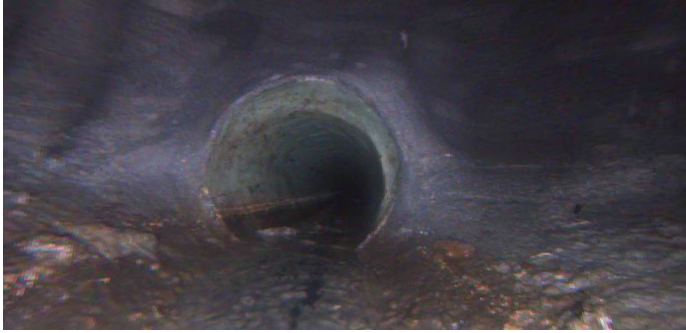
Code: **AMH**
Description: **Manhole**

Distance (ft): **274.7**
Structural Grade: **0**
O&M Grade: **0**
Clock Start/From:
Clock To:
1st Value:
2nd Value:
Value Percent:
Continuous Index:
Within 8" of Joint: **NO**
Remarks: **M-305-008**

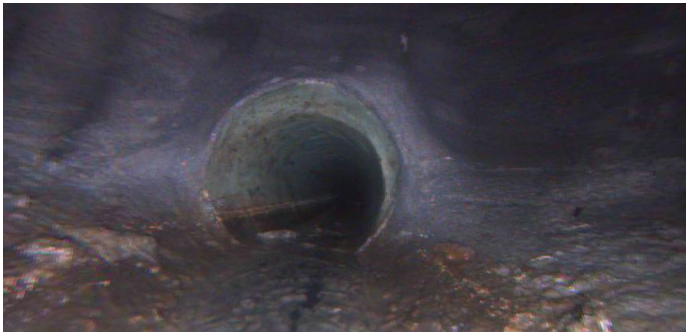
Code: **DAGS**
Description: **Deposits Attached Grease**

Distance (ft): **274.7**
Structural Grade: **0**
O&M Grade: **2**
Clock Start/From: **7**
Clock To: **5**
1st Value:
2nd Value:
Value Percent: **5.000**
Continuous Index: **F02**
Within 8" of Joint: **YES**
Remarks: **WANDER**

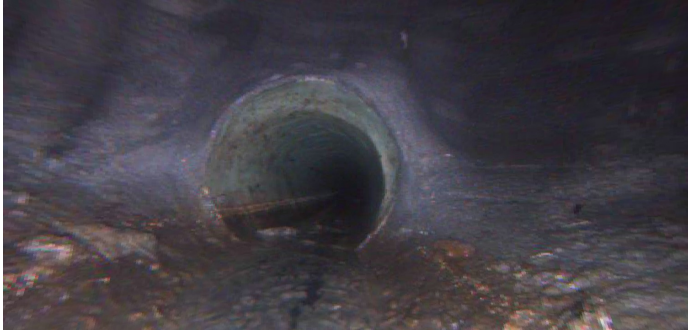
Code:	DSF
Description:	Deposits Settled Fine
Distance (ft):	274.7
Structural Grade:	0
O&M Grade:	2
Clock Start/From:	6
Clock To:	
1st Value:	
2nd Value:	
Value Percent:	5.000
Continuous Index:	F03
Within 8" of Joint:	NO
Remarks:
