Profile/Photo Observation Report

Date:	04/19/2018	Weather:		Coding:	PACP 6.0
Pipe Length (ft):	303.0	Owner:	NA	Pre Clean:	No Pre-Cleaning
P.O.#:		Surveyor:	Justin Gonzales	PSR:	P-305-012-002
Customer:		Clean Date:	01/01/1900	Shape:	C

Street:	WALNUT LN	Flow Control:	Not Controlled
City:	Hobart, IN	Year Renewed:	
Location:	Yard	Tape/Media #:	
Purpose:	Routine Assessment	Dia/Height:	10"
Use:	Sanitary	Material:	PVC
Drain Area:	NA	Lining:	Cured in Place
Category:	NA		
Comment:

Location Details:		Direction of Survey:	Upstream
US MH:	M-305-012	DS MH:	M-305-002
		Total Length Surveyed (ft):	301.9

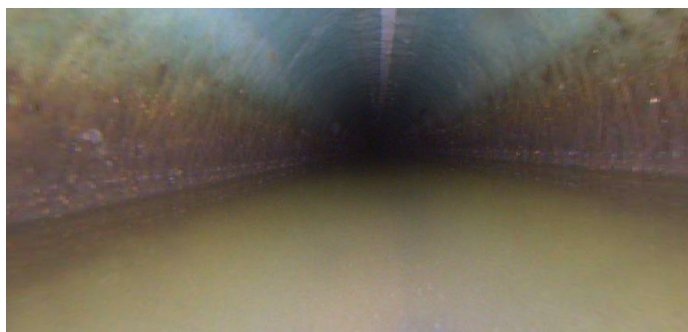
Code: **AMH**
Description: **Manhole**

Distance (ft): **.0**
Structural Grade: **0**
O&M Grade: **0**
Clock Start/From:
Clock To:
1st Value:
2nd Value:
Value Percent:
Continuous Index:
Within 8" of Joint: **NO**
Remarks: **M-305-002**

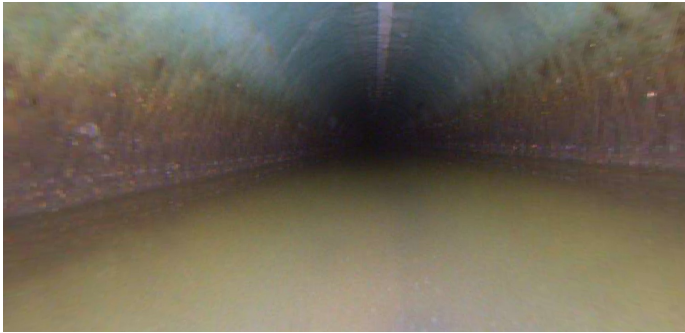
Code:	MWL
Description:	Water Level

Distance (ft):	.0
Structural Grade:	0
O&M Grade:	0
Clock Start/From:	
Clock To:	
1st Value:	
2nd Value:	
Value Percent:	15.000
Continuous Index:	
Within 8" of Joint:	NO
Remarks:

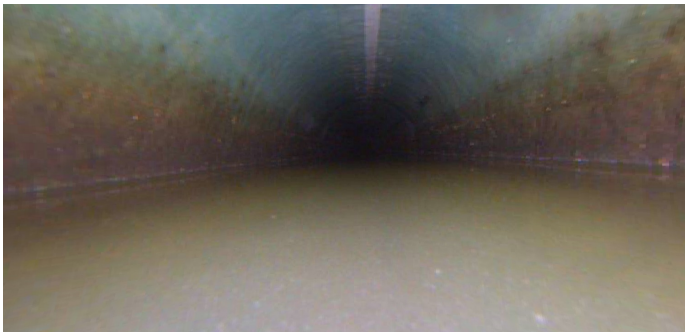
Code:	DAZ
Description:	Deposits Attached Other

Distance (ft):	1.7
Structural Grade:	0
O&M Grade:	2
Clock Start/From:	7
Clock To:	5
1st Value:	
2nd Value:	
Value Percent:	5.000
Continuous Index:	S01
Within 8" of Joint:	YES
Remarks:	WANDER

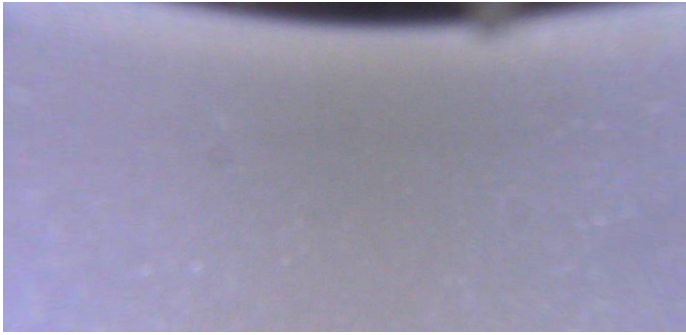
Code: **MCU**
Description: **Camera Underwater**

Distance (ft): **5.8**
Structural Grade: **0**
O&M Grade: **4**
Clock Start/From:
Clock To:
1st Value:
2nd Value:
Value Percent:
Continuous Index: **S02**
Within 8" of Joint: **NO**
Remarks:

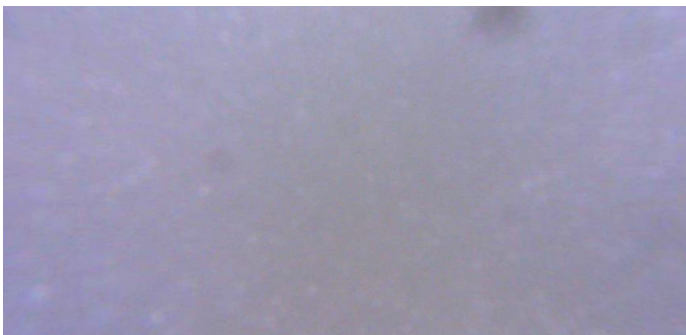
Code: **MGO**
Description: **General Observation**

Distance (ft): **10.6**
Structural Grade: **0**
O&M Grade: **0**
Clock Start/From:
Clock To:
1st Value:
2nd Value:
Value Percent:
Continuous Index:
Within 8" of Joint: **NO**
Remarks: **FLOW TO HIGH**

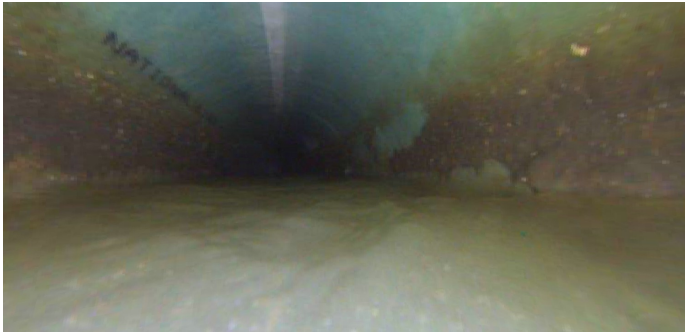
Code: **MCU**
Description: **Camera Underwater**

Distance (ft): **15.6**
Structural Grade: **0**
O&M Grade: **4**
Clock Start/From:
Clock To:
1st Value:
2nd Value:
Value Percent:
Continuous Index: **F02**
Within 8" of Joint: **NO**
Remarks:

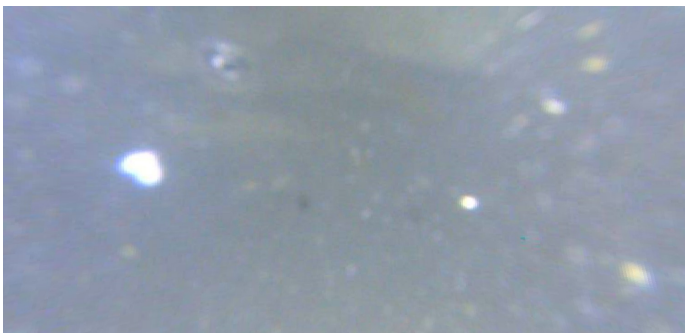
Code: **MCU**
Description: **Camera Underwater**

Distance (ft): **35.5**
Structural Grade: **0**
O&M Grade: **4**
Clock Start/From:
Clock To:
1st Value:
2nd Value:
Value Percent:
Continuous Index: **S03**
Within 8" of Joint: **NO**
Remarks:

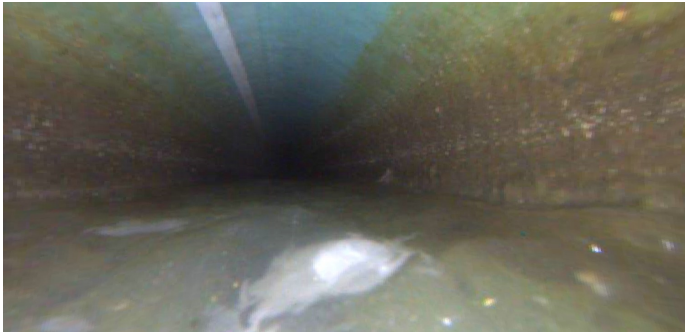
Code: **MCU**
Description: **Camera Underwater**

Distance (ft): **117.5**
Structural Grade: **0**
O&M Grade: **4**
Clock Start/From:
Clock To:
1st Value:
2nd Value:
Value Percent:
Continuous Index: **F03**
Within 8" of Joint: **NO**
Remarks:

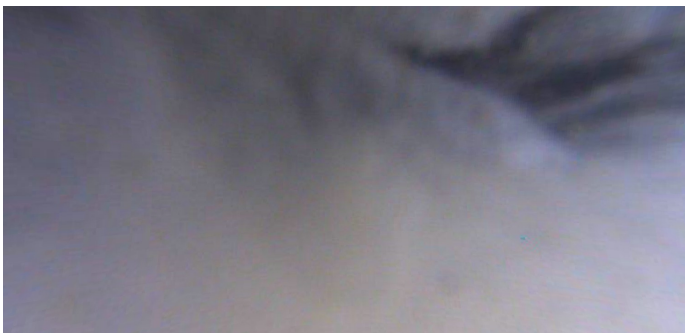
Code: **MCU**
Description: **Camera Underwater**

Distance (ft): **124.8**
Structural Grade: **0**
O&M Grade: **4**
Clock Start/From:
Clock To:
1st Value:
2nd Value:
Value Percent:
Continuous Index: **S04**
Within 8" of Joint: **NO**
Remarks:

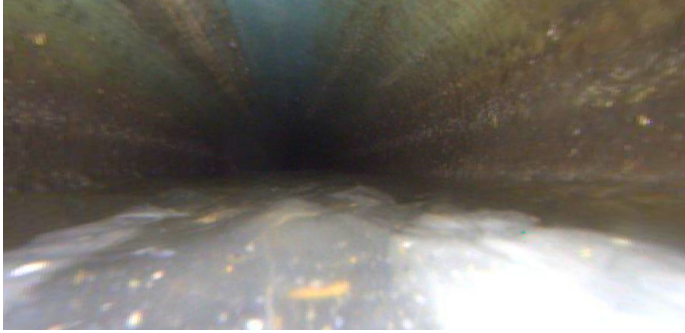
Code: **MCU**
Description: **Camera Underwater**

Distance (ft): **134.5**
Structural Grade: **0**
O&M Grade: **4**
Clock Start/From:
Clock To:
1st Value:
2nd Value:
Value Percent:
Continuous Index: **F04**
Within 8" of Joint: **NO**
Remarks:

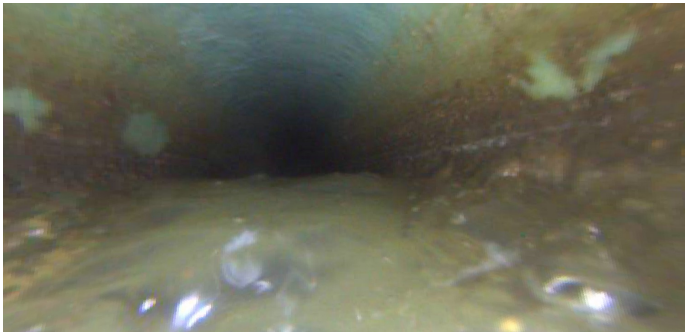
Code: **MWL**
Description: **Water Level**

Distance (ft): **240.8**
Structural Grade: **0**
O&M Grade: **0**
Clock Start/From:
Clock To:
1st Value:
2nd Value:
Value Percent: **20.000**
Continuous Index:
Within 8" of Joint: **NO**
Remarks:

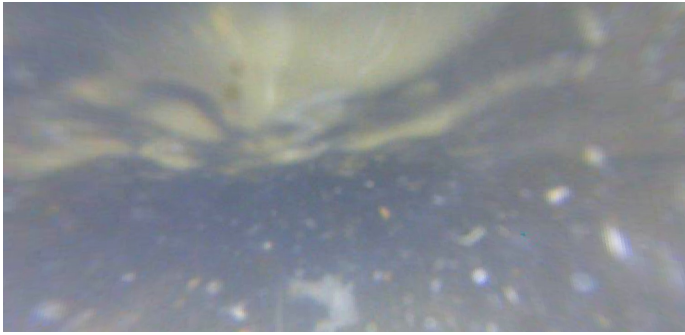
Code: **MCU**
Description: **Camera Underwater**

Distance (ft): **251.1**
Structural Grade: **0**
O&M Grade: **4**
Clock Start/From:
Clock To:
1st Value:
2nd Value:
Value Percent:
Continuous Index: **S05**
Within 8" of Joint: **NO**
Remarks:

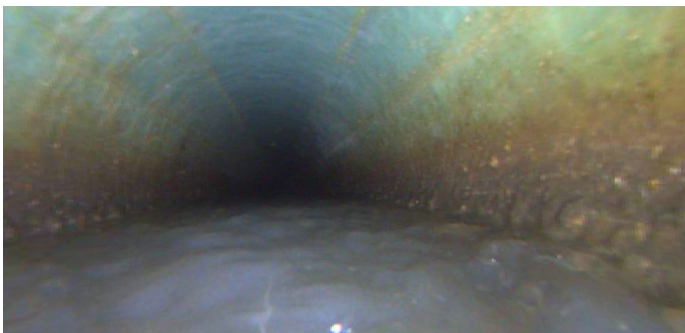
Code: **MCU**
Description: **Camera Underwater**

Distance (ft): **275.1**
Structural Grade: **0**
O&M Grade: **4**
Clock Start/From:
Clock To:
1st Value:
2nd Value:
Value Percent:
Continuous Index: **F05**
Within 8" of Joint: **NO**
Remarks:

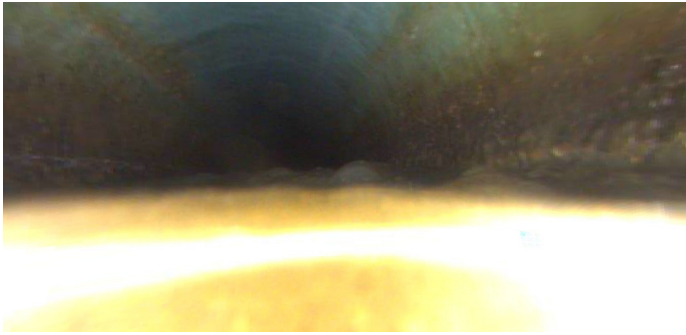
Code: **MWL**
Description: **Water Level**

Distance (ft): **281.8**
Structural Grade: **0**
O&M Grade: **0**
Clock Start/From:
Clock To:
1st Value:
2nd Value:
Value Percent: **20.000**
Continuous Index:
Within 8" of Joint: **NO**
Remarks:

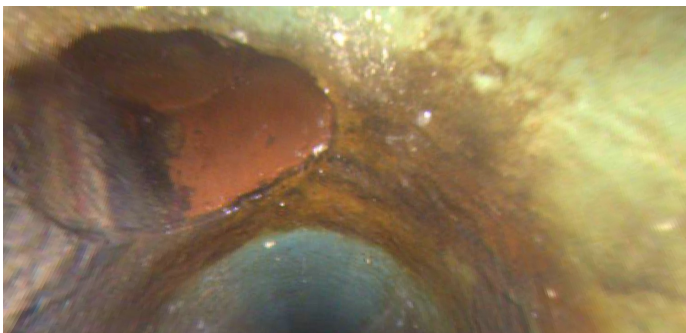
Code: **TF**
Description: **Tap Factory**

Distance (ft): **284.3**
Structural Grade: **0**
O&M Grade: **0**
Clock Start/From: **2**
Clock To:
1st Value: **4.000**
2nd Value:
Value Percent:
Continuous Index:
Within 8" of Joint:
Remarks:

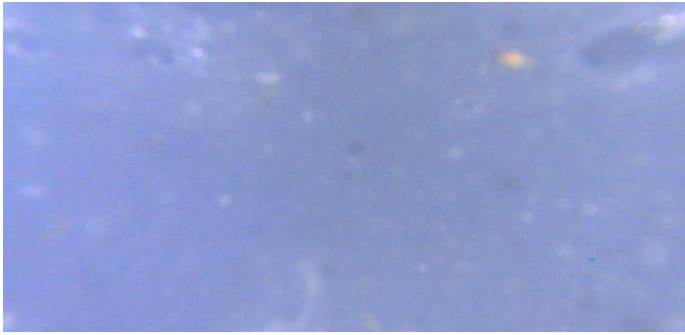
Code: **MCU**
Description: **Camera Underwater**

Distance (ft): **297.8**
Structural Grade: **0**
O&M Grade: **4**
Clock Start/From:
Clock To:
1st Value:
2nd Value:
Value Percent:
Continuous Index:
Within 8" of Joint: **NO**
Remarks:

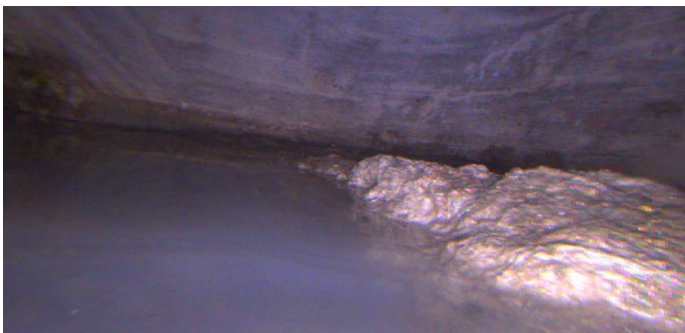
Code: **AMH**
Description: **Manhole**

Distance (ft): **301.9**
Structural Grade: **0**
O&M Grade: **0**
Clock Start/From:
Clock To:
1st Value:
2nd Value:
Value Percent:
Continuous Index:
Within 8" of Joint: **NO**
Remarks: **M-305-012**

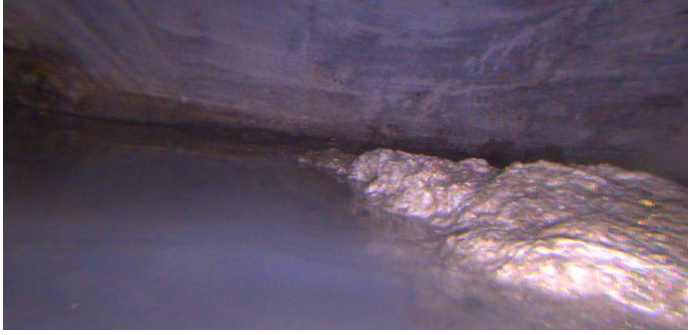
Code:	DAZ
Description:	Deposits Attached Other
Distance (ft):	301.9
Structural Grade:	0
O&M Grade:	2
Clock Start/From:	7
Clock To:	5
1st Value:	
2nd Value:	
Value Percent:	5.000
Continuous Index:	F01
Within 8" of Joint:	YES
Remarks:	WANDER
