## Profile/Photo Observation Report

Street:	<b>FOXCROFT STREET</b>	Flow Control:	<b>Not Controlled</b>
City:	<b>Hobart, IN</b>	Year Renewed:	
Location:	<b>Yard</b>	Tape/Media #:	
Purpose:	<b>Routine Assessment</b>	Dia/Height:	<b>10"</b>
Use:	<b>Sanitary</b>	Material:	<b>PVC</b>
Drain Area:	<b>NA</b>	Lining:	<b>Cured in Place</b>
Category:	<b>NA</b>		
Comment:

Location Details:		Direction of Survey:	<b>Upstream</b>
US MH:	<b>M-305-012</b>	DS MH:	<b>M-305-002</b>
		Total Length Surveyed (ft):	<b>301.9</b>

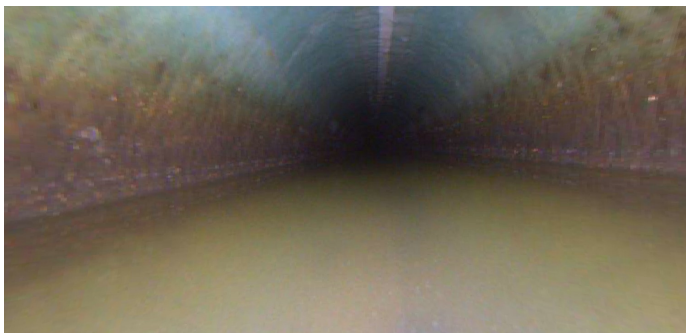
Code: **AMH**  
Description: **Manhole**

Distance (ft): **.0**  
Structural Grade: **0**  
O&M Grade: **0**  
Clock Start/From:  
Clock To:  
1st Value:  
2nd Value:  
Value Percent:  
Continuous Index:  
Within 8" of Joint: **NO**  
Remarks: **M-305-002**

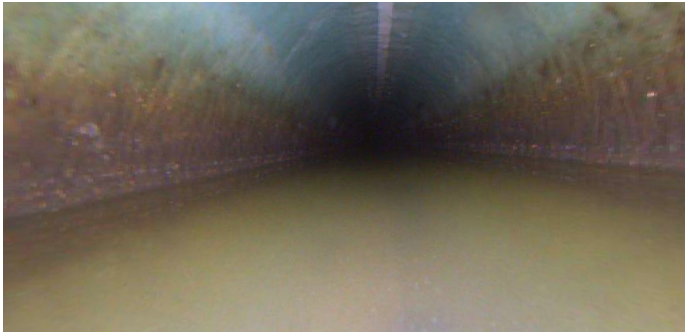
Code:	<b>MWL</b>
Description:	<b>Water Level</b>

Distance (ft):	<b>.0</b>
Structural Grade:	<b>0</b>
O&M Grade:	<b>0</b>
Clock Start/From:	
Clock To:	
1st Value:	
2nd Value:	
Value Percent:	<b>15.000</b>
Continuous Index:	
Within 8" of Joint:	<b>NO</b>
Remarks:

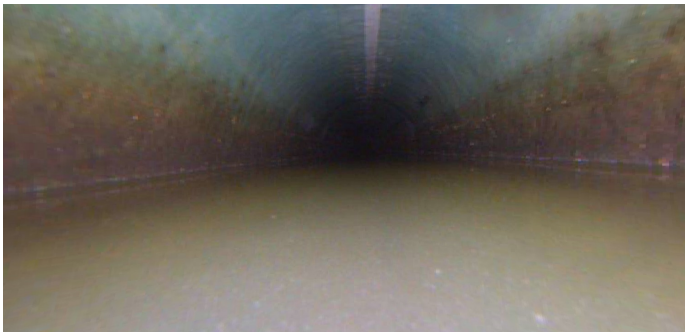
Code:	<b>DAZ</b>
Description:	<b>Deposits Attached Other</b>

Distance (ft):	<b>1.7</b>
Structural Grade:	<b>0</b>
O&M Grade:	<b>2</b>
Clock Start/From:	<b>7</b>
Clock To:	<b>5</b>
1st Value:	
2nd Value:	
Value Percent:	<b>5.000</b>
Continuous Index:	<b>S01</b>
Within 8" of Joint:	<b>YES</b>
Remarks:	<b>WANDER</b>

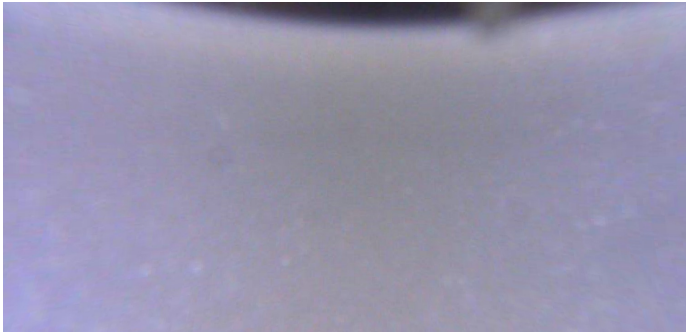
Code: **MCU**  
Description: **Camera Underwater**

Distance (ft): **5.8**  
Structural Grade: **0**  
O&M Grade: **4**  
Clock Start/From:  
Clock To:  
1st Value:  
2nd Value:  
Value Percent:  
Continuous Index: **S02**  
Within 8" of Joint: **NO**  
Remarks:

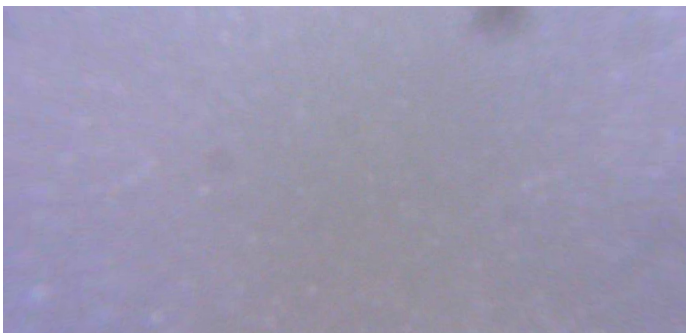
Code: **MGO**  
Description: **General Observation**

Distance (ft): **10.6**  
Structural Grade: **0**  
O&M Grade: **0**  
Clock Start/From:  
Clock To:  
1st Value:  
2nd Value:  
Value Percent:  
Continuous Index:  
Within 8" of Joint: **NO**  
Remarks: **FLOW TO HIGH**

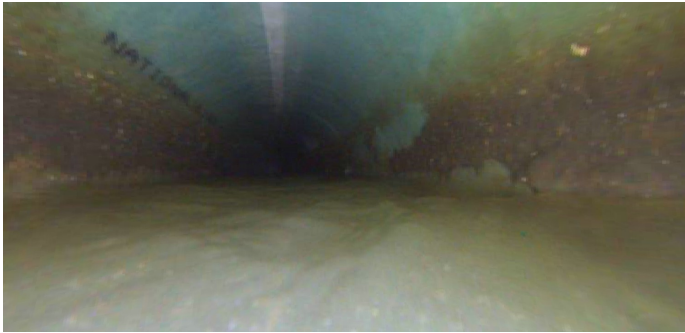
Code: **MCU**  
Description: **Camera Underwater**

Distance (ft): **15.6**  
Structural Grade: **0**  
O&M Grade: **4**  
Clock Start/From:  
Clock To:  
1st Value:  
2nd Value:  
Value Percent:  
Continuous Index: **F02**  
Within 8" of Joint: **NO**  
Remarks:

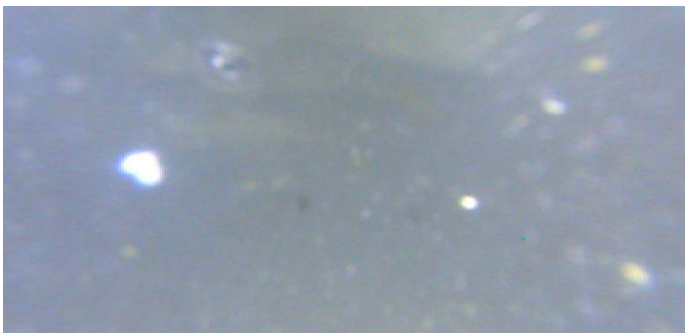
Code: **MCU**  
Description: **Camera Underwater**

Distance (ft): **35.5**  
Structural Grade: **0**  
O&M Grade: **4**  
Clock Start/From:  
Clock To:  
1st Value:  
2nd Value:  
Value Percent:  
Continuous Index: **S03**  
Within 8" of Joint: **NO**  
Remarks:

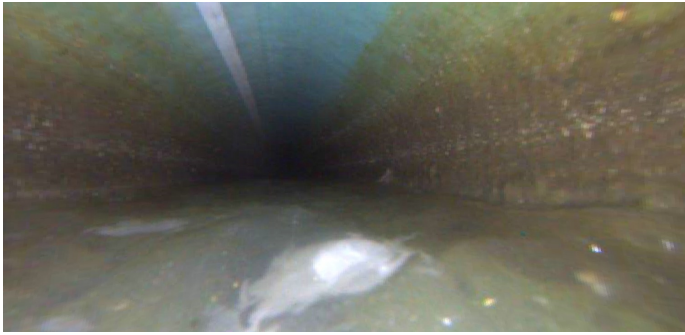
Code: **MCU**  
Description: **Camera Underwater**

Distance (ft): **117.5**  
Structural Grade: **0**  
O&M Grade: **4**  
Clock Start/From:  
Clock To:  
1st Value:  
2nd Value:  
Value Percent:  
Continuous Index: **F03**  
Within 8" of Joint: **NO**  
Remarks:

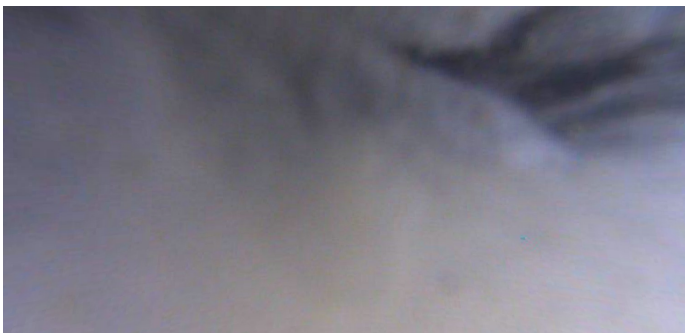
Code: **MCU**  
Description: **Camera Underwater**

Distance (ft): **124.8**  
Structural Grade: **0**  
O&M Grade: **4**  
Clock Start/From:  
Clock To:  
1st Value:  
2nd Value:  
Value Percent:  
Continuous Index: **S04**  
Within 8" of Joint: **NO**  
Remarks:

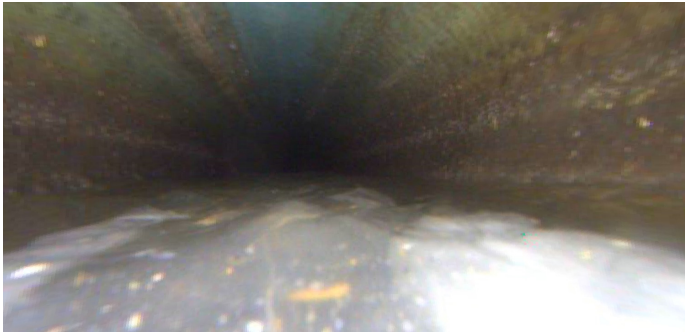
Code: **MCU**  
Description: **Camera Underwater**

Distance (ft): **134.5**  
Structural Grade: **0**  
O&M Grade: **4**  
Clock Start/From:  
Clock To:  
1st Value:  
2nd Value:  
Value Percent:  
Continuous Index: **F04**  
Within 8" of Joint: **NO**  
Remarks:

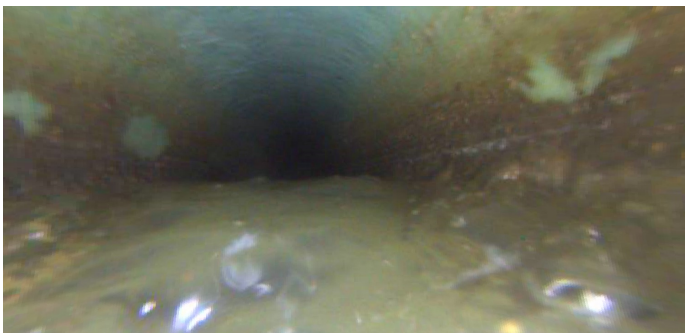
Code: **MWL**  
Description: **Water Level**

Distance (ft): **240.8**  
Structural Grade: **0**  
O&M Grade: **0**  
Clock Start/From:  
Clock To:  
1st Value:  
2nd Value:  
Value Percent: **20.000**  
Continuous Index:  
Within 8" of Joint: **NO**  
Remarks:

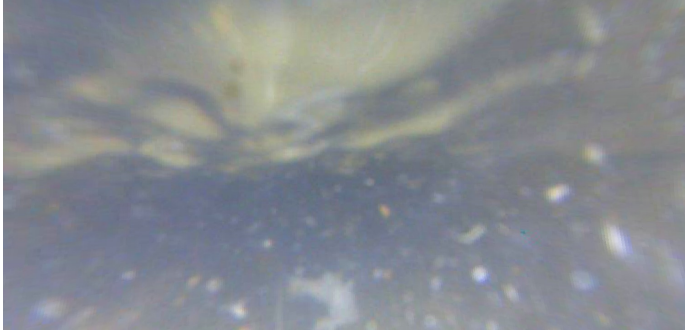
Code: **MCU**  
Description: **Camera Underwater**

Distance (ft): **251.1**  
Structural Grade: **0**  
O&M Grade: **4**  
Clock Start/From:  
Clock To:  
1st Value:  
2nd Value:  
Value Percent:  
Continuous Index: **S05**  
Within 8" of Joint: **NO**  
Remarks:

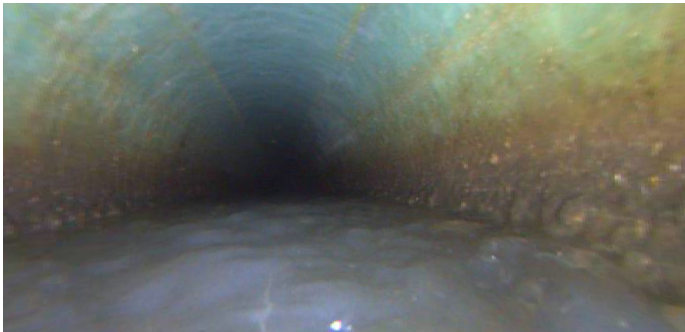
Code: **MCU**  
Description: **Camera Underwater**

Distance (ft): **275.1**  
Structural Grade: **0**  
O&M Grade: **4**  
Clock Start/From:  
Clock To:  
1st Value:  
2nd Value:  
Value Percent:  
Continuous Index: **F05**  
Within 8" of Joint: **NO**  
Remarks:

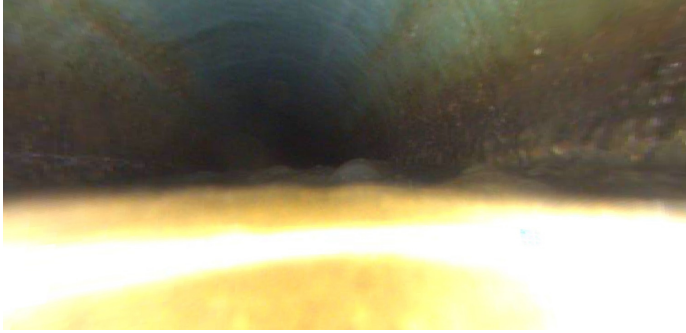
Code: **MWL**  
Description: **Water Level**

Distance (ft): **281.8**  
Structural Grade: **0**  
O&M Grade: **0**  
Clock Start/From:  
Clock To:  
1st Value:  
2nd Value:  
Value Percent: **20.000**  
Continuous Index:  
Within 8" of Joint: **NO**  
Remarks:

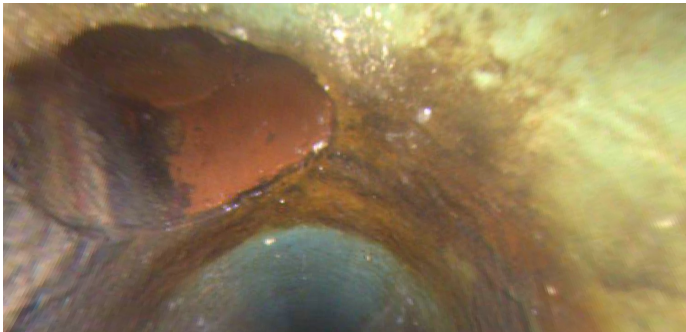
Code: **TF**  
Description: **Tap Factory**

Distance (ft): **284.3**  
Structural Grade: **0**  
O&M Grade: **0**  
Clock Start/From: **2**  
Clock To:  
1st Value: **4.000**  
2nd Value:  
Value Percent:  
Continuous Index:  
Within 8" of Joint:  
Remarks:

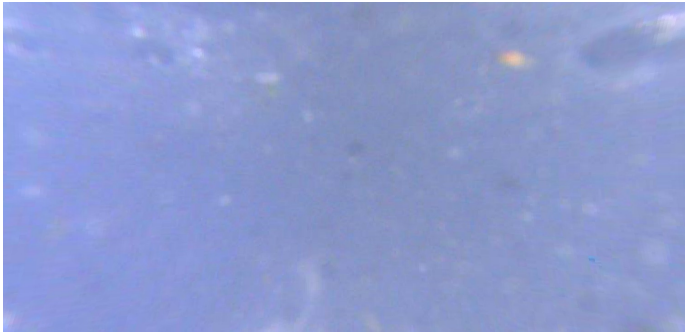
Code: **MCU**  
Description: **Camera Underwater**

Distance (ft): **297.8**  
Structural Grade: **0**  
O&M Grade: **4**  
Clock Start/From:  
Clock To:  
1st Value:  
2nd Value:  
Value Percent:  
Continuous Index:  
Within 8" of Joint: **NO**  
Remarks:

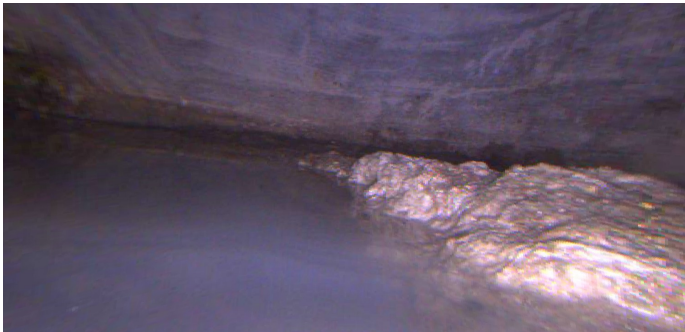
Code: **AMH**  
Description: **Manhole**

Distance (ft): **301.9**  
Structural Grade: **0**  
O&M Grade: **0**  
Clock Start/From:  
Clock To:  
1st Value:  
2nd Value:  
Value Percent:  
Continuous Index:  
Within 8" of Joint: **NO**  
Remarks: **M-305-012**

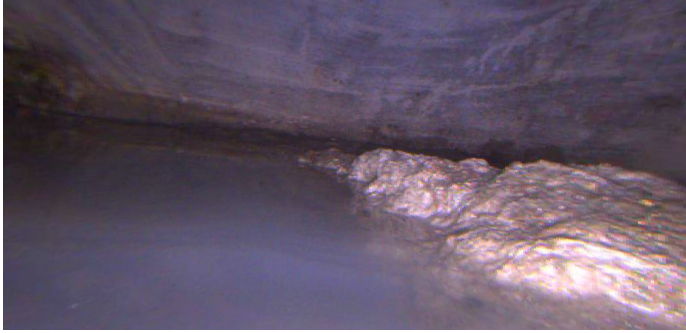
Code:	<b>DAZ</b>
Description:	<b>Deposits Attached Other</b>
Distance (ft):	<b>301.9</b>
Structural Grade:	<b>0</b>
O&M Grade:	<b>2</b>
Clock Start/From:	<b>7</b>
Clock To:	<b>5</b>
1st Value:	
2nd Value:	
Value Percent:	<b>5.000</b>
Continuous Index:	<b>F01</b>
Within 8" of Joint:	<b>YES</b>
Remarks:	<b>WANDER</b>
