Profile/Photo Observation Report

Street:	ALLEY BETWEEN WALNUT LN & CRO	Flow Control:	Not Controlled
City:	Hobart, IN	Year Renewed:	
Location:	Yard	Tape/Media #:	
Purpose:	Routine Assessment	Dia/Height:	10"
Use:	Sanitary	Material:	XXX
Drain Area:	NA	Lining:	Cured in Place
Category:	NA		
Comment:	Debris on lenses

Location Details:		Direction of Survey:	Downstream
US MH:	M-305-013	DS MH:	M-305-012
		Total Length Surveyed (ft):	279.8

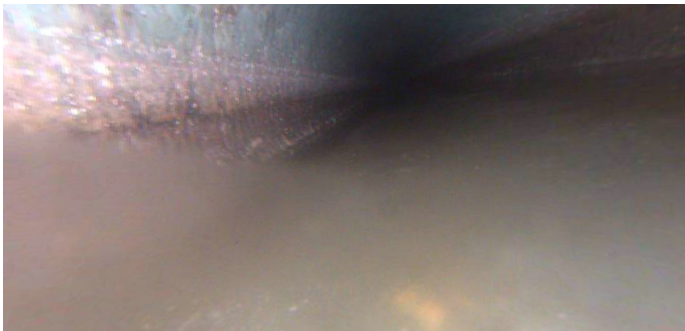
Code:	AMH
Description:	Manhole

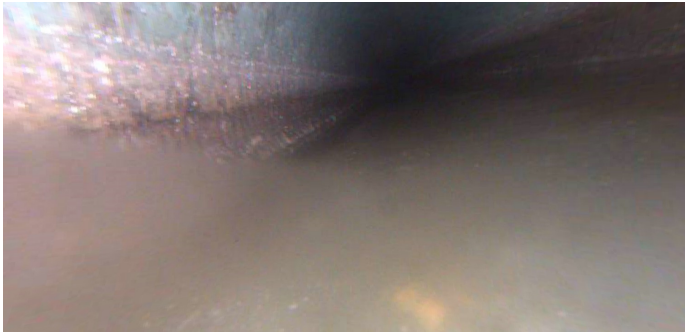
Code:	MWL
Description:	Water Level

Distance (ft):	.0
Structural Grade:	0
O&M Grade:	0
Clock Start/From:	
Clock To:	
1st Value:	
2nd Value:	
Value Percent:	5.000
Continuous Index:	
Within 8" of Joint:	NO
Remarks:

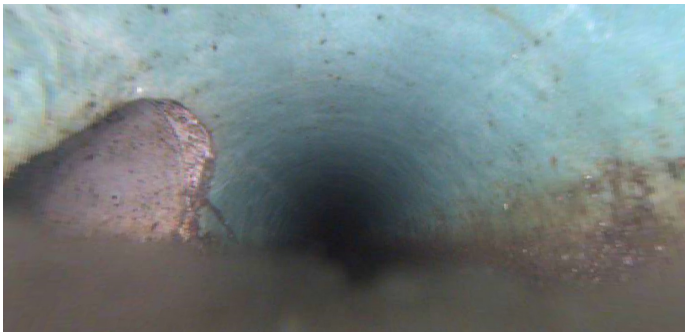
Code:	TB
Description:	Tap Break-in

Distance (ft):	42.2
Structural Grade:	0
O&M Grade:	0
Clock Start/From:	9
Clock To:	
1st Value:	4.000
2nd Value:	
Value Percent:	
Continuous Index:	
Within 8" of Joint:	
Remarks:

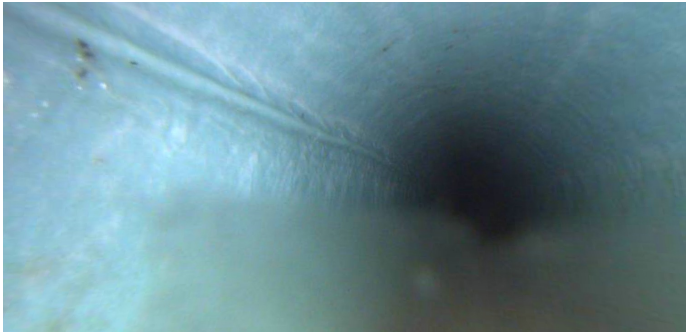
Code: **LFW**
Description: **Lining Failure Wrinkled**

Distance (ft): **56.4**
Structural Grade: **3**
O&M Grade: **0**
Clock Start/From: **10**
Clock To:
1st Value:
2nd Value:
Value Percent:
Continuous Index:
Within 8" of Joint: **NO**
Remarks:

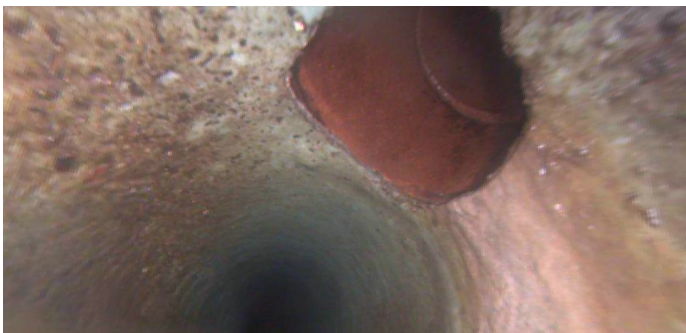
Code: **TB**
Description: **Tap Break-in**

Distance (ft): **70.5**
Structural Grade: **0**
O&M Grade: **0**
Clock Start/From: **1**
Clock To:
1st Value: **4.000**
2nd Value:
Value Percent:
Continuous Index:
Within 8" of Joint:
Remarks:

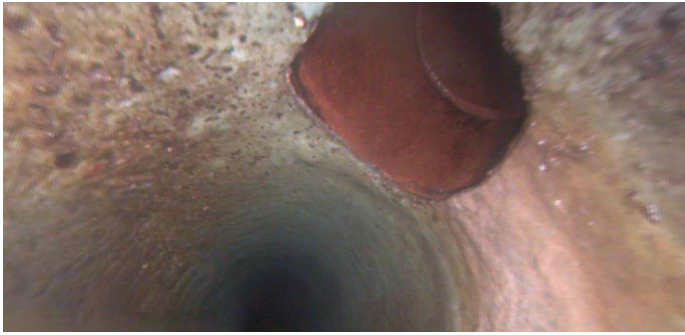
Code: **DAGS**
Description: **Deposits Attached Grease**

Distance (ft): **70.5**
Structural Grade: **0**
O&M Grade: **2**
Clock Start/From: **2**
Clock To: **5**
1st Value:
2nd Value:
Value Percent: **5.000**
Continuous Index:
Within 8" of Joint: **NO**
Remarks:

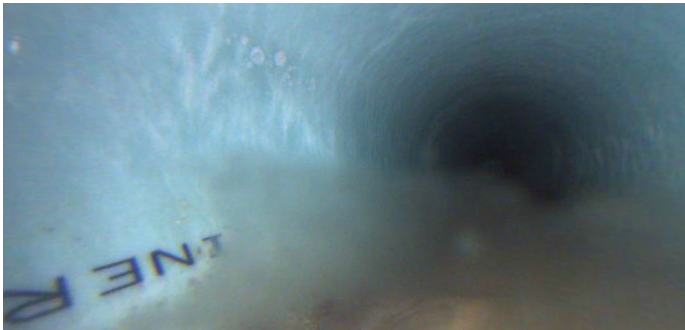
Code: **LFAC**
Description: **Lining Failure Abandoned Connection**

Distance (ft): **75.1**
Structural Grade: **0**
O&M Grade: **0**
Clock Start/From: **9**
Clock To:
1st Value:
2nd Value:
Value Percent:
Continuous Index:
Within 8" of Joint: **NO**
Remarks:

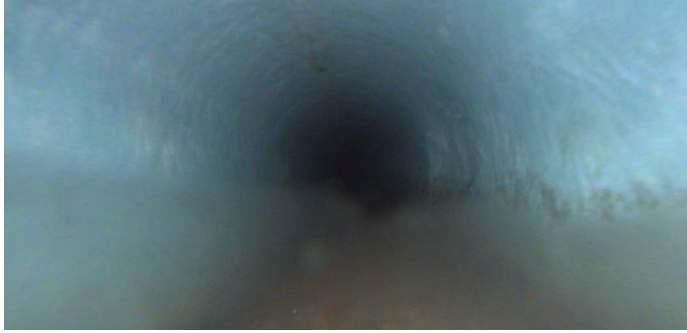
Code:	LFAC
Description:	Lining Failure Abandoned Connection
Distance (ft):	76.6
Structural Grade:	0
O&M Grade:	0
Clock Start/From:	3
Clock To:	
1st Value:	
2nd Value:	
Value Percent:	
Continuous Index:	
Within 8" of Joint:	NO
Remarks:

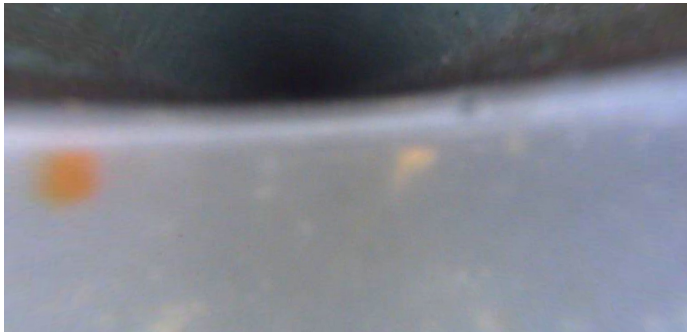
Code:	MCU
Description:	Camera Underwater
Distance (ft):	144.6
Structural Grade:	0
O&M Grade:	4
Clock Start/From:	
Clock To:	
1st Value:	
2nd Value:	
Value Percent:	
Continuous Index:	
Within 8" of Joint:	NO
Remarks:

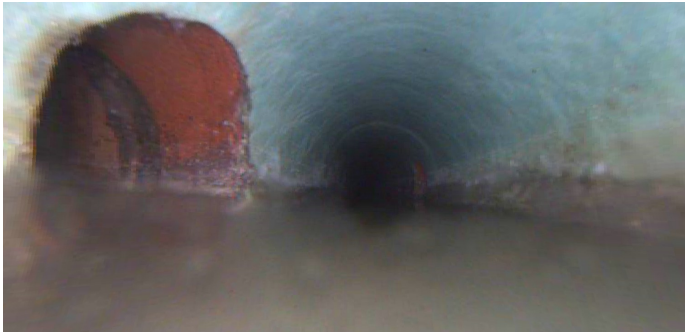
Code: **TB**
Description: **Tap Break-in**

Distance (ft): **154.3**
Structural Grade: **0**
O&M Grade: **0**
Clock Start/From: **9**
Clock To:
1st Value: **4.000**
2nd Value:
Value Percent:
Continuous Index:
Within 8" of Joint:
Remarks:

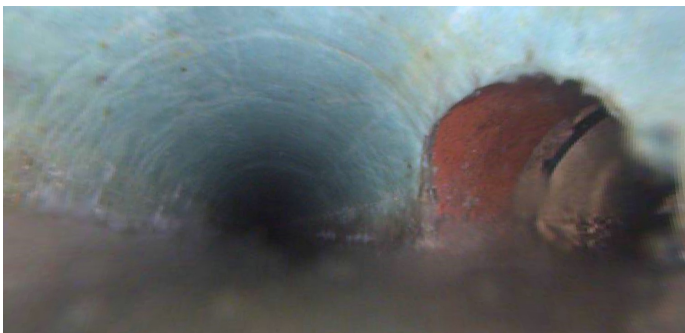
Code: **TB**
Description: **Tap Break-in**

Distance (ft): **156.4**
Structural Grade: **0**
O&M Grade: **0**
Clock Start/From: **3**
Clock To:
1st Value: **4.000**
2nd Value:
Value Percent:
Continuous Index:
Within 8" of Joint:
Remarks:

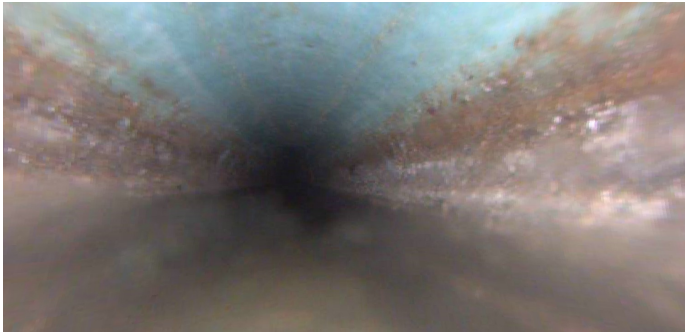
Code: **DAGS**
Description: **Deposits Attached Grease**

Distance (ft): **195.8**
Structural Grade: **0**
O&M Grade: **2**
Clock Start/From: **7**
Clock To: **5**
1st Value:
2nd Value:
Value Percent: **5.000**
Continuous Index: **S01**
Within 8" of Joint: **NO**
Remarks:

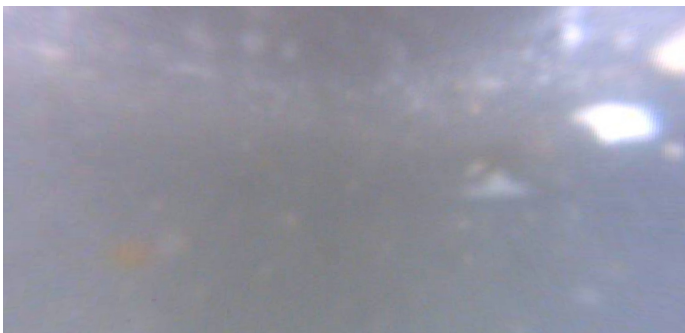
Code: **MCU**
Description: **Camera Underwater**

Distance (ft): **221.2**
Structural Grade: **0**
O&M Grade: **4**
Clock Start/From:
Clock To:
1st Value:
2nd Value:
Value Percent:
Continuous Index: **S02**
Within 8" of Joint: **NO**
Remarks:

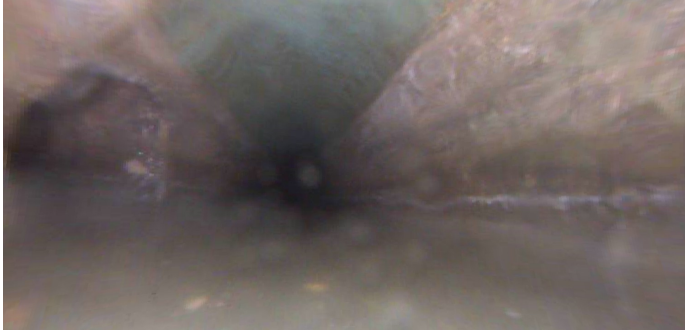
Code: **TB**
Description: **Tap Break-in**

Distance (ft): **238.3**
Structural Grade: **0**
O&M Grade: **0**
Clock Start/From: **9**
Clock To:
1st Value: **4.000**
2nd Value:
Value Percent:
Continuous Index:
Within 8" of Joint:
Remarks:

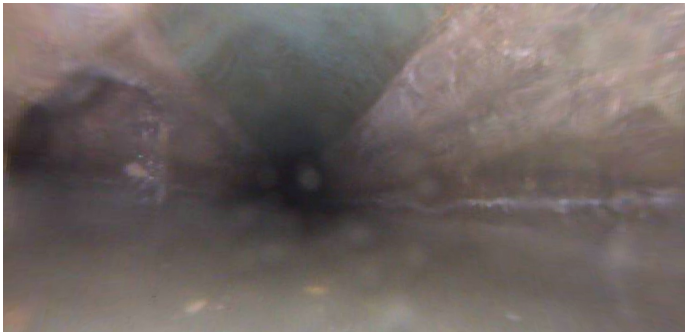
Code: **MCU**
Description: **Camera Underwater**

Distance (ft): **238.3**
Structural Grade: **0**
O&M Grade: **4**
Clock Start/From:
Clock To:
1st Value:
2nd Value:
Value Percent:
Continuous Index: **F02**
Within 8" of Joint: **NO**
Remarks:

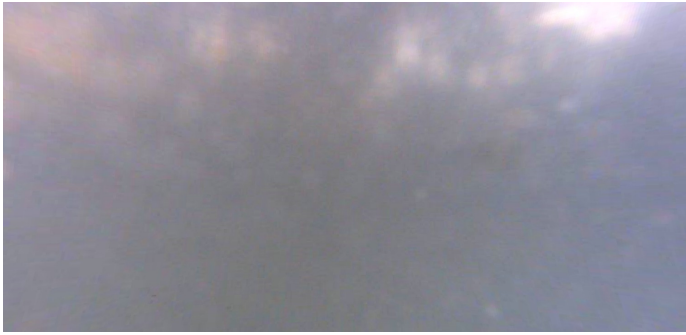
Code: **MCU**
Description: **Camera Underwater**

Distance (ft): **247.0**
Structural Grade: **0**
O&M Grade: **4**
Clock Start/From:
Clock To:
1st Value:
2nd Value:
Value Percent:
Continuous Index: **S03**
Within 8" of Joint: **NO**
Remarks:
