Profile/Photo Observation Report

Street:	FOXCROFT STREET	Flow Control:	Not Controlled
City:	Hobart, IN	Year Renewed:	
Location:	Yard	Tape/Media #:	
Purpose:	Routine Assessment	Dia/Height:	10"
Use:	Sanitary	Material:	XXX
Drain Area:	NA	Lining:	Cured in Place
Category:	NA		
Comment:	Debris on lenses

Location Details:		Direction of Survey:	Downstream
US MH:	M-305-013	DS MH:	M-305-012
		Total Length Surveyed (ft):	279.8

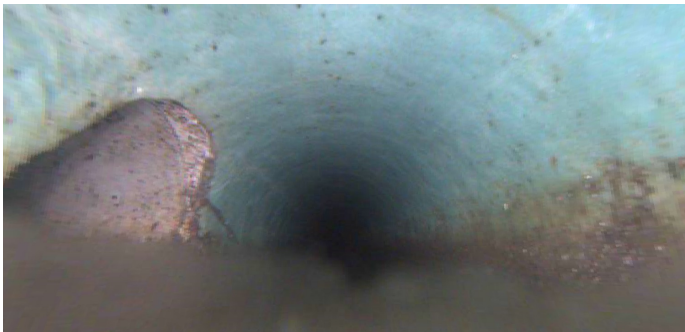
Code:	TB
Description:	Tap Break-in

Distance (ft):	42.2
Structural Grade:	0
O&M Grade:	0
Clock Start/From:	9
Clock To:	
1st Value:	4.000
2nd Value:	
Value Percent:	
Continuous Index:	
Within 8" of Joint:	
Remarks:

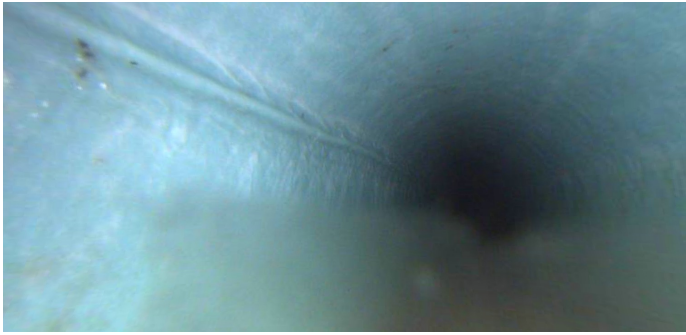
Code: **LFW**
Description: **Lining Failure Wrinkled**

Distance (ft): **56.4**
Structural Grade: **3**
O&M Grade: **0**
Clock Start/From: **10**
Clock To:
1st Value:
2nd Value:
Value Percent:
Continuous Index:
Within 8" of Joint: **NO**
Remarks:

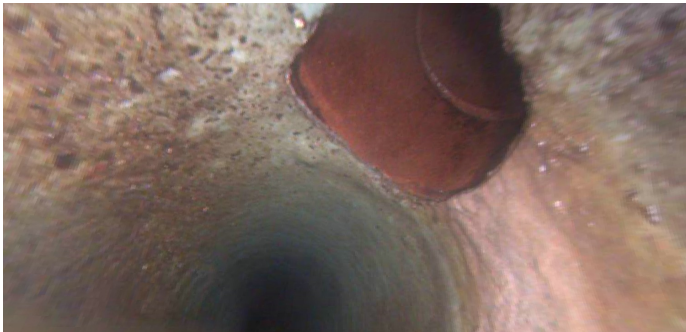
Code: **TB**
Description: **Tap Break-in**

Distance (ft): **70.5**
Structural Grade: **0**
O&M Grade: **0**
Clock Start/From: **1**
Clock To:
1st Value: **4.000**
2nd Value:
Value Percent:
Continuous Index:
Within 8" of Joint:
Remarks:

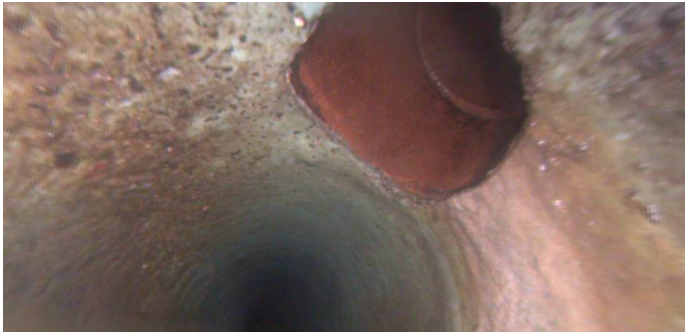
Code: **DAGS**
Description: **Deposits Attached Grease**

Distance (ft): **70.5**
Structural Grade: **0**
O&M Grade: **2**
Clock Start/From: **2**
Clock To: **5**
1st Value:
2nd Value:
Value Percent: **5.000**
Continuous Index:
Within 8" of Joint: **NO**
Remarks:

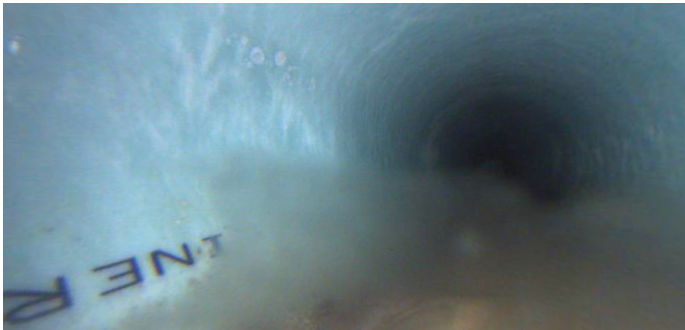
Code: **LFAC**
Description: **Lining Failure Abandoned Connection**

Distance (ft): **75.1**
Structural Grade: **0**
O&M Grade: **0**
Clock Start/From: **9**
Clock To:
1st Value:
2nd Value:
Value Percent:
Continuous Index:
Within 8" of Joint: **NO**
Remarks:

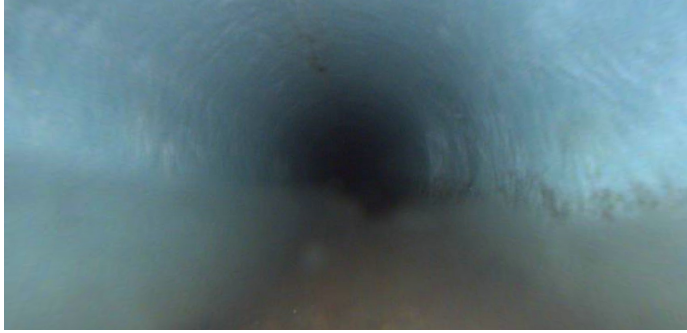
Code:	LFAC
Description:	Lining Failure Abandoned Connection
Distance (ft):	76.6
Structural Grade:	0
O&M Grade:	0
Clock Start/From:	3
Clock To:	
1st Value:	
2nd Value:	
Value Percent:	
Continuous Index:	
Within 8" of Joint:	NO
Remarks:

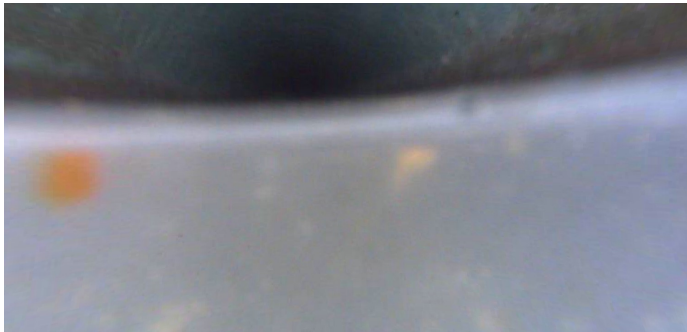
Code:	MCU
Description:	Camera Underwater
Distance (ft):	144.6
Structural Grade:	0
O&M Grade:	4
Clock Start/From:	
Clock To:	
1st Value:	
2nd Value:	
Value Percent:	
Continuous Index:	
Within 8" of Joint:	NO
Remarks:

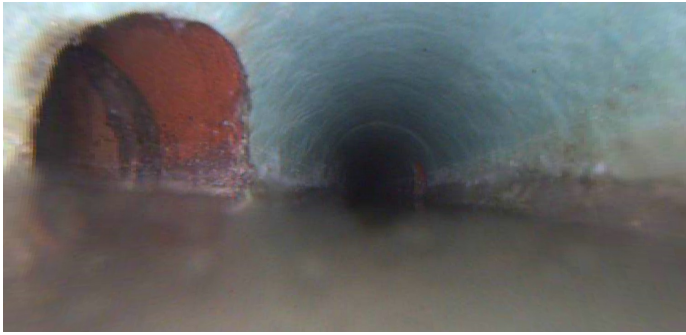
Code: **TB**
Description: **Tap Break-in**

Distance (ft): **154.3**
Structural Grade: **0**
O&M Grade: **0**
Clock Start/From: **9**
Clock To:
1st Value: **4.000**
2nd Value:
Value Percent:
Continuous Index:
Within 8" of Joint:
Remarks:

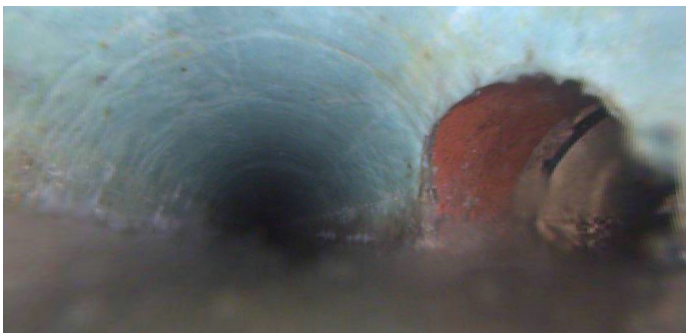
Code: **TB**
Description: **Tap Break-in**

Distance (ft): **156.4**
Structural Grade: **0**
O&M Grade: **0**
Clock Start/From: **3**
Clock To:
1st Value: **4.000**
2nd Value:
Value Percent:
Continuous Index:
Within 8" of Joint:
Remarks:

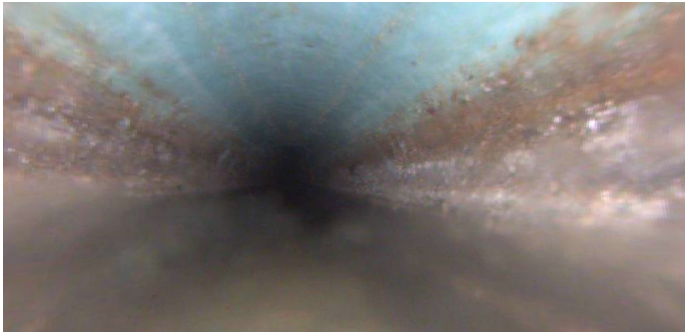
Code: **DAGS**
Description: **Deposits Attached Grease**

Distance (ft): **195.8**
Structural Grade: **0**
O&M Grade: **2**
Clock Start/From: **7**
Clock To: **5**
1st Value:
2nd Value:
Value Percent: **5.000**
Continuous Index: **S01**
Within 8" of Joint: **NO**
Remarks:

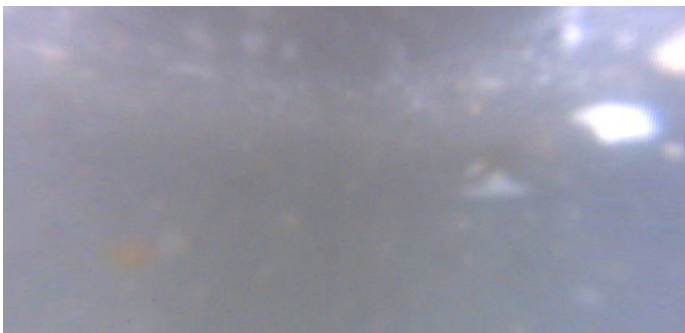
Code: **MCU**
Description: **Camera Underwater**

Distance (ft): **221.2**
Structural Grade: **0**
O&M Grade: **4**
Clock Start/From:
Clock To:
1st Value:
2nd Value:
Value Percent:
Continuous Index: **S02**
Within 8" of Joint: **NO**
Remarks:

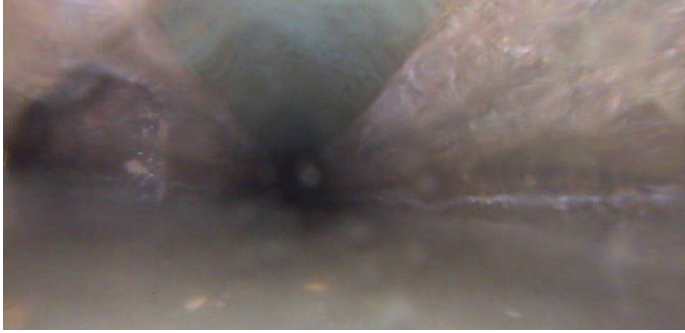
Code: **TB**
Description: **Tap Break-in**

Distance (ft): **238.3**
Structural Grade: **0**
O&M Grade: **0**
Clock Start/From: **9**
Clock To:
1st Value: **4.000**
2nd Value:
Value Percent:
Continuous Index:
Within 8" of Joint:
Remarks:

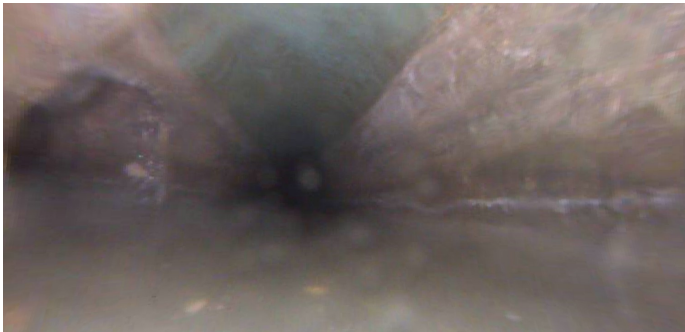
Code: **MCU**
Description: **Camera Underwater**

Distance (ft): **238.3**
Structural Grade: **0**
O&M Grade: **4**
Clock Start/From:
Clock To:
1st Value:
2nd Value:
Value Percent:
Continuous Index: **F02**
Within 8" of Joint: **NO**
Remarks:

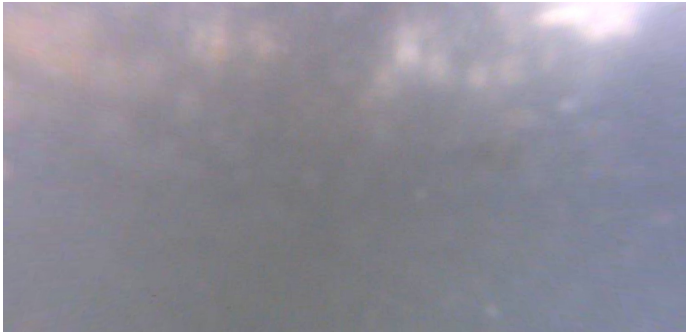
Code: **MCU**
Description: **Camera Underwater**

Distance (ft): **247.0**
Structural Grade: **0**
O&M Grade: **4**
Clock Start/From:
Clock To:
1st Value:
2nd Value:
Value Percent:
Continuous Index: **S03**
Within 8" of Joint: **NO**
Remarks:
