Profile/Photo Observation Report

Street:	ALLEY BETWEEN WALNUT LN & CRO	Flow Control:	Not Controlled
City:	Hobart, IN	Year Renewed:	
Location:	Yard	Tape/Media #:	
Purpose:	Routine Assessment	Dia/Height:	10"
Use:	Sanitary	Material:	PVC
Drain Area:	NA	Lining:	
Category:	NA		
Comment:	M_T_P_C at 406 ft CU/ debris on the lenses		
Location Details:		Direction of Survey:	Upstream
US MH:	M-305-014	DS MH:	M-305-013
		Total Length Surveyed (ft):	408.0

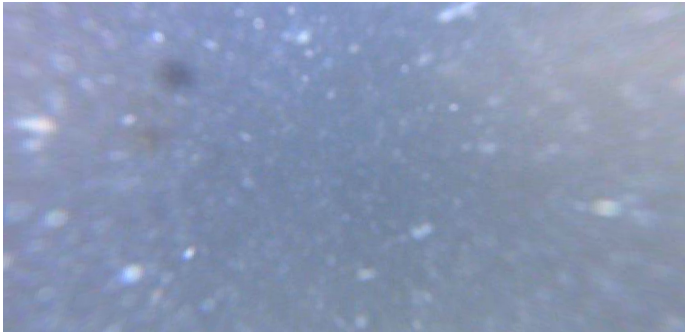
Code:	MWL
Description:	Water Level

Distance (ft):	.0
Structural Grade:	0
O&M Grade:	0
Clock Start/From:	
Clock To:	
1st Value:	
2nd Value:	
Value Percent:	100.000
Continuous Index:	
Within 8" of Joint:	NO
Remarks:	mcu
