Profile/Photo Observation Report

Date:	04/18/2018	Weather:		Coding:	PACP 6.0
Pipe Length (ft):	277.0	Owner:	NA	Pre Clean:	No Pre-Cleaning
P.O.#:		Surveyor:	Byrd Fitzgerald	PSR:	P-305-014-013
Customer:		Clean Date:	01/01/1900	Shape:	C

Street:	FOXCROFT STREET	Flow Control:	Not Controlled
City:	Hobart, IN	Year Renewed:	
Location:	Yard	Tape/Media #:	
Purpose:	Routine Assessment	Dia/Height:	10"
Use:	Sanitary	Material:	PVC
Drain Area:	NA	Lining:	
Category:	NA		
Comment:	M_T_P_C at 406 ft CU/ debris on the lenses		
Location Details:		Direction of Survey:	Upstream
US MH:	M-305-014	DS MH:	M-305-013
		Total Length Surveyed (ft):	408.0

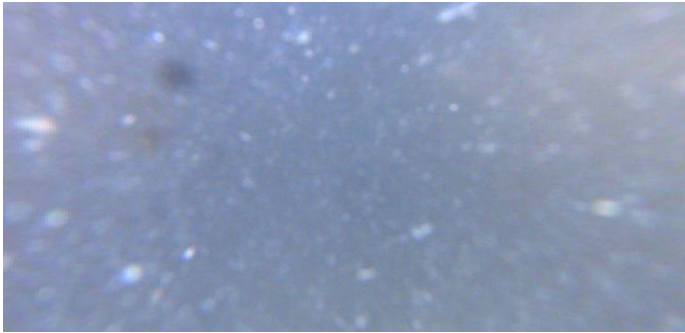
Code:	MWL
Description:	Water Level

Distance (ft):	.0
Structural Grade:	0
O&M Grade:	0
Clock Start/From:	
Clock To:	
1st Value:	
2nd Value:	
Value Percent:	100.000
Continuous Index:	
Within 8" of Joint:	NO
Remarks:	mcu
