Profile/Photo Observation Report

Street:	ALLEY BETWEEN WALNUT LN & CRO	Flow Control:	Not Controlled
City:	Hobart, IN	Year Renewed:	
Location:	Yard	Tape/Media #:	
Purpose:	Routine Assessment	Dia/Height:	10"
Use:	Sanitary	Material:	XXX
Drain Area:	NA	Lining:	Cured in Place
Category:	NA		
Comment:

Location Details:		Direction of Survey:	Downstream
US MH:	M-305-015	DS MH:	M-305-014
		Total Length Surveyed (ft):	274.8

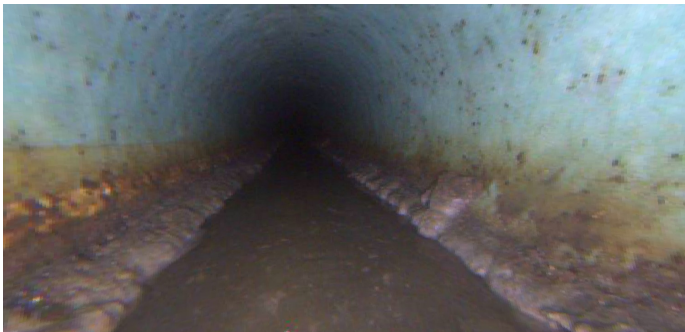
Code:	DAGS
Description:	Deposits Attached Grease

Distance (ft):	35.8
Structural Grade:	0
O&M Grade:	2
Clock Start/From:	7
Clock To:	5
1st Value:	
2nd Value:	
Value Percent:	5.000
Continuous Index:	S01
Within 8" of Joint:	NO
Remarks:	7 and 5 oclock

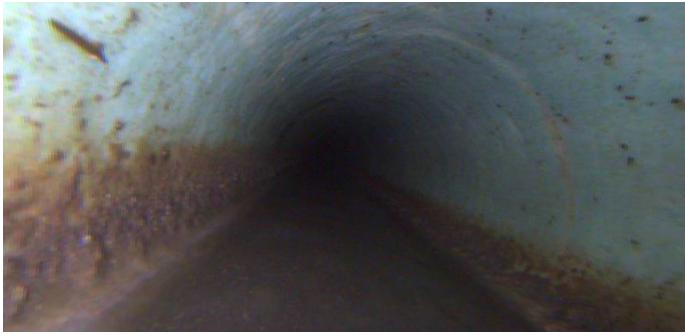
Code: **DAGS**
Description: **Deposits Attached Grease**

Distance (ft): **46.8**
Structural Grade: **0**
O&M Grade: **2**
Clock Start/From: **7**
Clock To: **5**
1st Value:
2nd Value:
Value Percent: **5.000**
Continuous Index: **F01**
Within 8" of Joint: **NO**
Remarks: **7 and 5 oclock**

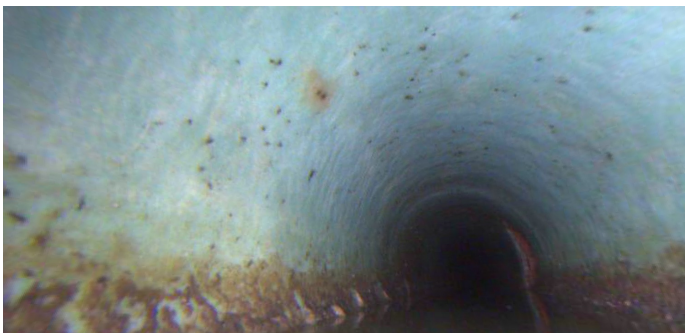
Code: **LFAC**
Description: **Lining Failure Abandoned Connection**

Distance (ft): **55.1**
Structural Grade: **0**
O&M Grade: **0**
Clock Start/From: **9**
Clock To:
1st Value:
2nd Value:
Value Percent:
Continuous Index:
Within 8" of Joint: **NO**
Remarks:

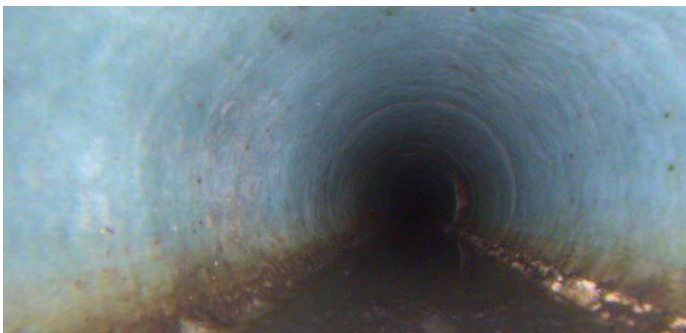
Code: **LFAC**
Description: **Lining Failure Abandoned Connection**

Distance (ft): **134.3**
Structural Grade: **0**
O&M Grade: **0**
Clock Start/From: **9**
Clock To:
1st Value:
2nd Value:
Value Percent:
Continuous Index:
Within 8" of Joint: **NO**
Remarks:

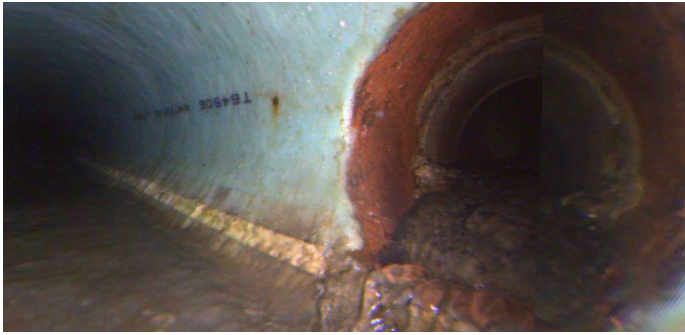
Code: **TBD**
Description: **Tap Break-in Defective**

Distance (ft): **136.9**
Structural Grade: **0**
O&M Grade: **3**
Clock Start/From: **3**
Clock To:
1st Value: **6.000**
2nd Value:
Value Percent:
Continuous Index:
Within 8" of Joint:
Remarks: **partially blocked by debris**

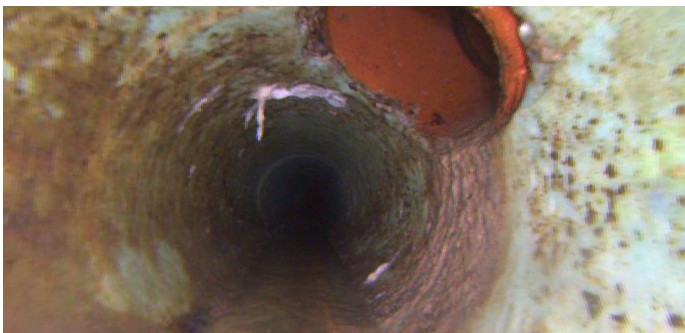
Code: **DAGS**
Description: **Deposits Attached Grease**

Distance (ft): **195.7**
Structural Grade: **0**
O&M Grade: **2**
Clock Start/From: **2**
Clock To: **5**
1st Value:
2nd Value:
Value Percent: **5.000**
Continuous Index:
Within 8" of Joint: **NO**
Remarks:

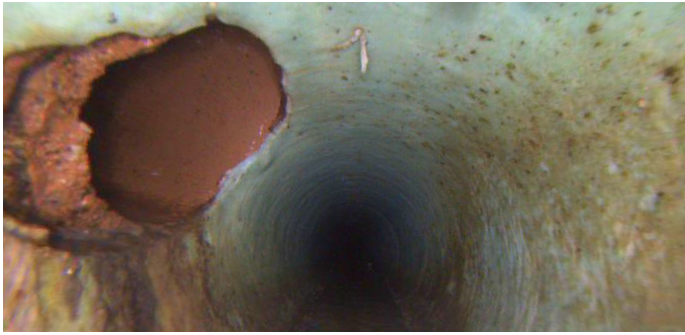
Code: **TBI**
Description: **Tap Break-in Intruding**

Distance (ft): **205.8**
Structural Grade: **0**
O&M Grade: **2**
Clock Start/From: **10**
Clock To:
1st Value: **4.000**
2nd Value: **1.000**
Value Percent:
Continuous Index:
Within 8" of Joint:
Remarks:

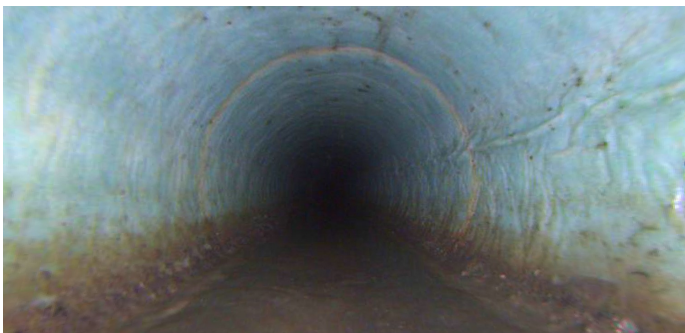
Code: **LFW**
Description: **Lining Failure Wrinkled**

Distance (ft): **213.7**
Structural Grade: **3**
O&M Grade: **0**
Clock Start/From: **2**
Clock To:
1st Value:
2nd Value:
Value Percent:
Continuous Index:
Within 8" of Joint: **NO**
Remarks:

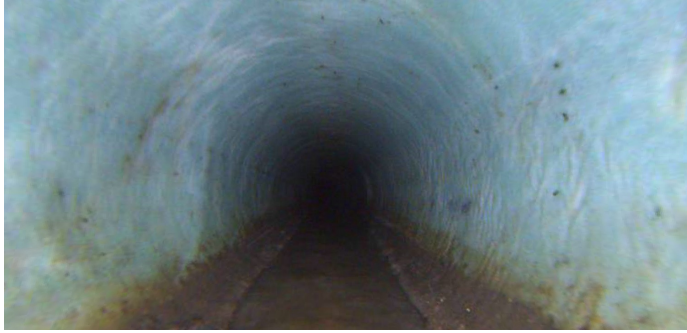
Code:	LFAC
Description:	Lining Failure Abandoned Connection
Distance (ft):	218.4
Structural Grade:	0
O&M Grade:	0
Clock Start/From:	9
Clock To:	
1st Value:	
2nd Value:	
Value Percent:	
Continuous Index:	
Within 8" of Joint:	NO
Remarks:

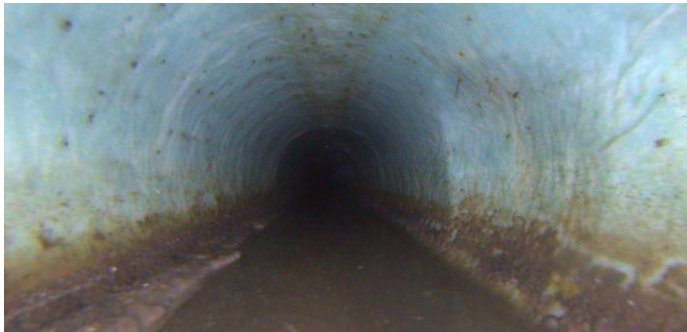
Code:	LFAC
Description:	Lining Failure Abandoned Connection
Distance (ft):	220.5
Structural Grade:	0
O&M Grade:	0
Clock Start/From:	3
Clock To:	
1st Value:	
2nd Value:	
Value Percent:	
Continuous Index:	
Within 8" of Joint:	NO
Remarks:
