## Profile/Photo Observation Report

Date:	<b>04/18/2018</b>	Weather:		Coding:	<b>PACP 6.0</b>
Pipe Length (ft):	<b>316.2</b>	Owner:	<b>NA</b>	Pre Clean:	<b>No Pre-Cleaning</b>
P.O.#:		Surveyor:	<b>Byrd Fitzgerald</b>	PSR:	<b>P-305-016-015</b>
Customer:		Clean Date:	<b>01/01/1900</b>	Shape:	<b>C</b>

Street:	<b>FOXCROFT STREET</b>	Flow Control:	<b>Not Controlled</b>
City:	<b>Hobart, IN</b>	Year Renewed:	
Location:	<b>Yard</b>	Tape/Media #:	
Purpose:	<b>Routine Assessment</b>	Dia/Height:	<b>10"</b>
Use:	<b>Sanitary</b>	Material:	<b>XXX</b>
Drain Area:	<b>NA</b>	Lining:	<b>Cured in Place</b>
Category:	<b>NA</b>		
Comment:	<b>P_C at 283 ft debris</b>		
Location Details:		Direction of Survey:	<b>Downstream</b>
US MH:	<b>M-305-016</b>	DS MH:	<b>M-305-015</b>
		Total Length Surveyed (ft):	<b>284.2</b>

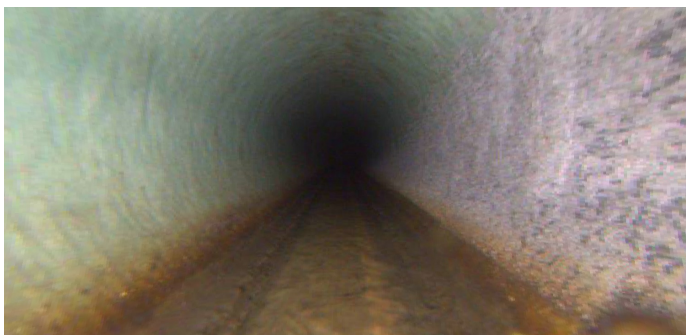
Code: **AMH**  
Description: **Manhole**

Distance (ft): **.0**  
Structural Grade: **0**  
O&M Grade: **0**  
Clock Start/From:  
Clock To:  
1st Value:  
2nd Value:  
Value Percent:  
Continuous Index:  
Within 8" of Joint: **NO**  
Remarks: **M-305-016**

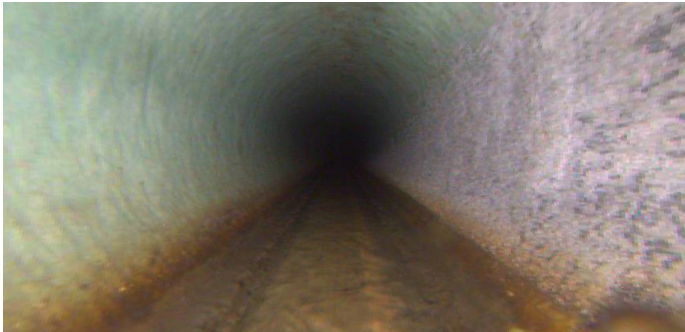
Code:	<b>MWL</b>
Description:	<b>Water Level</b>

Distance (ft):	<b>.0</b>
Structural Grade:	<b>0</b>
O&M Grade:	<b>0</b>
Clock Start/From:	
Clock To:	
1st Value:	
2nd Value:	
Value Percent:	<b>5.000</b>
Continuous Index:	
Within 8" of Joint:	<b>NO</b>
Remarks:

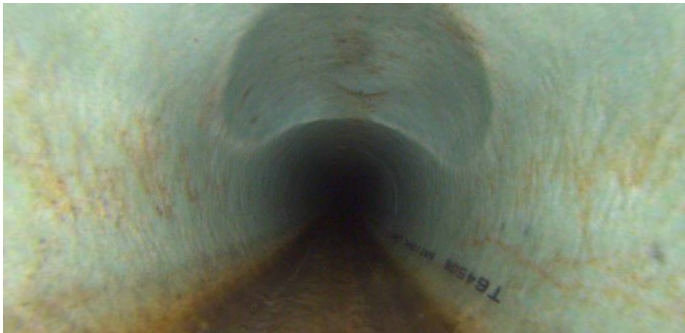
Code:	<b>LFAC</b>
Description:	<b>Lining Failure Abandoned Connection</b>

Distance (ft):	<b>9.7</b>
Structural Grade:	<b>0</b>
O&M Grade:	<b>0</b>
Clock Start/From:	<b>12</b>
Clock To:	
1st Value:	
2nd Value:	
Value Percent:	
Continuous Index:	
Within 8" of Joint:	<b>NO</b>
Remarks:

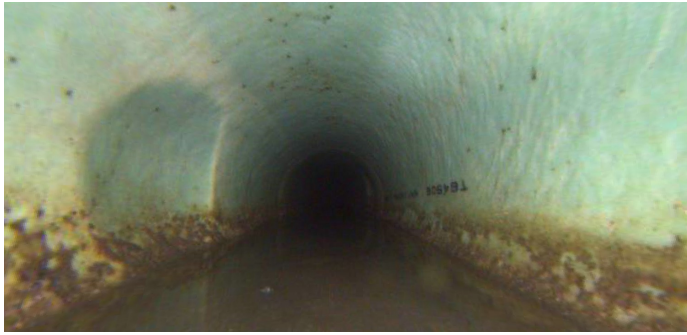
Code: **LFAC**  
Description: **Lining Failure Abandoned Connection**

Distance (ft): **106.1**  
Structural Grade: **0**  
O&M Grade: **0**  
Clock Start/From: **9**  
Clock To:  
1st Value:  
2nd Value:  
Value Percent:  
Continuous Index:  
Within 8" of Joint: **NO**  
Remarks:

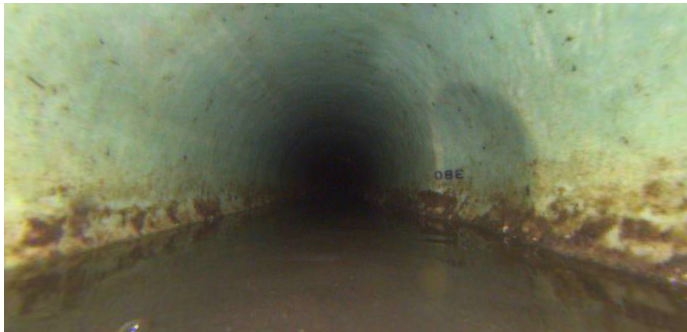
Code: **LFAC**  
Description: **Lining Failure Abandoned Connection**

Distance (ft): **108.1**  
Structural Grade: **0**  
O&M Grade: **0**  
Clock Start/From: **3**  
Clock To:  
1st Value:  
2nd Value:  
Value Percent:  
Continuous Index:  
Within 8" of Joint: **NO**  
Remarks:

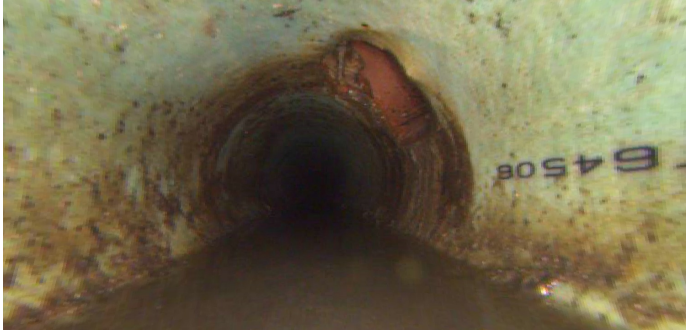
Code: **TB**  
Description: **Tap Break-in**

Distance (ft): **111.8**  
Structural Grade: **0**  
O&M Grade: **0**  
Clock Start/From: **1**  
Clock To:  
1st Value: **4.000**  
2nd Value:  
Value Percent:  
Continuous Index:  
Within 8" of Joint:  
Remarks:

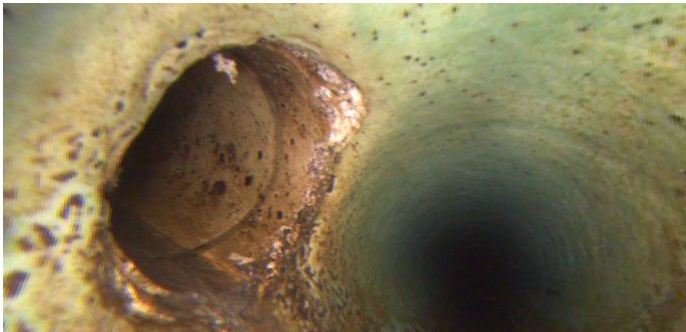
Code: **TB**  
Description: **Tap Break-in**

Distance (ft): **130.6**  
Structural Grade: **0**  
O&M Grade: **0**  
Clock Start/From: **10**  
Clock To:  
1st Value: **4.000**  
2nd Value:  
Value Percent:  
Continuous Index:  
Within 8" of Joint:  
Remarks:

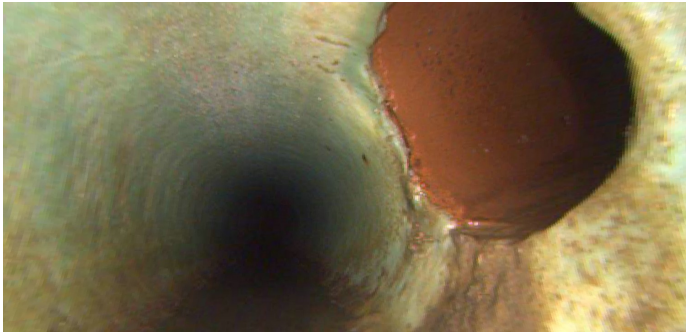
Code: **TB**  
Description: **Tap Break-in**

Distance (ft): **161.3**  
Structural Grade: **0**  
O&M Grade: **0**  
Clock Start/From: **2**  
Clock To:  
1st Value: **4.000**  
2nd Value:  
Value Percent:  
Continuous Index:  
Within 8" of Joint:  
Remarks:

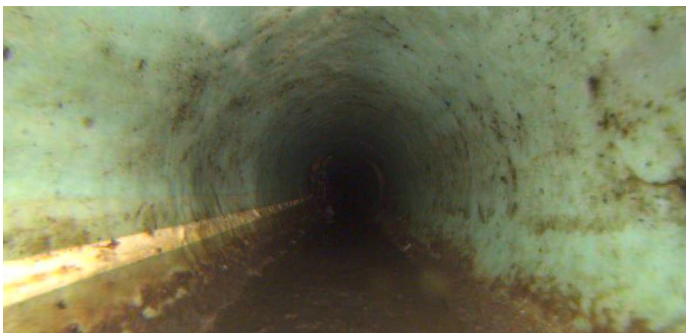
Code: **LFAC**  
Description: **Lining Failure Abandoned Connection**

Distance (ft): **194.2**  
Structural Grade: **0**  
O&M Grade: **0**  
Clock Start/From: **9**  
Clock To:  
1st Value:  
2nd Value:  
Value Percent:  
Continuous Index:  
Within 8" of Joint: **NO**  
Remarks:

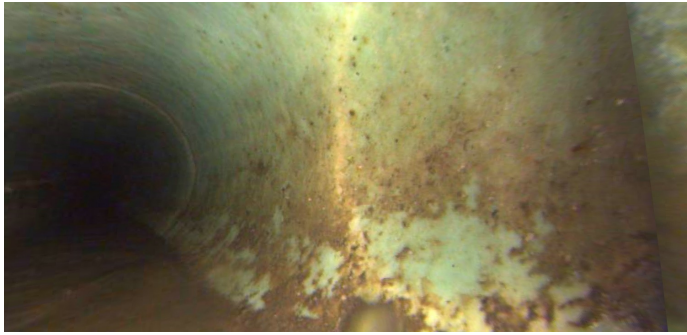
Code:	<b>LFAC</b>
Description:	<b>Lining Failure Abandoned Connection</b>
Distance (ft):	<b>196.9</b>
Structural Grade:	<b>0</b>
O&M Grade:	<b>0</b>
Clock Start/From:	<b>3</b>
Clock To:	
1st Value:	
2nd Value:	
Value Percent:	
Continuous Index:	
Within 8" of Joint:	<b>NO</b>
Remarks:

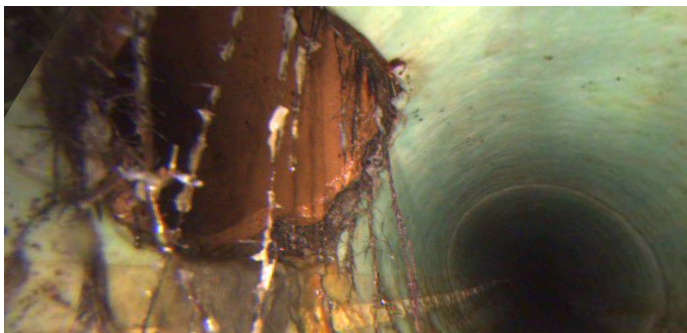
Code:	<b>TBD</b>
Description:	<b>Tap Break-in Defective</b>
Distance (ft):	<b>197.0</b>
Structural Grade:	<b>0</b>
O&M Grade:	<b>3</b>
Clock Start/From:	<b>10</b>
Clock To:	
1st Value:	<b>4.000</b>
2nd Value:	
Value Percent:	
Continuous Index:	
Within 8" of Joint:	
Remarks:	<b>roots</b>

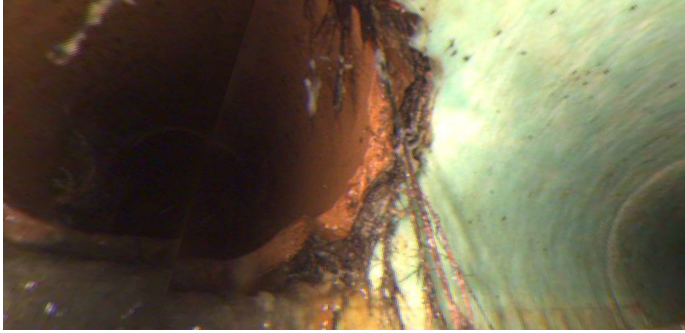
Code: **RFC**  
Description: **Roots Fine Connection**

Distance (ft): **197.4**  
Structural Grade: **0**  
O&M Grade: **1**  
Clock Start/From: **12**  
Clock To: **12**  
1st Value:  
2nd Value:  
Value Percent:  
Continuous Index:  
Within 8" of Joint: **NO**  
Remarks:

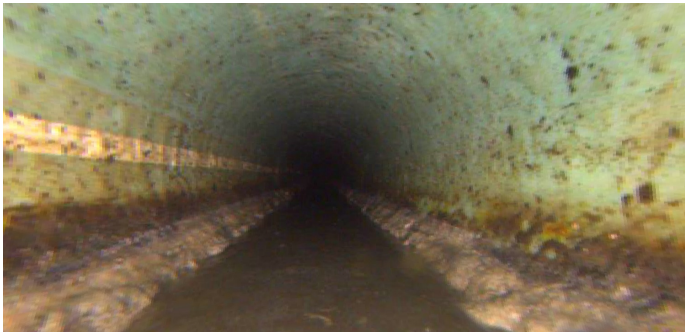
Code: **DAGS**  
Description: **Deposits Attached Grease**

Distance (ft): **215.9**  
Structural Grade: **0**  
O&M Grade: **2**  
Clock Start/From: **7**  
Clock To: **5**  
1st Value:  
2nd Value:  
Value Percent: **5.000**  
Continuous Index: **S01**  
Within 8" of Joint: **NO**  
Remarks: **7 and 5 oclock**

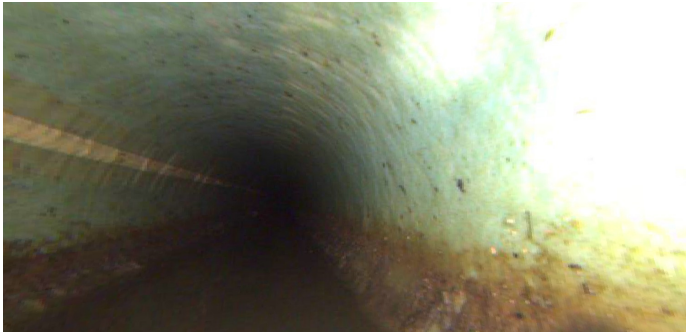
Code: **DAGS**  
Description: **Deposits Attached Grease**

Distance (ft): **248.8**  
Structural Grade: **0**  
O&M Grade: **2**  
Clock Start/From: **7**  
Clock To: **5**  
1st Value:  
2nd Value:  
Value Percent: **5.000**  
Continuous Index: **F01**  
Within 8" of Joint: **NO**  
Remarks: **7 and 5 oclock**

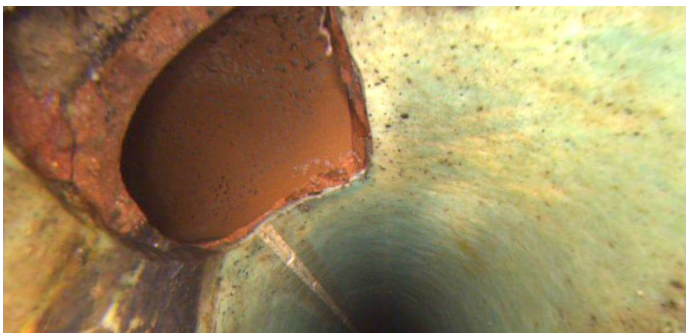
Code: **TBI**  
Description: **Tap Break-in Intruding**

Distance (ft): **266.0**  
Structural Grade: **0**  
O&M Grade: **2**  
Clock Start/From: **10**  
Clock To:  
1st Value: **4.000**  
2nd Value: **1.000**  
Value Percent:  
Continuous Index:  
Within 8" of Joint:  
Remarks:

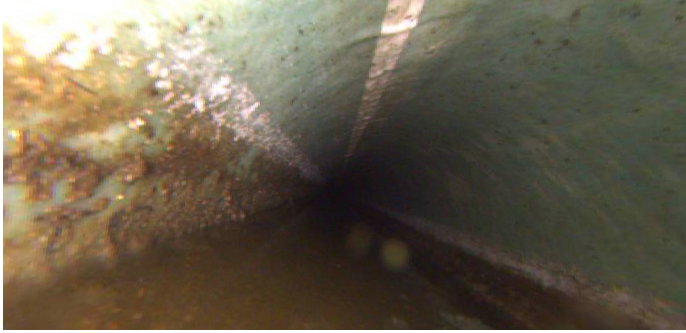
Code:	<b>MSA</b>
Description:	<b>Abandoned Survey</b>
Distance (ft):	<b>284.2</b>
Structural Grade:	<b>0</b>
O&M Grade:	<b>0</b>
Clock Start/From:	
Clock To:	
1st Value:	
2nd Value:	
Value Percent:	
Continuous Index:	
Within 8" of Joint:	<b>NO</b>
Remarks:	<b>stuck on wall</b>
