Profile/Photo Observation Report

Date:	04/18/2018	Weather:		Coding:	PACP 6.0
Pipe Length (ft):	316.2	Owner:	NA	Pre Clean:	No Pre-Cleaning
P.O.#:		Surveyor:	Byrd Fitzgerald	PSR:	P-305-016-015
Customer:		Clean Date:	01/01/1900	Shape:	C

Street:	WILDROSE DR	Flow Control:	Not Controlled
City:	Hobart, IN	Year Renewed:	
Location:	Yard	Tape/Media #:	
Purpose:	Routine Assessment	Dia/Height:	10"
Use:	Sanitary	Material:	VCP
Drain Area:	NA	Lining:	Cured in Place
Category:	NA		
Comment:

Location Details:		Direction of Survey:	Upstream
US MH:	M-305-016	DS MH:	M-305-015
		Total Length Surveyed (ft):	302.3

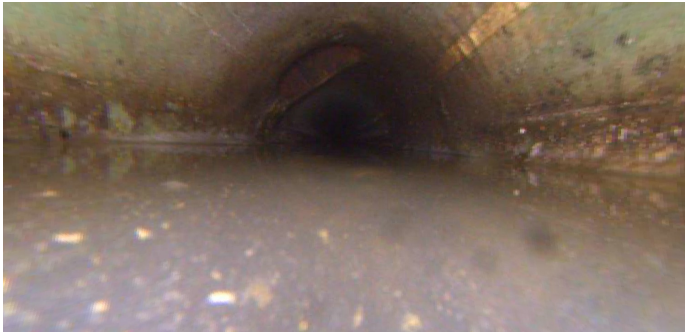
Code: **AMH**
Description: **Manhole**

Distance (ft): **.0**
Structural Grade: **0**
O&M Grade: **0**
Clock Start/From:
Clock To:
1st Value:
2nd Value:
Value Percent:
Continuous Index:
Within 8" of Joint: **NO**
Remarks: **M-305-015**

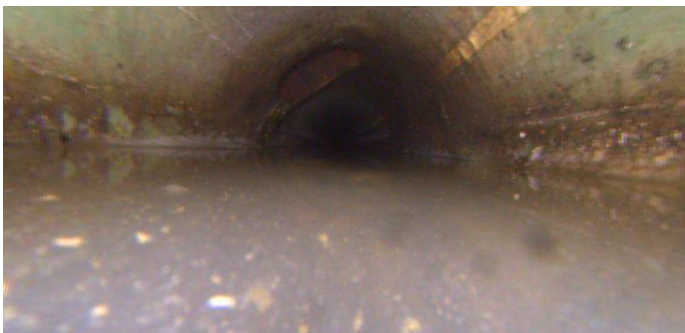
Code: **MWL**
Description: **Water Level**

Distance (ft): **.0**
Structural Grade: **0**
O&M Grade: **0**
Clock Start/From:
Clock To:
1st Value:
2nd Value:
Value Percent: **25.000**
Continuous Index:
Within 8" of Joint: **NO**
Remarks:

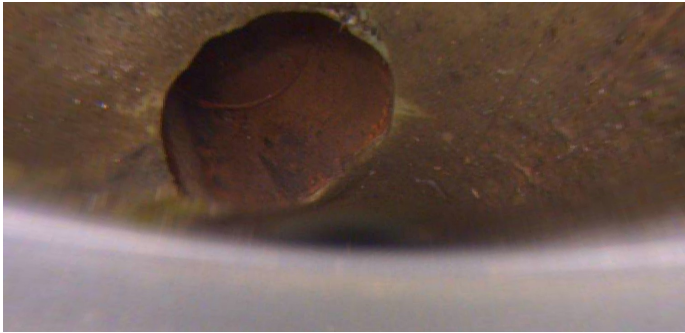
Code: **TB**
Description: **Tap Break-in**

Distance (ft): **2.2**
Structural Grade: **0**
O&M Grade: **0**
Clock Start/From: **11**
Clock To:
1st Value: **4.000**
2nd Value:
Value Percent:
Continuous Index:
Within 8" of Joint:
Remarks:

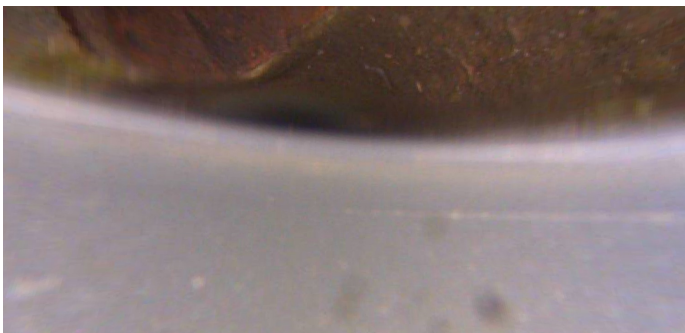
Code: **MWL**
Description: **Water Level**

Distance (ft): **2.2**
Structural Grade: **0**
O&M Grade: **0**
Clock Start/From:
Clock To:
1st Value:
2nd Value:
Value Percent: **70.000**
Continuous Index:
Within 8" of Joint: **NO**
Remarks:

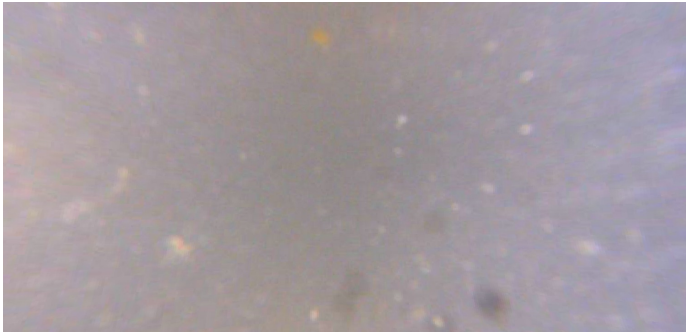
Code: **MCU**
Description: **Camera Underwater**

Distance (ft): **3.2**
Structural Grade: **0**
O&M Grade: **4**
Clock Start/From:
Clock To:
1st Value:
2nd Value:
Value Percent:
Continuous Index:
Within 8" of Joint: **NO**
Remarks:

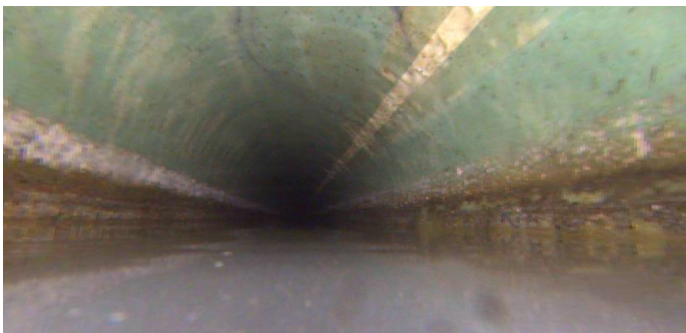
Code: **MWL**
Description: **Water Level**

Distance (ft): **10.7**
Structural Grade: **0**
O&M Grade: **0**
Clock Start/From:
Clock To:
1st Value:
2nd Value:
Value Percent: **5.000**
Continuous Index:
Within 8" of Joint: **NO**
Remarks:

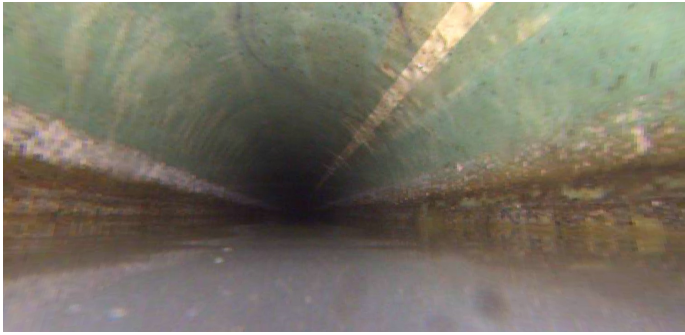
Code: **MWLS**
Description: **Water Level Sag**

Distance (ft): **10.7**
Structural Grade: **2**
O&M Grade: **3**
Clock Start/From:
Clock To:
1st Value:
2nd Value:
Value Percent: **5.000**
Continuous Index: **S01**
Within 8" of Joint: **NO**
Remarks:

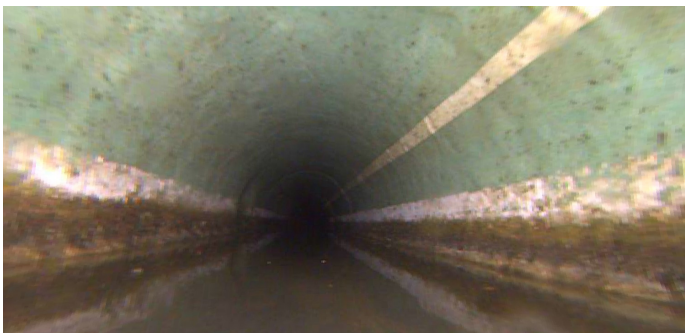
Code: **MWLS**
Description: **Water Level Sag**

Distance (ft): **23.7**
Structural Grade: **2**
O&M Grade: **3**
Clock Start/From:
Clock To:
1st Value:
2nd Value:
Value Percent: **5.000**
Continuous Index: **F01**
Within 8" of Joint: **NO**
Remarks:

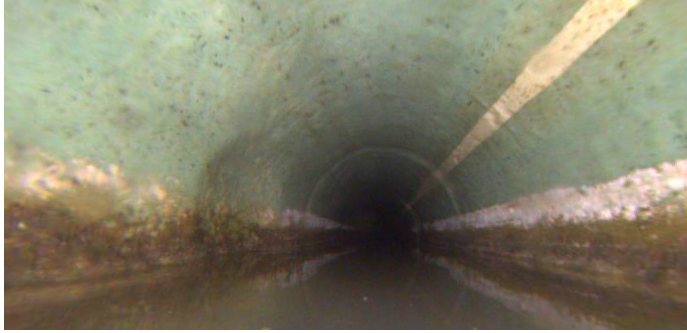
Code:	LFAC
Description:	Lining Failure Abandoned Connection
Distance (ft):	24.7
Structural Grade:	0
O&M Grade:	0
Clock Start/From:	9
Clock To:	
1st Value:	
2nd Value:	
Value Percent:	
Continuous Index:	
Within 8" of Joint:	NO
Remarks:

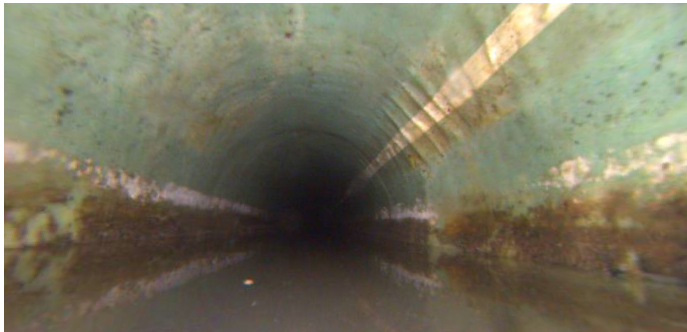
Code:	LFAC
Description:	Lining Failure Abandoned Connection
Distance (ft):	27.0
Structural Grade:	0
O&M Grade:	0
Clock Start/From:	3
Clock To:	
1st Value:	
2nd Value:	
Value Percent:	
Continuous Index:	
Within 8" of Joint:	NO
Remarks:

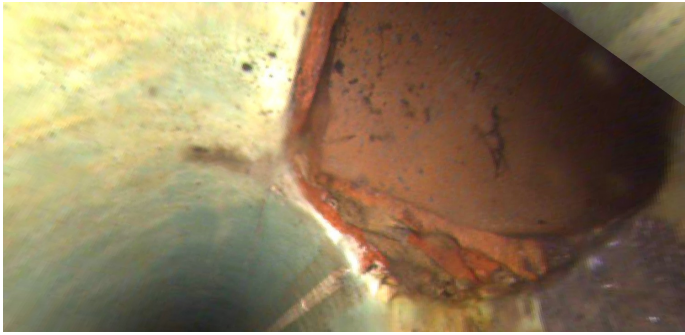
Code: **TB**
Description: **Tap Break-in**

Distance (ft): **34.5**
Structural Grade: **0**
O&M Grade: **0**
Clock Start/From: **2**
Clock To:
1st Value: **4.000**
2nd Value:
Value Percent:
Continuous Index:
Within 8" of Joint:
Remarks:

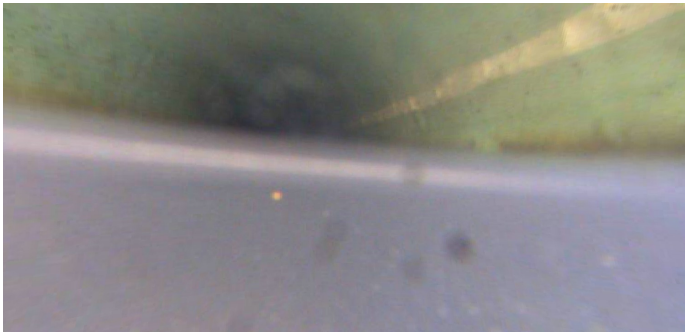
Code: **MCU**
Description: **Camera Underwater**

Distance (ft): **63.5**
Structural Grade: **0**
O&M Grade: **4**
Clock Start/From:
Clock To:
1st Value:
2nd Value:
Value Percent:
Continuous Index:
Within 8" of Joint: **NO**
Remarks: **partially**

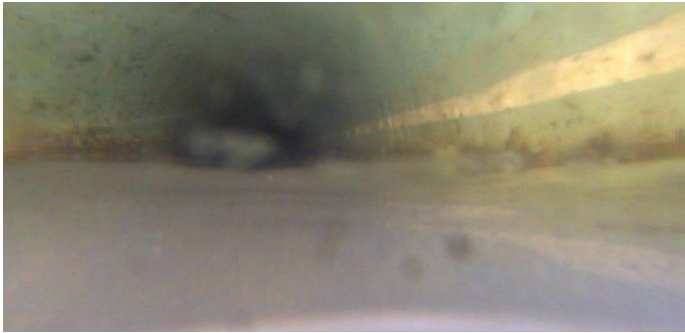
Code: **MWL**
Description: **Water Level**

Distance (ft): **72.9**
Structural Grade: **0**
O&M Grade: **0**
Clock Start/From:
Clock To:
1st Value:
2nd Value:
Value Percent: **25.000**
Continuous Index:
Within 8" of Joint: **NO**
Remarks:

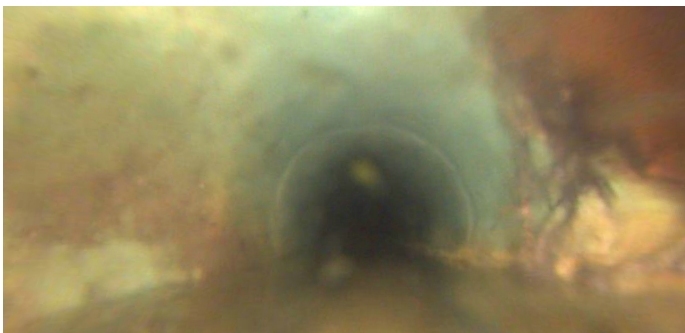
Code: **LFAC**
Description: **Lining Failure Abandoned Connection**

Distance (ft): **103.6**
Structural Grade: **0**
O&M Grade: **0**
Clock Start/From: **9**
Clock To:
1st Value:
2nd Value:
Value Percent:
Continuous Index:
Within 8" of Joint: **NO**
Remarks:

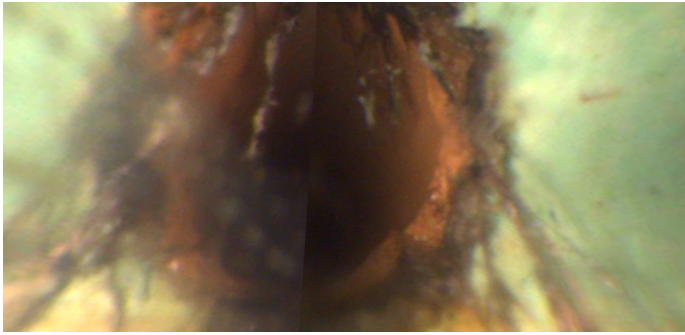
Code: **TBD**
Description: **Tap Break-in Defective**

Distance (ft): **103.9**
Structural Grade: **0**
O&M Grade: **3**
Clock Start/From: **2**
Clock To:
1st Value: **4.000**
2nd Value:
Value Percent:
Continuous Index:
Within 8" of Joint:
Remarks: **roots**

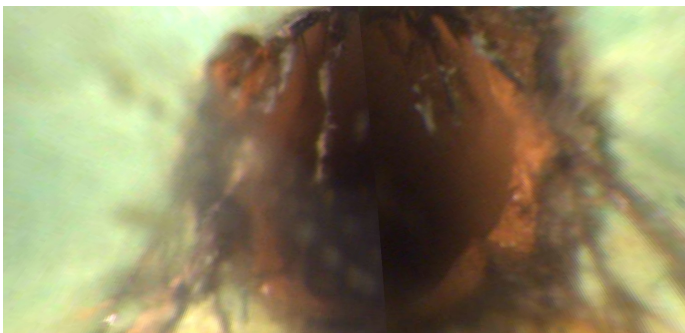
Code: **RFC**
Description: **Roots Fine Connection**

Distance (ft): **103.9**
Structural Grade: **0**
O&M Grade: **1**
Clock Start/From: **7**
Clock To: **5**
1st Value:
2nd Value:
Value Percent:
Continuous Index:
Within 8" of Joint: **NO**
Remarks:

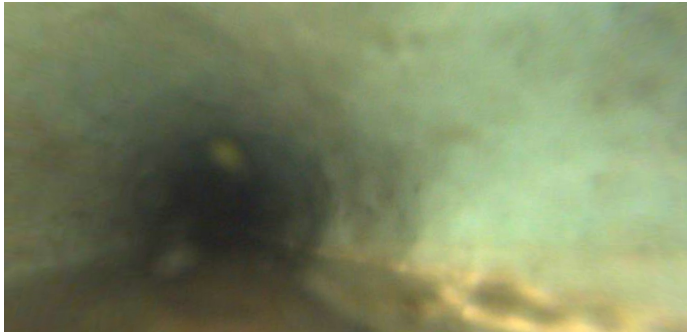
Code:	LFAC
Description:	Lining Failure Abandoned Connection
Distance (ft):	105.3
Structural Grade:	0
O&M Grade:	0
Clock Start/From:	3
Clock To:	
1st Value:	
2nd Value:	
Value Percent:	
Continuous Index:	
Within 8" of Joint:	NO
Remarks:

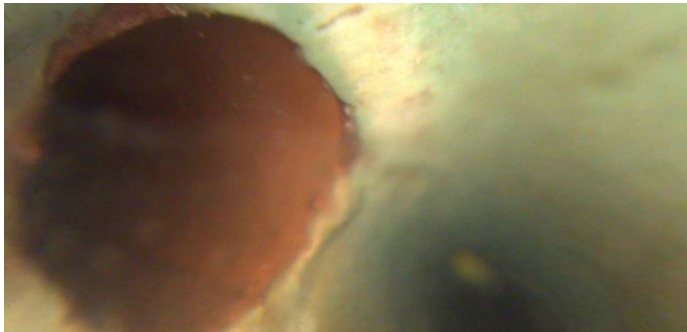
Code:	TB
Description:	Tap Break-in
Distance (ft):	139.1
Structural Grade:	0
O&M Grade:	0
Clock Start/From:	10
Clock To:	
1st Value:	4.000
2nd Value:	
Value Percent:	
Continuous Index:	
Within 8" of Joint:	
Remarks:

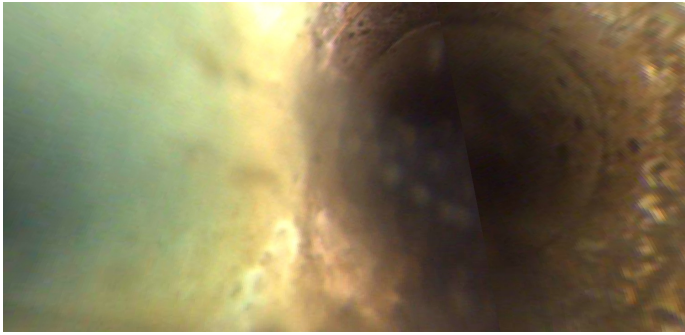
Code: **TB**
Description: **Tap Break-in**

Distance (ft): **170.2**
Structural Grade: **0**
O&M Grade: **0**
Clock Start/From: **3**
Clock To:
1st Value: **4.000**
2nd Value:
Value Percent:
Continuous Index:
Within 8" of Joint:
Remarks:

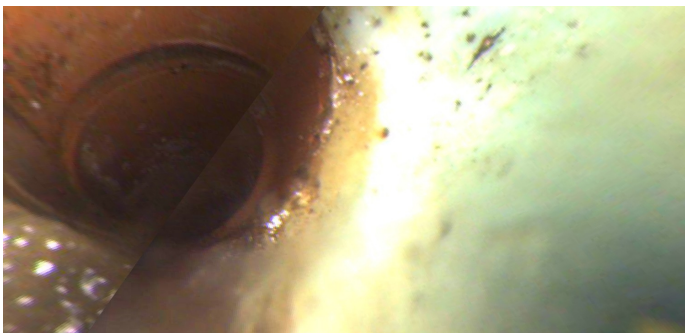
Code: **TB**
Description: **Tap Break-in**

Distance (ft): **188.5**
Structural Grade: **0**
O&M Grade: **0**
Clock Start/From: **11**
Clock To:
1st Value: **4.000**
2nd Value:
Value Percent:
Continuous Index:
Within 8" of Joint:
Remarks:

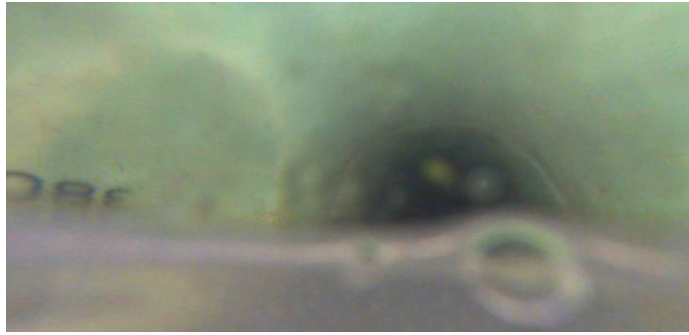
Code:	LFAC
Description:	Lining Failure Abandoned Connection
Distance (ft):	191.9
Structural Grade:	0
O&M Grade:	0
Clock Start/From:	9
Clock To:	
1st Value:	
2nd Value:	
Value Percent:	
Continuous Index:	
Within 8" of Joint:	NO
Remarks:

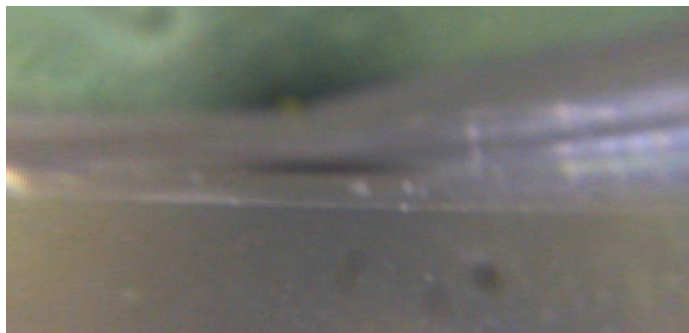
Code:	MCU
Description:	Camera Underwater
Distance (ft):	193.8
Structural Grade:	0
O&M Grade:	4
Clock Start/From:	
Clock To:	
1st Value:	
2nd Value:	
Value Percent:	
Continuous Index:	
Within 8" of Joint:	NO
Remarks:

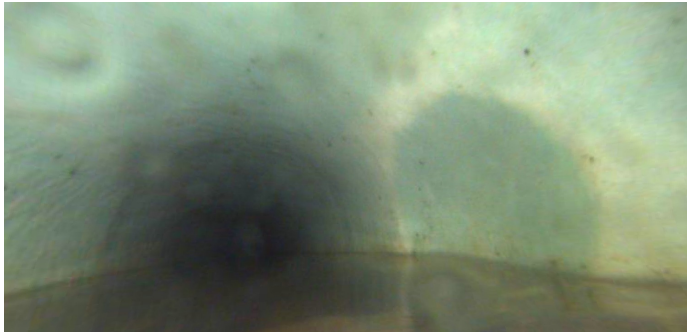
Code:	LFAC
Description:	Lining Failure Abandoned Connection
Distance (ft):	194.0
Structural Grade:	0
O&M Grade:	0
Clock Start/From:	3
Clock To:	
1st Value:	
2nd Value:	
Value Percent:	
Continuous Index:	
Within 8" of Joint:	NO
Remarks:

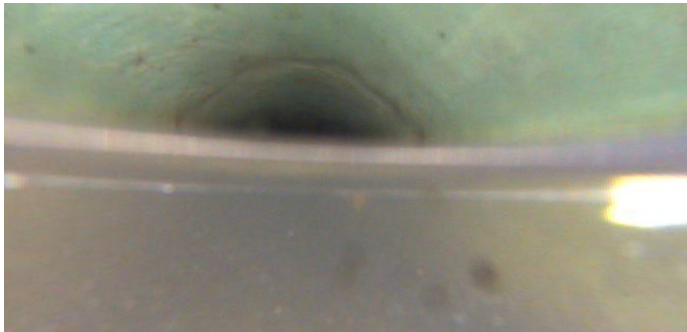
Code:	MCU
Description:	Camera Underwater
Distance (ft):	199.1
Structural Grade:	0
O&M Grade:	4
Clock Start/From:	
Clock To:	
1st Value:	
2nd Value:	
Value Percent:	
Continuous Index:	
Within 8" of Joint:	NO
Remarks:

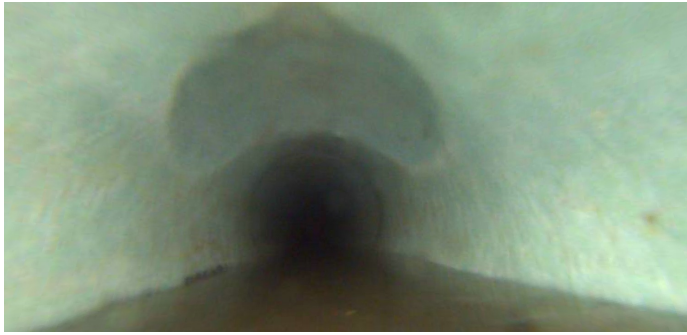
Code:	LFAC
Description:	Lining Failure Abandoned Connection
Distance (ft):	289.6
Structural Grade:	0
O&M Grade:	0
Clock Start/From:	12
Clock To:	
1st Value:	
2nd Value:	
Value Percent:	
Continuous Index:	
Within 8" of Joint:	NO
Remarks:

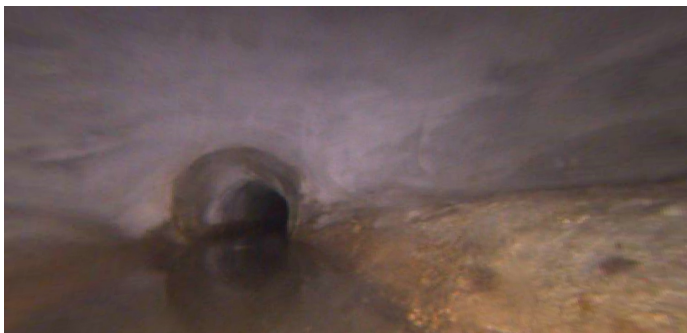
Code:	AMH
Description:	Manhole
Distance (ft):	302.3
Structural Grade:	0
O&M Grade:	0
Clock Start/From:	
Clock To:	
1st Value:	
2nd Value:	
Value Percent:	
Continuous Index:	
Within 8" of Joint:	NO
Remarks:	M-305-016
